Customer: Cintas

Situation: Auxiliary heater may blow fuse on main dash harness

Corrective Action Summary: Replace heater switch and route new

power harness with inline fuse from battery

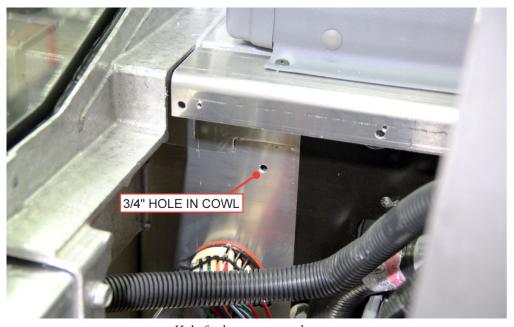
Hole for battery power harness

- 1. Disconnect the **Negative (-)** battery cable(s).
- 2. Use an F-bit to drill a pilot hole in the LH cowl.
- 3. Use a 3/4" bit to enlarge hole.

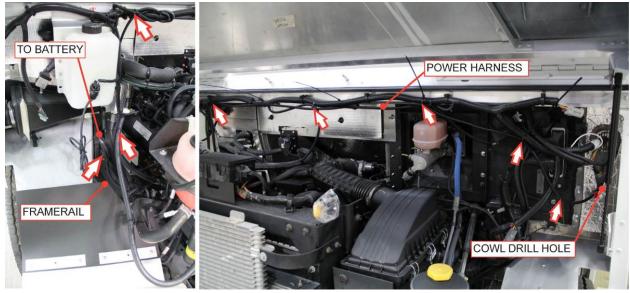
Power harness secured to cowl harness to frame rail

- 4. Feed the heater power supply harness through cowl riser, apply sealant to harness bushing and secure.
- 5. Route power harness along the cowl harness, RH chassis harness and frame rail to the battery box.

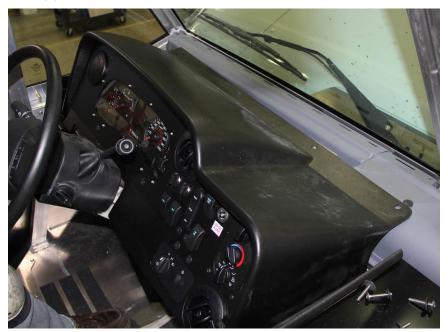
Dash hood

6. Remove (6) screws from the dash hood and set aside.

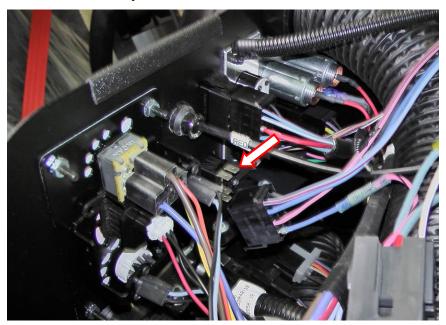
Auxiliary heater switch

7. Disconnect the auxiliary heater control switch and discard.

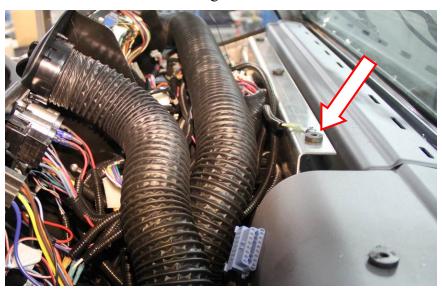
Relay Ground wire

- 8. Drill a 7/32" hole in the dash bracket.
- 9. Cut and strip Ground wire and crimp a ring terminal and terminal connector to each end.
- 10. Secure the WHITE Ground wire ring terminal to the cowl with a 1/4-20 fastener.

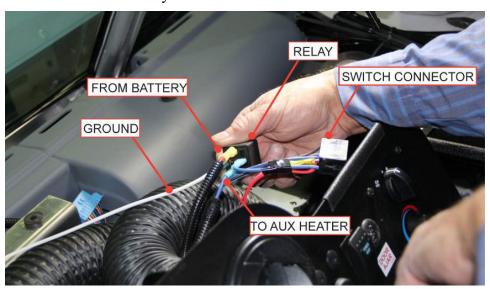
Switch wiring

- 11. Cut, strip and crimp a terminal connector to the RED battery harness.
- 12. Cut the DARK BLUE switch wire. Strip wires and crimp terminal connectors to both ends.
- 13. Connect RED Battery harness, both DARK BLUE heater power switch and Ground terminals to relay.

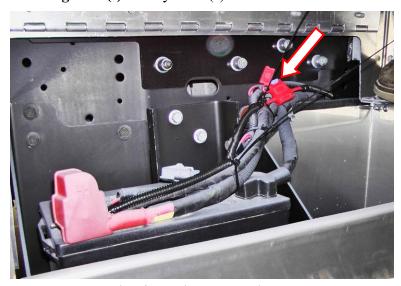
Inline fuse on heater power harness

- 15. Install inline fuse at battery box.
- 16. Connect to **Positive (+)** battery terminal.
- 17. Connect the **Negative (-)** battery cable(s).

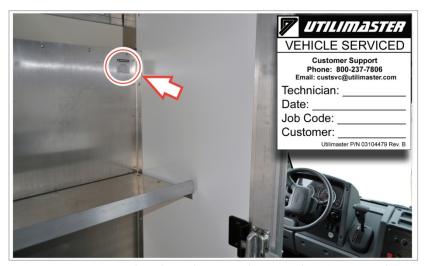
Service decal on driver's door pocket (cargo side)

- 21. Use Job Code 13-N3-91-Z4 from this document to complete the SERVICED decal.
- 22. Adhere the decal to the upper right-hand corner of the driver's door pocket panel next to the bulkhead wall. Do NOT cover any previously applied decals.
