Suspension Bushings Leaking

Vehicle Type: Sports Cars (9x1)

Model Year: 2012 - Present

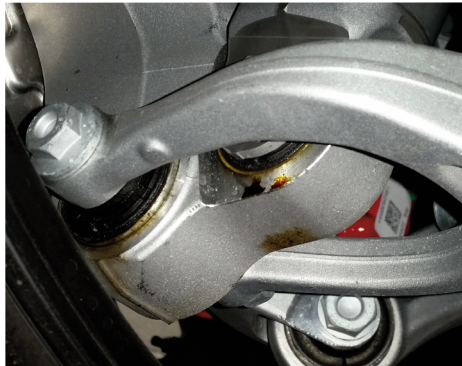
Information: Suspension bushings appear to be leaking.

When suspension bushings are installed, an assembly lubricant is used. It is possible that over time this lube will weep and appear to be a leak from a bushing that is not hydraulic.

Verify that fluid is not leaking from other components such as shocks or struts and clean off the weeping lube.

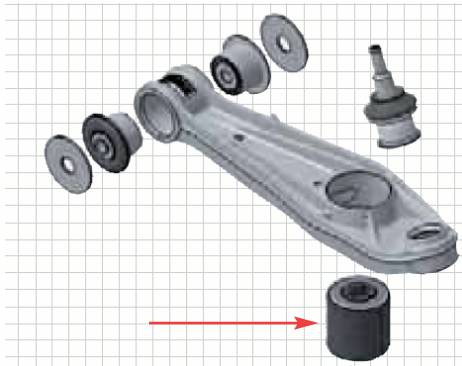
The only hydraulic bushing on the 9X1 vehicles is in the lower control arm of the front suspension.
