**No.: 16 TS-1**  
January 13, 2016

SUBJECT: **Misdiagnosed High Pressure Fuel Pump**

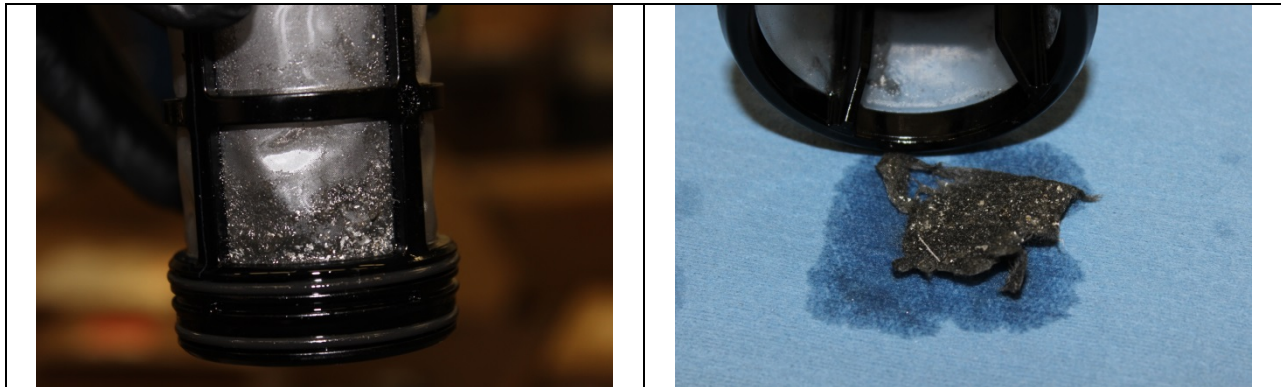
Pre Filter

Table 1 gives examples of typical debris in the fuel filters/filter bowls that are not associated with a high pressure fuel pump failure.

The troubleshooting and repair strategy has been updated for the two-filter fuel system and must be utilized immediately. Inspecting the fuel filters is no longer part of the metal in fuel troubleshooting. Replacing the fuel injectors is no longer required or permitted for high pressure fuel pump failure.
