Service Bulletin

Object: **Front headlight replacement**

Product: **Brutale 800 MY 2016**

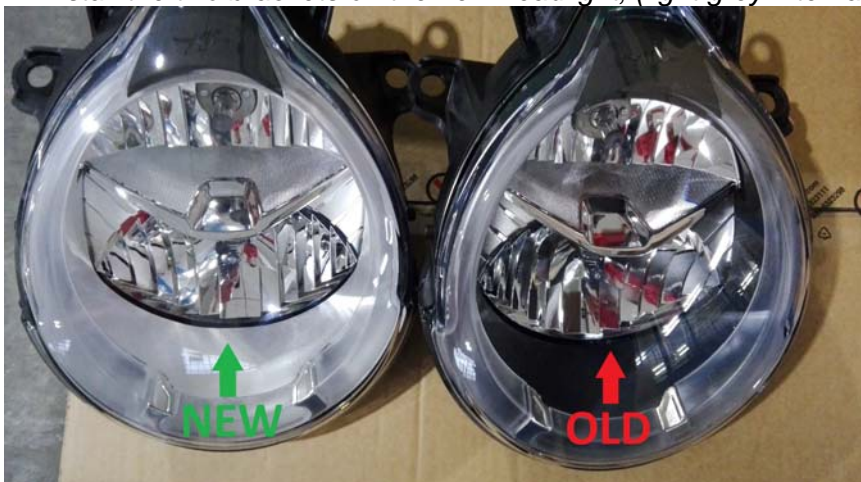
Further to the continuous quality improvement process of our products, we found that on some bikes Brutale 800 MY 2016 the headlight might suffer of dulling effects in the front side.

- *Remove the 4 screws that hold the support's bracket of the headlight.*
- *Disconnect the electrical connectors from the headlight and from the turn signals .*
- *Then remove the two support's brackets (RH and LH) from the headlight.*
- *Install the two brackets on the new headlight, (light grey internal surface).*

- *Complete the repair in all its parts*
- *Test the motorcycle before delivery to the customer*
