NUMBER: 08-004-16

Two Underhood Relays Not Capped and Unsecured

2016 (JK) Jeep Wrangler

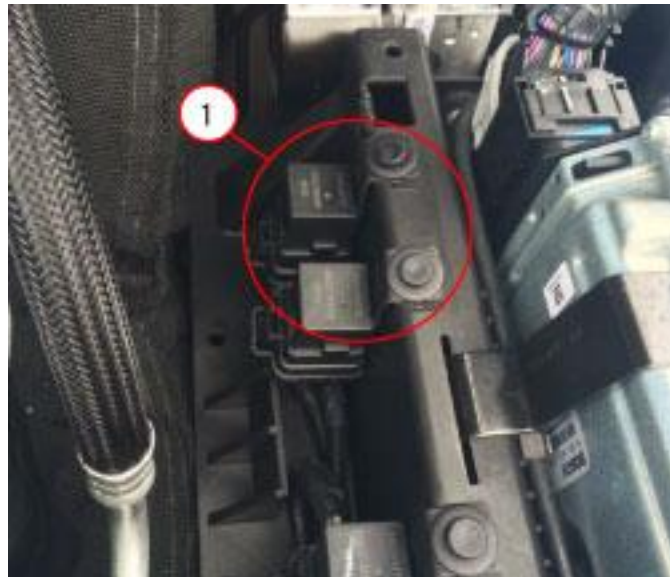
Fig. 3 Fasten Relays to Component Tray

1 - Fasten relays to tray.

3. Attach the relay to the component tray with PIA push pins as shown ([Fig. 3](#)).
