NUMBER: 08-060-16

Electronic Parking Brake Module Connector Water Intrusion

2014 - 2016 (KL) Jeep Cherokee

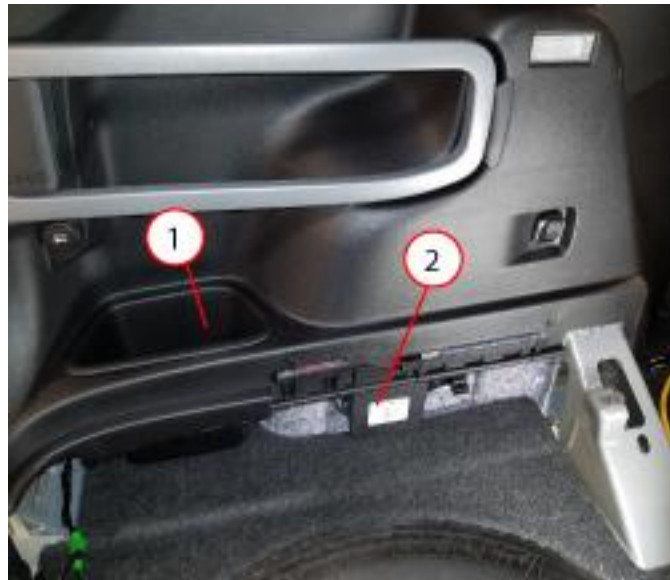
Fig. 1 Location of EPB Module

1. The Electronic Parking Brake (EPB) module is located in the back left side of the cargo area interior, near the spare tire (Fig. 1) and is attached by a slide locking retainer and fastener.

- 1 - Storage Bin
- 2 - EPB Module Location (Shown with Load floor Support Removed)

-
2. Remove EPB module hold down nut.

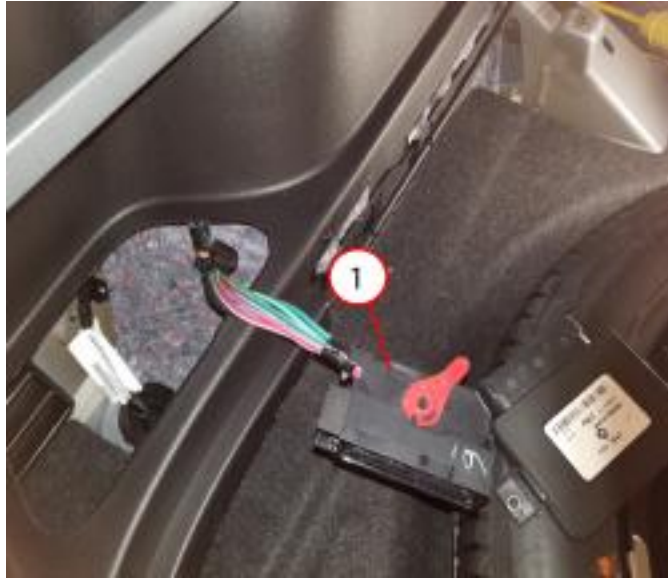
Fig. 2 Pull EPB Module and Connector Through Cutaway For Inspection

1 - EPB Module and Connector Pulled Through Cutaway

3. Remove the storage bin and pull EPB Module and connector through opening (Fig. 2).

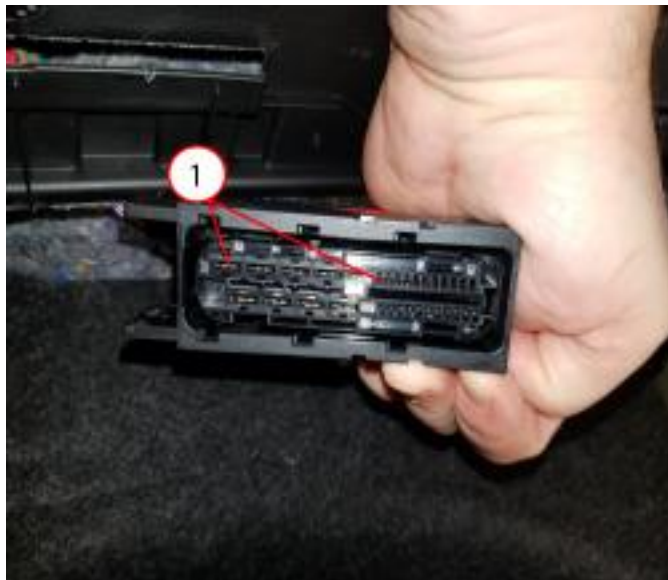
Fig. 3 Connector Face Inspection

1 - Check Connectors for Corrosion

4. Remove the connector and inspect for terminal corrosion (Fig. 3).

5. Is there evidence of corrosion on the terminal(s)?
 - a. YES>>> Proceed to [Step #6](#).
 - b. NO>>> This Bulletin does not apply. Normal diagnosis should be performed.
6. Remove interior trim panels to allow access to the harness for EPB connector pigtail replacement ([Fig. 4](#)).

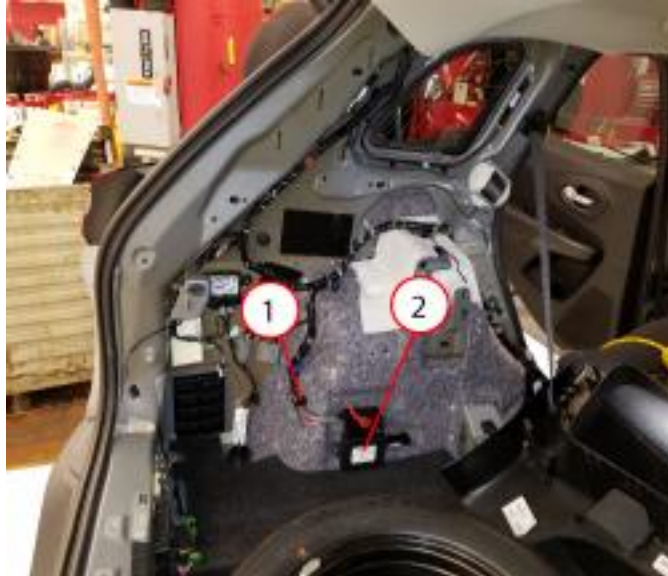
Fig. 4 Interior Trim Panels Removed For Access

- 1 - Wire/Cable Hold-down
 - 2 - EPB Module
-

7. Replace EPB Module and connector.

CAUTION: The orange and yellow wires are a twisted pair for shielding purposes, take care to continue twist and at the same rate for the orange and yellow wires.
