NUMBER: 10-003-16

Rear Outboard Seat Belt Is Slow To Retract

2016 (FB) Fiat 500X

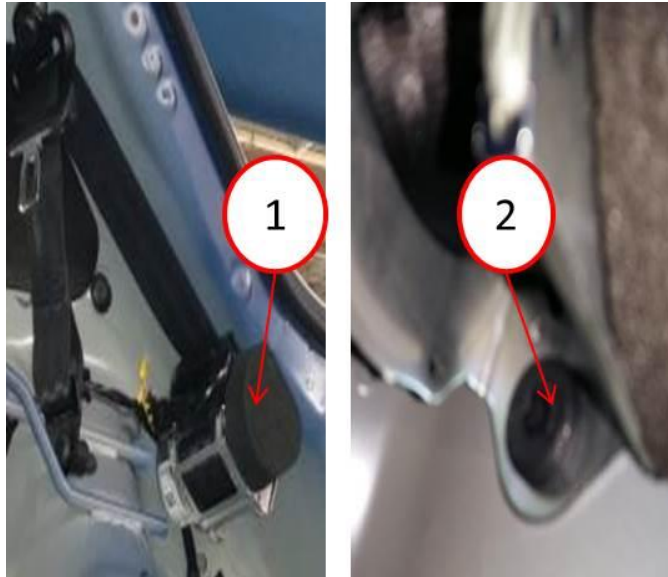
Fig. 1 Seat Belt Retractor

1 - Retractor

2 - Seat Belt Retractor Bolt

2. Remove the seat belt bolt that secures the retractor to the quarter inner panel ([Fig. 1](#)).

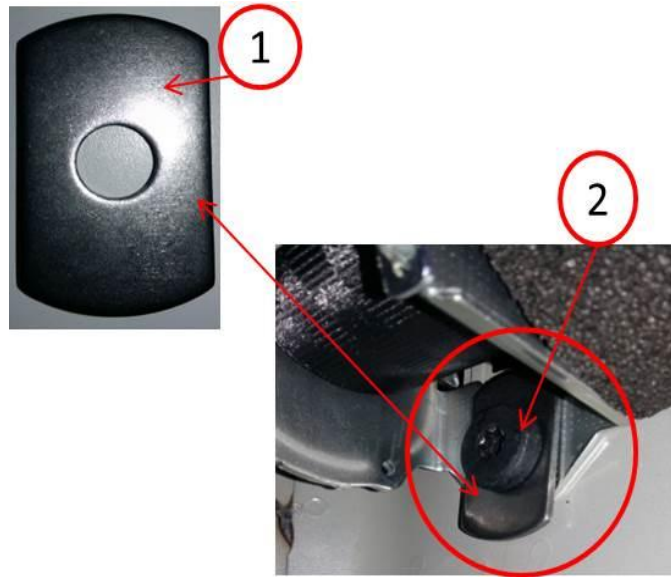
Fig. 2 Additional Washer To Add

1 - Washer

2 - Washer Added To The Seat Belt Retractor Bolt

- 3. Add a washer on the bolt between the bolt and seat belt retractor (Fig. 2). Tighten to 40 N·m (30 ft. lbs).
