NUMBER: 08-062-16

Front Seat Bottom Cushion Hard Or Lumpy Spot

2015 (UF) Chrysler 200

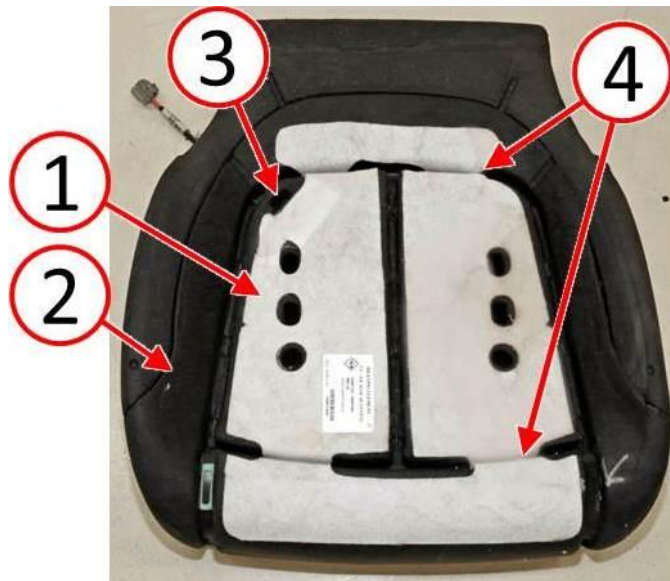
Fig. 2 Install New Heater Pad To Foam Cushion

NOTE: Ensure the heated seat pad wire harness lays flat and is guided into the pass-through (3) without kinking (**Fig. 2**).

NOTE: Ensure the heated seat pad (1) is tucked fully into the seat foam cushion channels (4) at front and back of the foam cushion and the heater pad lays flat on the foam cushion without wrinkles (**Fig. 2**).

- 1 - Heated Seat Pad
- 2 - Seat Foam Cushion
- 3 - Heating Pad Wiring Pass-Through
- 4 - Tuck Heater Pad Fully Into Cushion Channel

5. Assemble the **NEW** heated pads (1) to the **NEW** drivers seat cushion and passengers seat foam cushion kit (2) (). Refer to the detailed service procedures available in DealerCONNECT> TechCONNECT under: Service Info> 08 - Electrical> 8G - Heated/Cooled Systems> Heated Seats> Pad, Heater> Installation.

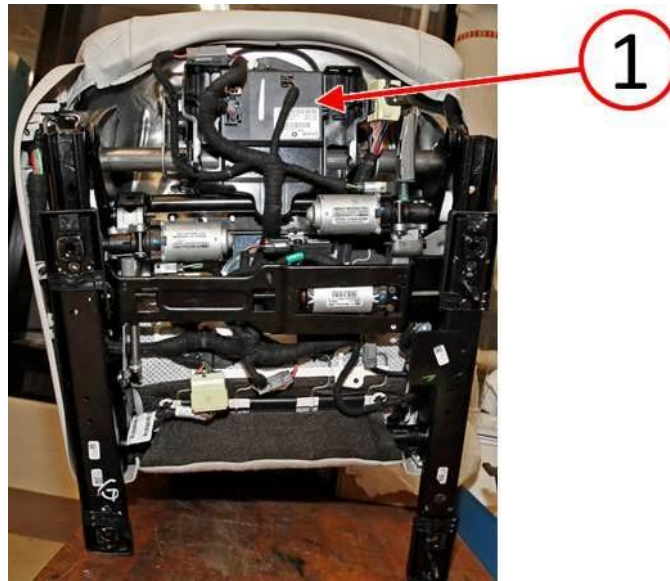
Fig. 4 CSWM Location Under Passenger Side Seat

1 - CSWM

8. ** Replace the OCM to the passenger seat structure. Refer to the detailed service procedures available in DealerCONNECT> TechCONNECT under: 08 - Electrical/8E - Electronic Control Modules/Module, Occupant Classification/Removal/Installation.**
9. Assemble the seat cover to the bottom foam cushion using new hog rings, then install the seat bottom cushion with cover to the seat. Refer to the detailed service procedures available in DealerCONNECT> TechCONNECT under: Service Info> 23 - Body> Seats, Front> COVER, Seat Cushion> Installation.
10. Replace the CSWM (1) located under the passenger side seat (Fig. 4). Obtain the appropriate module from the Parts Required list. Refer to the detailed service procedures available in DealerCONNECT> TechCONNECT under: Service Info> 08 - Electrical> 8E - Electronic Control Modules> Module, Comfort Seat and Wheel> Removal/Installation.
