# Technical Bulletin

55 16 03 February 17, 2016 2039446 Supersedes Technical Bulletin V551501 dated January 28, 2015 to include Passat, Passat Wagon and A5 Jetta SportWagen.

### Corrosion Hood Edge

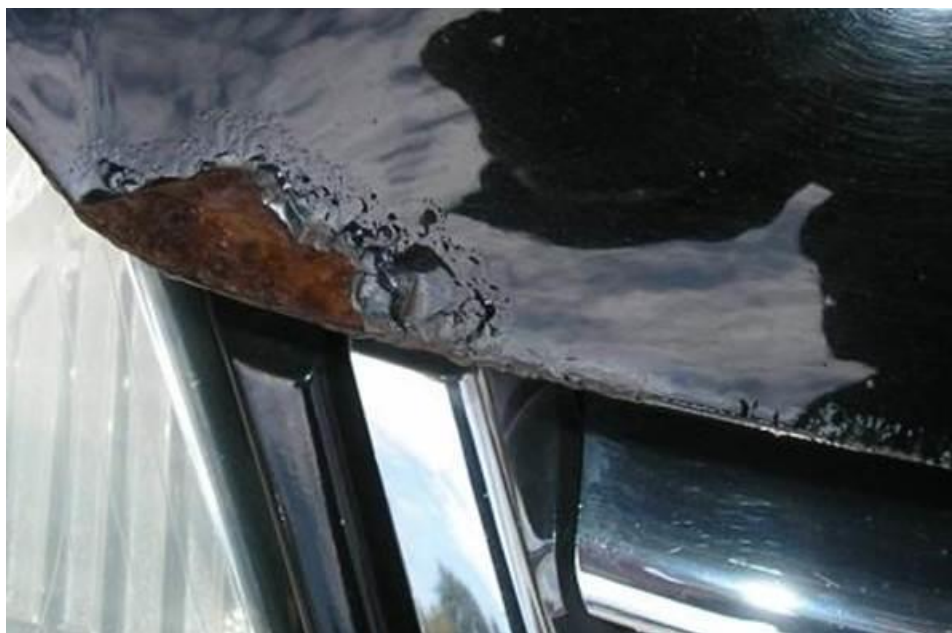
Corrosion may be found on the folded edge of the hood. The corrosion may be found on this edge anywhere around the hood.

- Remove the Hood from the vehicle. See Repair Group 55 in Elsa.
- Remove the corrosion with Pneumatic Brush Grinder Set -VAS6446 or similar tool.
- Sand the overlapping areas with P360 - P400 sandpaper.

- Clean the base surface with a VOC compliant cleaning solution.
- After a corrosion repair and before sealing, insulate the base surface with a Two-Part Wash Primer and then fill with Two-Part HS Performance Filler. (Both Locally Sourced).

- After the filler has dried, the filled area must be dry sanded with P400- P500. While doing so, make sure to avoid "sanding through". Then clean the sanded areas with a VOC compliant cleaning solution.

- After the filler has dried and has been sanded, the metal edges in the fold area must be thinly sealed with Polyurethane adhesive -AKD 476 KD5 05.
- Paint the hood according to Volkswagen specifications.

- Install the hood on the vehicle. See Repair Group 55 in Elsa.

- When repairing, the seam sealant is to be returned to replicate stock visual appearance and layer thickness.
- In order to avoid damage and malfunctions, seam sealant must be applied smoothly in the area of attached components.
- Water drain holes must remain free.
