# Technical Bulletin

**60 16 01** February 1, 2016 **2043031**

### **Rattle or Creaking Noise from Panoramic Sunroof**

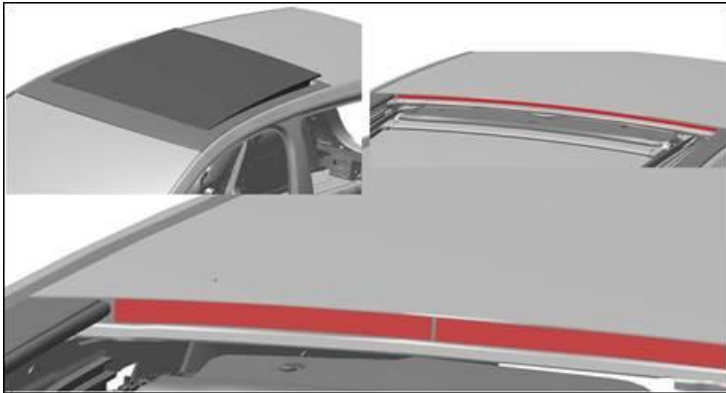
Figure 1) Area to apply the self-adhesive film (glass panel removed for illustration purposes).

- Cut the protective film sheet (part number AKL 448 300 04) into 3 strips 12 mm wide x 290 mm (290 mm is the length of the long side of the protective film sheet).
- Move the glass panel to the tilt open position.
- Thoroughly clean the contact area between the rear glass panel seal and the body.
- Apply the self-adhesive protective film strip to the body (Figure 1, in red).
- Close the glass panel.
