## Service Bulletin

Bulletin No.: 16-NA-003

**Subject:** Chirp, Squeak Noise from Rear of Vehicle

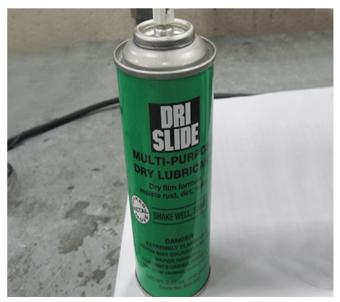
4340714

**Important:** Regardless the noisy valve location, lubricate ALL exhaust valves on the system.

Generously lubricate the forward, and rear if equipped, exhaust valves following the steps below:

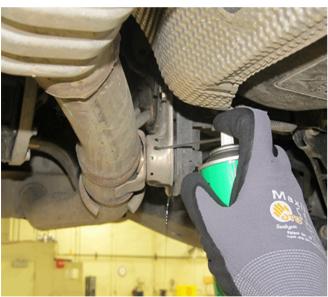
4340727

Apply DRY SLIDE Multi-Purpose Dry Lubricant, P/N 1052948 (in Canada, use 89021511), into the valve by inserting the nozzle into the slot on the valve. Liberally apply a generous amount of the lubricant.
