Service Bulletin

Subject: RKE / Passive Entry And Start / No Audio / SWC / Touch Screen / Display Blank/ Rear Wiper And Rear Power Windows Inoperative / Dead Battery / Service Tire Pressure System DTC B3101 B144C C0710 C0544 U0028 U0029 U0077 U0126 U0151 U0415 U1548 U1549 U154A

Models: 2015-2016 Cadillac Escalade Models
2014 Chevrolet Silverado 1500
2015-2016 Chevrolet Silverado, Suburban, Tahoe
2014 GMC Sierra 1500
2015-2016 GMC Sierra, Yukon Models

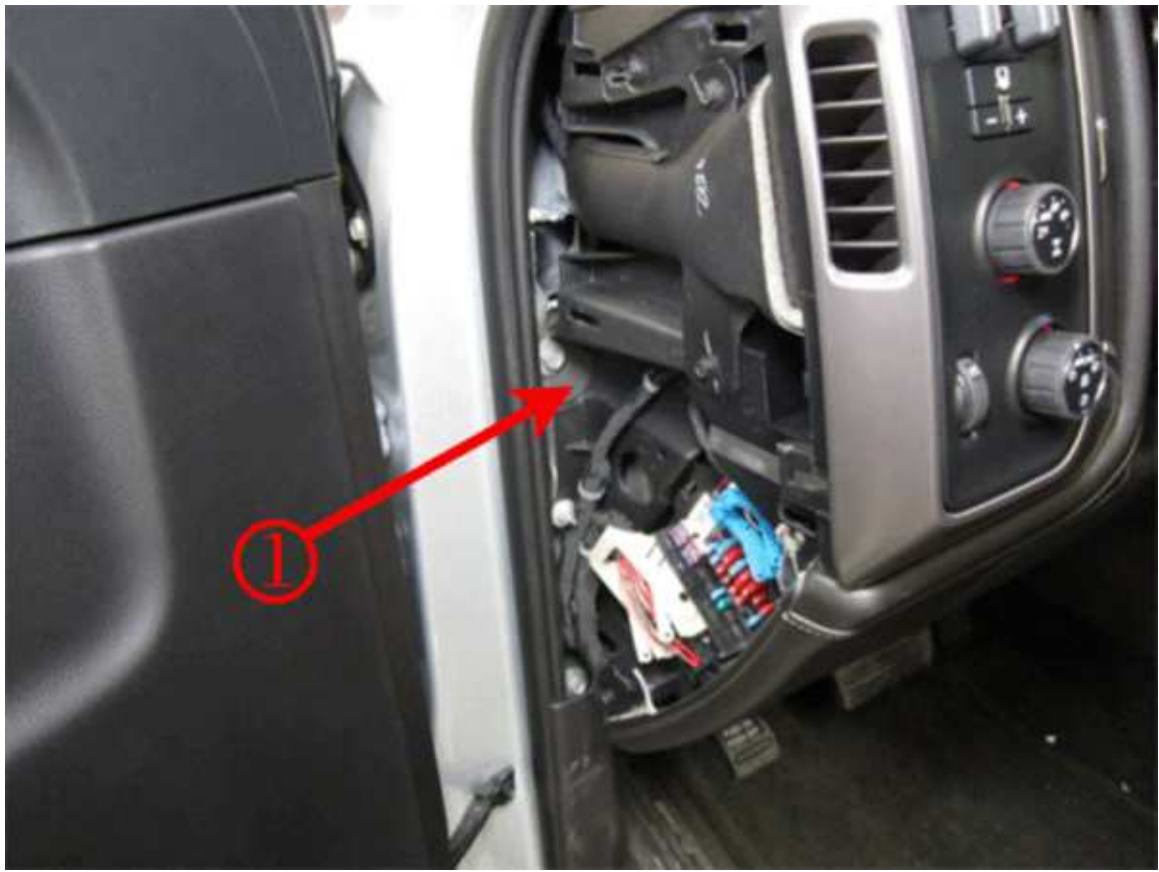
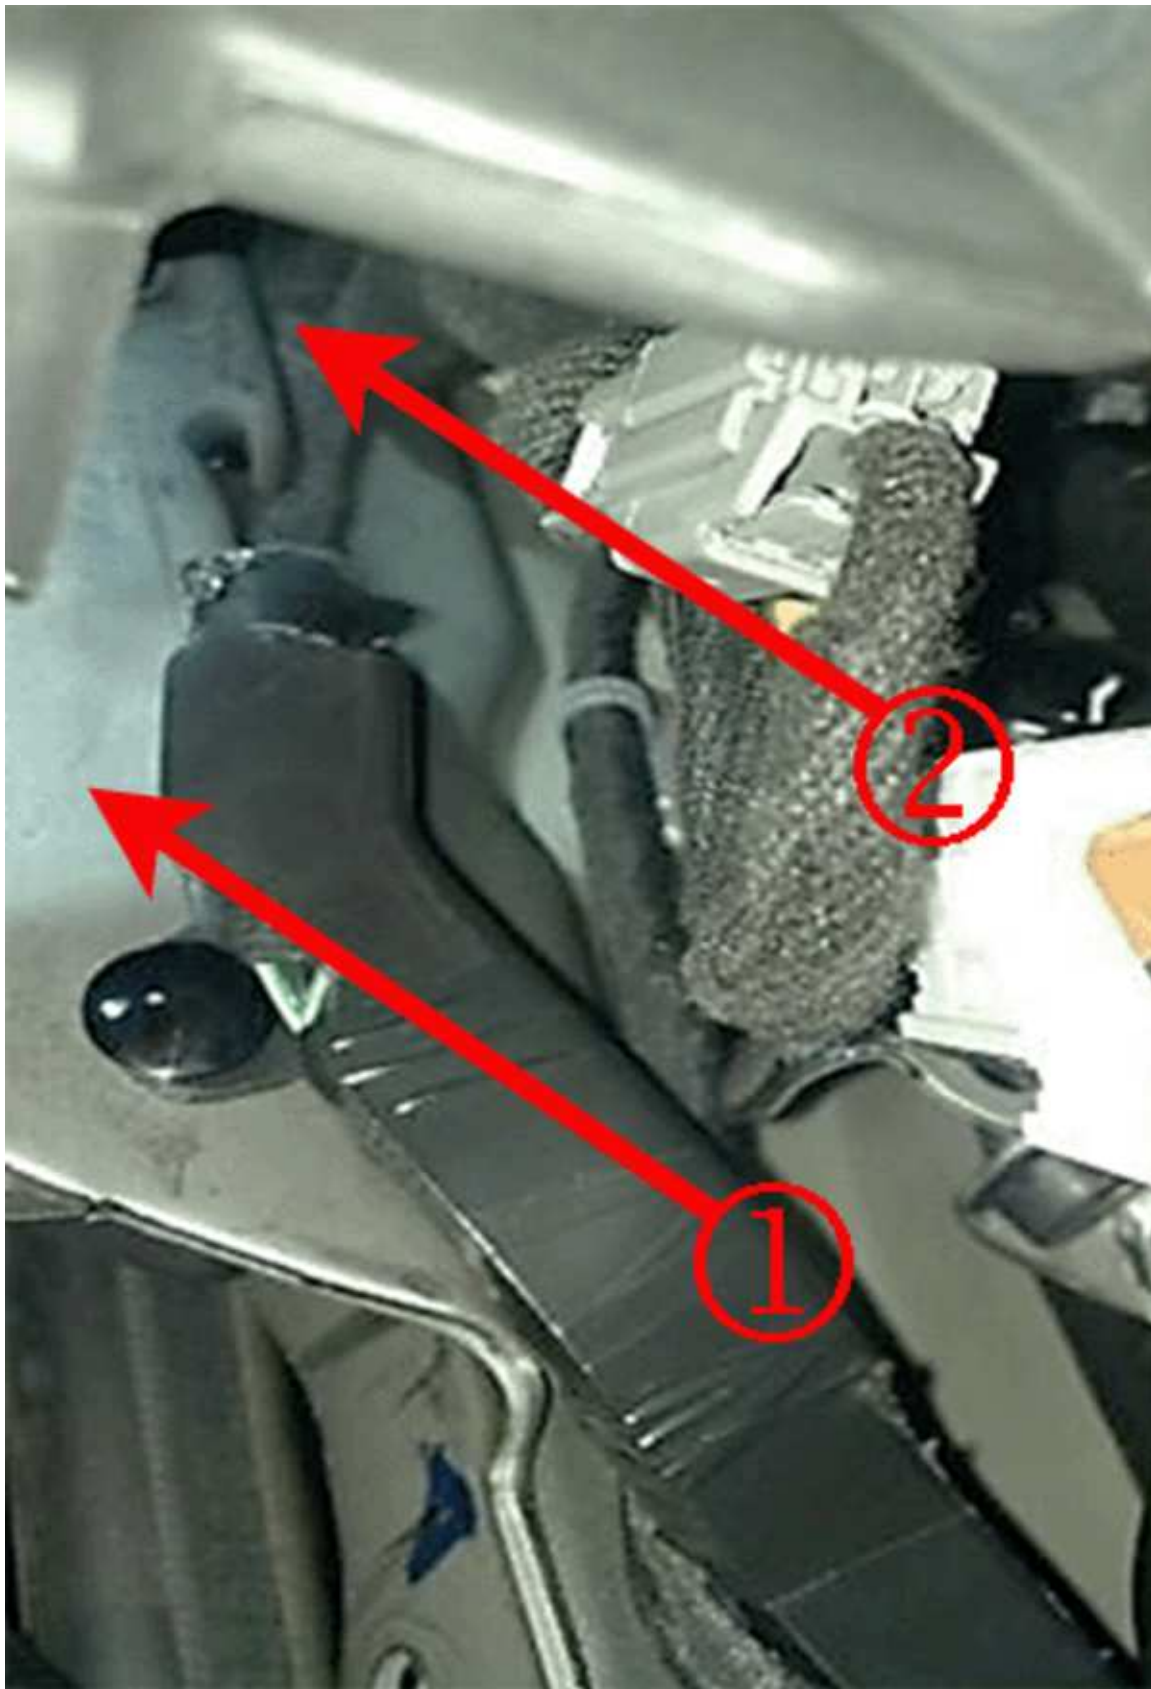
These concerns could be caused by the dash harness (2) being pinched between the left I/P dash mounting bracket (1) and the body, as shown below. In many cases, the complete harness is not pinched and may not be as apparent as shown in the below photo. When inspecting for a pinched harness, make sure the harness can be moved freely away from the bracket to body interface.

To repair this concern, loosen the left I/P dash mounting bracket bolts and pull the harness free. Open the harness and repair any damaged wires as necessary.
