| DOC # | PROCESS NAME | PAGE | REVISION | STATION | BY | DATE |
|---|---|---|---|---|---|---|
| <b>AR828</b> | <b>Dodge Promaster Coolant Hose Routing</b> | <b>1 OF 2</b> | | <b>SER-E</b> | <b>C.WARD</b> | <b>9/23/2016</b> |

**Purpose:** Re-route hoses to avoid belt contact

**Vehicles Affected:** 2645 - Serial #1A9D09225H6925150 - VIN# 3C7WRVLG9F8 [REDACTED]

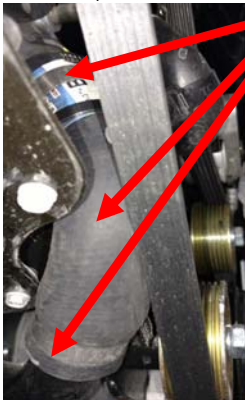
1. Disconnect Battery
2. Remove Splash Guard
3. Empty Cooling System (catch/retain fluid)
4. Remove/discard lower radiator hose and clamps

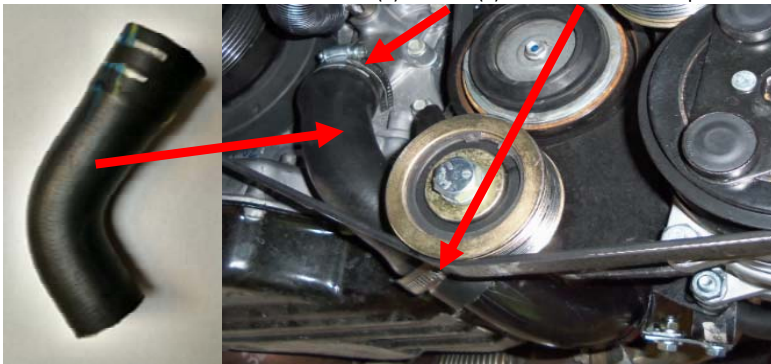
5. Install modified lower radiator hose with (1) #20 and (1) #28 Worm Gear Clamp

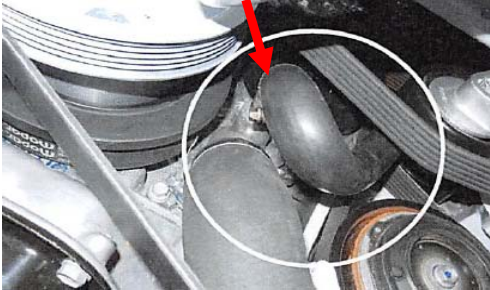
6. Remove/discard clamp from upper hose

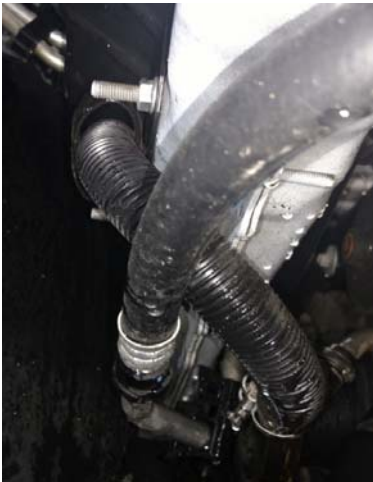
7. Re-route hose from the top connection over the curb side frame rail

8. Use splice connector and clamps to add approximately 11-12 inches of 5/8" heater hose. Cover with split loom for protection.

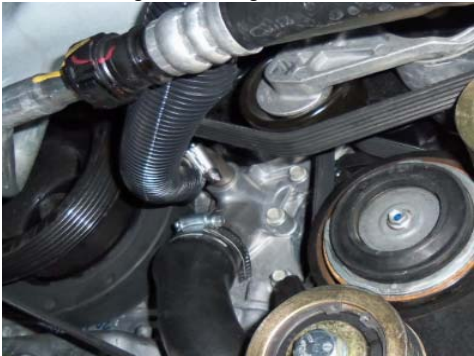
9. Route through belt routing and connect to the waterpump with #12 Clamp
