# Recall Campaign

FL709AB

## Subject: TBB HDX Heater Hoses

**Models Affected:** Specific Thomas Built Buses Saf-T-Liner HDX buses manufactured April 28, 2010, through April 15, 2016.

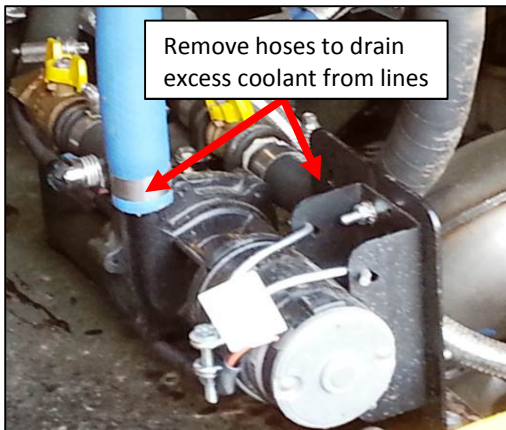
- 3) Remove two hoses as shown in **Figure 2**. Drain the hoses into a clean drain pan as shown in **Figure 3**.

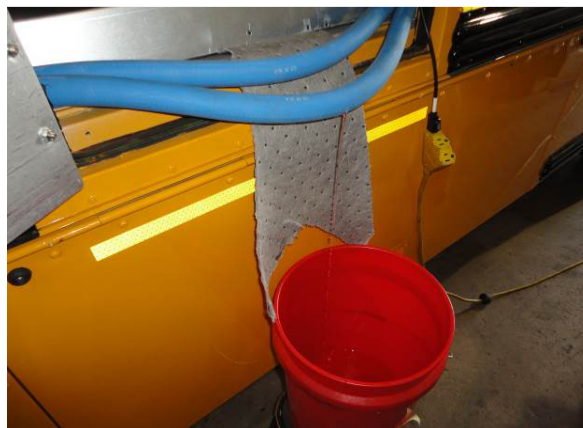
**Figure 4, Drain Coolant From the Side Emergency Door Hoses**

- 4) At the side emergency door, remove the hose cover. Pull hoses out over edge of door threshold. Drill holes in the hoses and drain into a clean drain pan. Make sure the side of the bus is protected from coolant. See **Figure 4**.

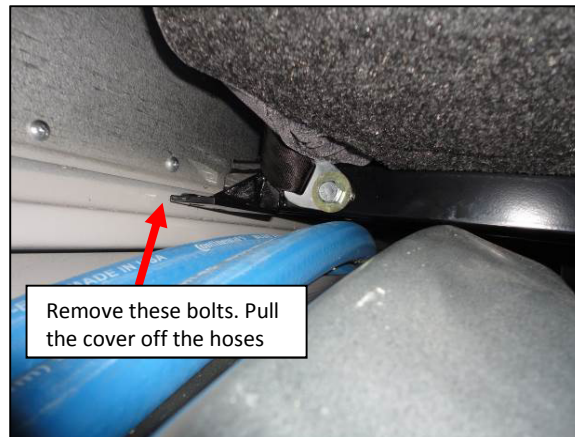
**Figure 5, Remove Seat Rail Bolts to Remove Wheel Well Cover**

- 6) Where the hoses go over the wheel wells, remove and retain the seat rail bolts for reinstallation. See **Figure 5**.

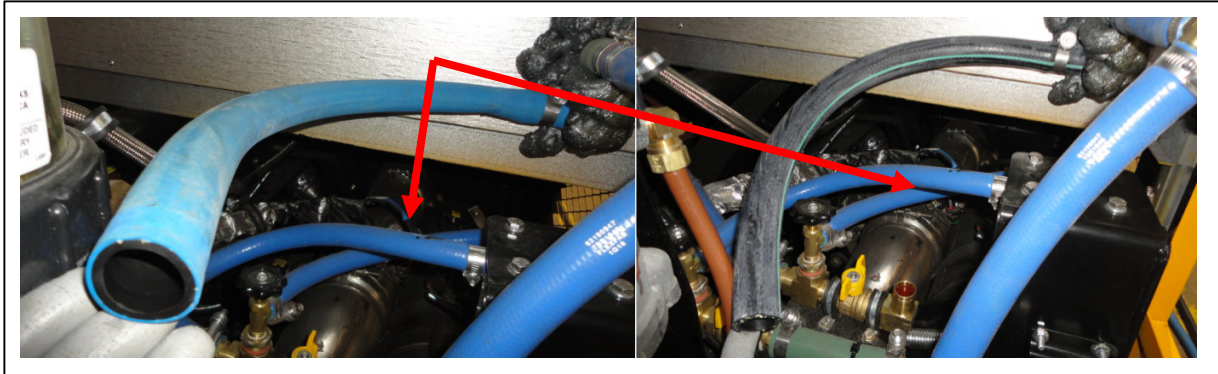
**Figure 9, Removal and Replacement of the Supply Line**

14) Replace the supply hose in the engine compartment. See **Figure 9**.
