Bulletin No.: PIT5288D

Service Bulletin

Subject: RKE / Passive Entry And Start / No Audio / SWC / Touch Screen / Display Blank/ Rear Wiper And Rear

Models: 2015-2016 Cadillac Escalade Models

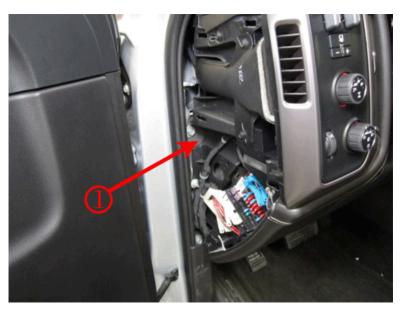
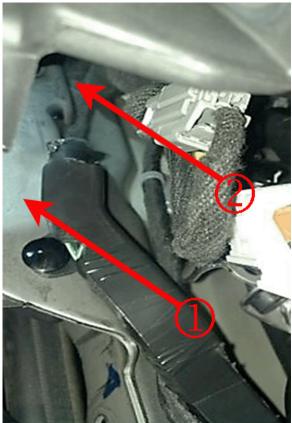
These concerns could be caused by the dash harness (2) being pinched between the left I/P dash mounting bracket (1) and the body, as shown below. In many cases, the complete harness is not pinched and may not be as apparent as shown in the below photo. When inspecting for a pinched harness, make sure the harness can be moved freely away from the bracket to body interface.

To repair this concern, loosen the left I/P dash mounting bracket bolts and pull the harness free. Open the harness and repair any damaged wires as necessary.
