51869-02162 Version 7

Warranty Extension: MIL Comes On with DTCs P0301 thru P0304

Year	Model	Trim	VIN Range
2008–12	Accord	All V6 A/T	Check the iN VIN Status for Eligibility.

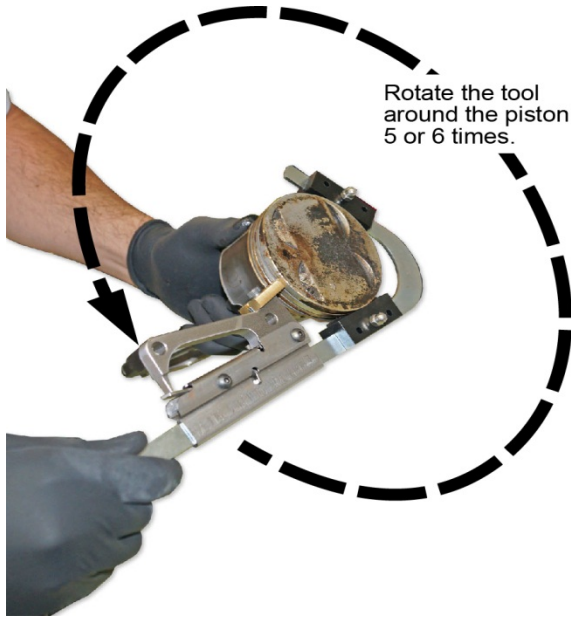
6. Hold the piston steady and rotate the tool counterclockwise five to six times to remove any carbon deposits in the piston ring grooves. **Do not** rotate the tool clockwise.

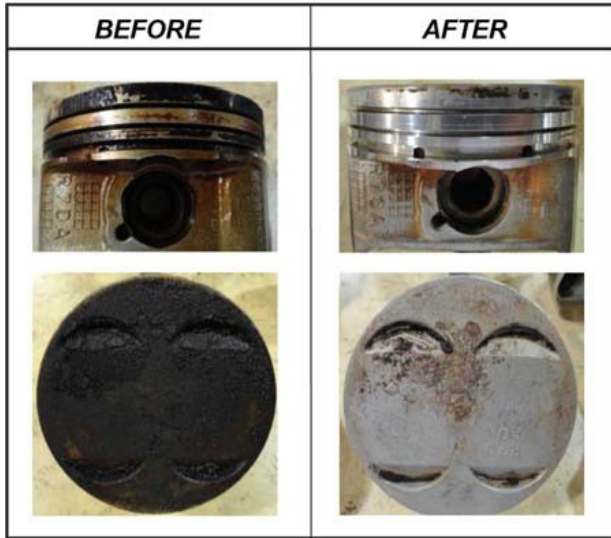
54K PISTON

NOTE: Below are some examples of before and after pictures. Depending on mileage and running conditions, the pistons will achieve different levels of cleanliness.
