RECALL SERVICE BULLETIN

DATE ISSUED	MODEL YEAR(S) AFFECTED	RSB #
8/18/2016	2017	461

How to Secure Fascia at Front of HWH Flat Floor Slideout

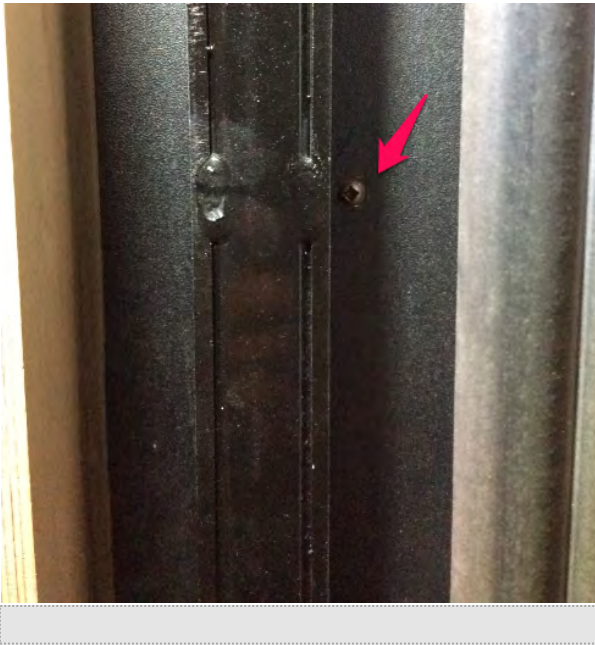
Front Fascia Instructions

Verify the coach has a HWH Flat Floor Slideout and determine which side of the unit it is on (this will vary by model and floorplan). Check the recall population list for the coach number. Early 2017 model year coaches were built with the front slideout fascia being attached with magnets and will need to be secured with screws.

There is no need to remove the existing magnets or steel plates in order to secure the fascia with screws.

Install a minimum of three screws on the front vertical slide fascia column. The screws will need to be installed from the back side of the structural fascia close to the steel frame of the HWH system. Screws should be placed within one foot of the bottom, within one foot of the top and near the middle of the column (avoiding the magnet and steel plate). The exact placement of the screws is not as important as securing the decorative fascia's wood backers to the structural fascia.

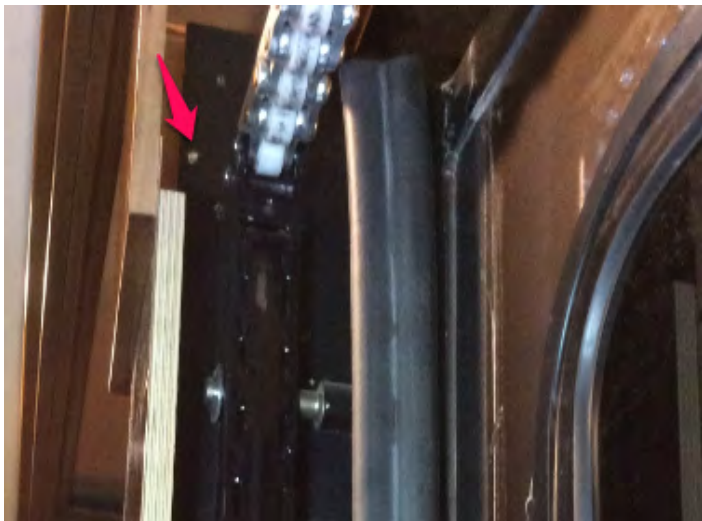
The screw should be installed on the opposite side of the steel HWH frame and near the outer edge of the structural fascia to miss steel magnet plate.

On King Aire coaches, install an additional screw into the top fascia block, as it is separate from the vertical column.
