# Service Bulletin

Bulletin No.: 16-NA-210

**Subject: Lack of Power on Hard Acceleration**

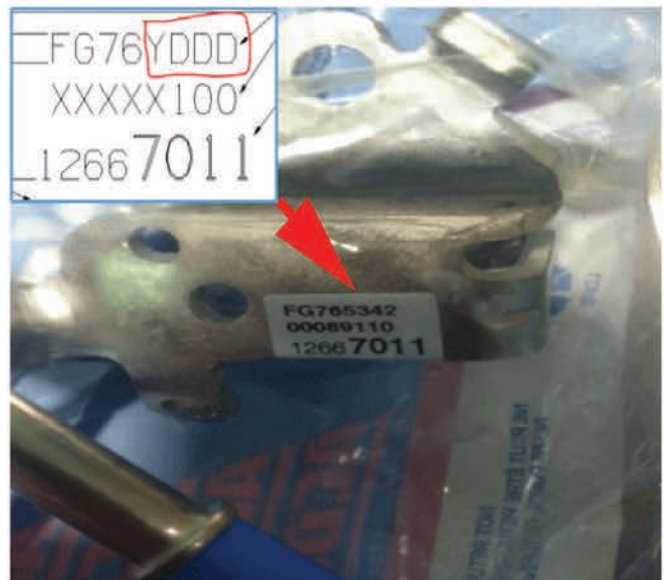
4538134

**Note:** The suspect fuel feed pipe will have a Julian date code of 6077 or lower. This can be found on the tag attached to the pipe. See picture above for location of date code. The suspect date code is as follows: The Y= 6 the next 3 digits is the Julian date.

If this verifies the concern, then replace the low pressure inlet pipe to the high pressure fuel pump and perform steps 1-4 again. Refer to *Fuel Feed Pipe Replacement (LGX at Engine)* in SI.
