<b>HYUNDAI</b>   NEW THINKING. NEW POSSIBILITIES.  <b>Technical Service Bulletin</b>	GROUP <b>AUTOMATIC TRANSMISSION</b>	NUMBER 16-AT-011
	DATE <b>OCTOBER 2016</b>	MODEL GENESIS SEDAN (BH/DH), GENESIS G80 GENESIS COUPE (BK) EQUUS (VI)
<b>SUBJECT:</b>	AUTOMATIC TRANSMISSION SOLENOID & SENSOR DTC P0741, P0743, P0748, P0753, P0758, P075A, P0763, P0768, P0773, P2709 & P0841

***This TSB supersedes TSB 15-AT-003 to update the Warranty Information and Service Procedure and include 2017 Genesis G80.***

**Description:** Do not replace the transmission for the DTC listed below. Instead, follow the repair procedure and replace the related part.

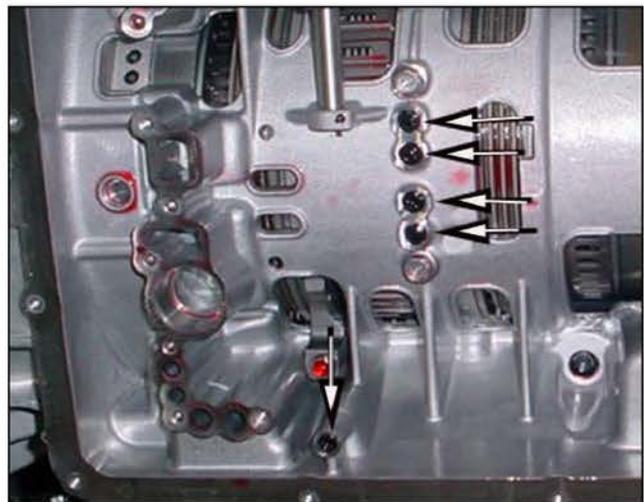
15. Confirm that 5 O-rings are seated in the case.

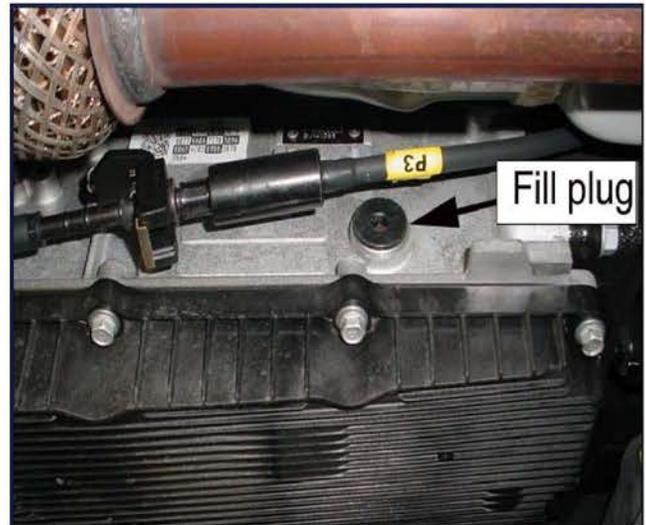
21. Use an 8mm or 5/16" hex socket and remove the fill plug and washer.

Shift into Park and lift the vehicle on a hoist.

Use a fluid pump or suction gun to add approximately 4 quarts of SPH-IV-**RR** ATF through the fill plug.

Use only SPH-IV-RR ATF, P/N 00232-19052.
