Title: Cube fuse installation after maintenance

Applies To: Prostar with 0008WSP

This document will guide the user through correct positioning the Cube Fuse Holder after regular maintenance.

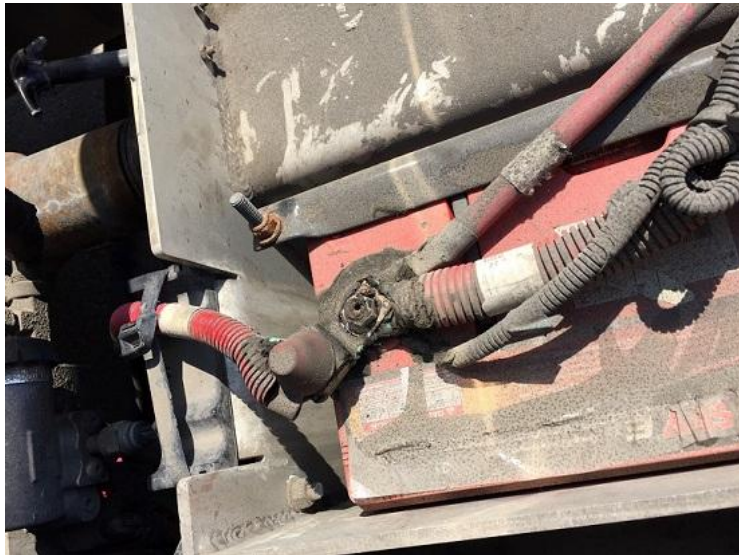
When performing maintenance on Prostars with 0008WSP you will notice the Cube Fuse Holder orientation to be incorrect as shown below.

This must be corrected when reinstalling the Cube Fuse Holder to the following: **Cab feed cable must be at a 90 degree angle to the Cube Fuse Holder, while the Cube Fuse Holder must be parallel to the front wall of the battery box.**

Nut for cube fuse holder and other cables on battery post: **16-20 N-M**

Nut for feed cable & cube fuse on cube fuse holder: **12NM +/- 1NM**
