SERVICE BULLETIN

Classification: Reference: Date:			
Classification:	Reference:	Date:	
EL16-026	NTB16-071	July 27, 2016

2004-2014 ARMADA; POWER BACK DOOR INOPERATIVE AND BOLT ON POWER BACK DOOR OPENER LOOSE

APPLIED VEHICLE: 2004-2014 Armada (TA60)

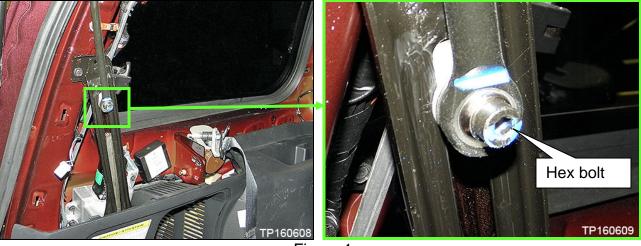
The linkage for power back door has a loose or missing hex bolt (Figure 1).

- 1. Replace the bolt shown in Figure 1 with a new bolt from the Parts Information.
 - Do not reuse the old bolt.
 - Clean the threads in the linkage before installing the new bolt.
 - Install the new bolt and torque to 7 N•m (0.7 kg-m, 62 in-lb.).

NOTE: Refer to the Electronic Service Manual (ESM), section **DLK – Door & Lock** to gain access to the power back door linkage bolt.
