# Technical Service Bulletin

SUBJECT:		No: <b>TSB-16-54-004</b>	
<b>TAIL LIGHT REMOVAL &amp; INSTALLATION PROCEDURE – SERVICE MANUAL REVISION</b>		DATE: <b>October, 2016</b>	
		MODEL: <b>2016 Outlander</b>	
CIRCULATE TO:	<input type="checkbox"/> GENERAL MANAGER	<input checked="" type="checkbox"/> PARTS MANAGER	<input checked="" type="checkbox"/> TECHNICIAN
<input checked="" type="checkbox"/> SERVICE ADVISOR	<input checked="" type="checkbox"/> SERVICE MANAGER	<input type="checkbox"/> WARRANTY PROCESSOR	<input type="checkbox"/> SALES MANAGER

This TSB updates the Chassis Electrical section of the affected Service Manuals to correct a reference in Tail Light removal and installation.

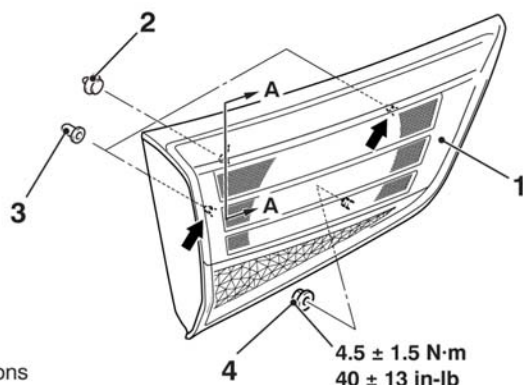
ACE03212AB

NOTE  
 ← : Stud pin positions

- <<A>> >>A<<
1. Tail light assembly
  2. Clip

3. Grommet
4. Nut

Pre-removal and Post-installation Operation <Correct>  
 • Liftgate Trim Removal and Installation  
 (Refer to GROUP 52A-Liftgate Trim).

~~Pre-removal and Post-installation Operation <Incorrect>~~  
~~• Liftgate garnish Removal and Installation (Refer to GROUP 51-Liftgate garnish).~~

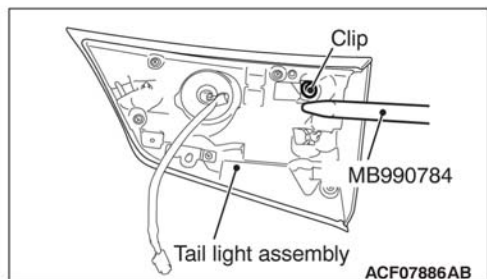
#### <<A>> TAIL LIGHT ASSEMBLY REMOVAL

Disengage the clip by inserting the special tool Ornament remover (MB990784) as shown. Then remove the tail light assembly.

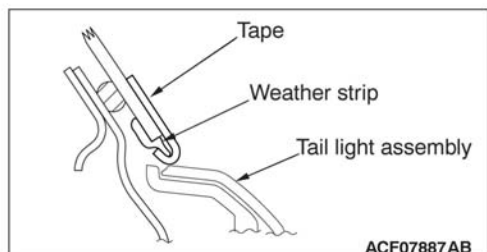
#### >>A<< TAIL LIGHT ASSEMBLY INSTALLATION

When installing the tail light assembly, roll up the weather-strip and secure it by a tape as shown to avoid trapping it.
