Technical Service Bulletin

24 Changeover valve for intake manifold flap N316, DTC P2015

24 16 54 2044003/2 May 24, 2016. Supersedes Technical Service Bulletin Group 24 number 16-53 dated April 19, 2016 for reasons listed below.

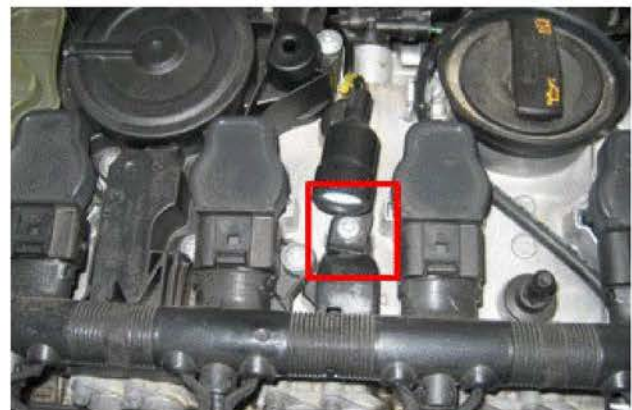
Figure 3. Securing bolt for engine wiring in in-line engine.

3. Install fresh air line with part number **06H 133 583 F** by first routing it along the cylinder head cover, then securing it with the included clips on the high pressure fuel line and activated charcoal filter cable (Figure 2).
 - **On in-line engines:** Loosen the securing bolt for engine wiring between the second and third cylinder and secure the fresh air line with this bolt (Figure 3).
 - **On transverse engines:** The M6 x 14 bolt with part number **N 107 732 01** (thread-cutting) must be used in addition. Tighten the bolt with 9 Nm +/- 1 Nm.

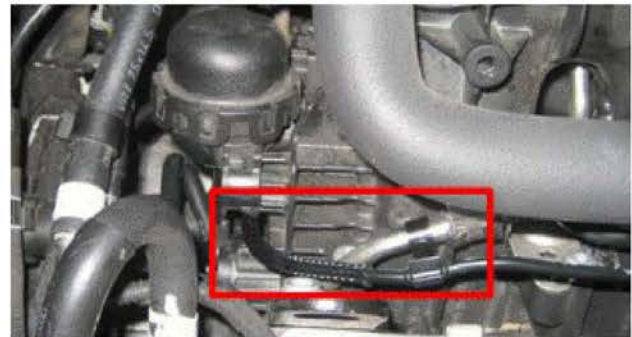
Figure 4. Routing of clean air line to intake manifold flap valve.

When routing the clean air line to the intake manifold flap valve, ensure that the clean air line is routed between the cylinder head cover and the vacuum unit lever for the intake manifold flap (Figure 4).
