2010-13 MAZDA3 - HAZARD WARNING LIGHTS STAY ON AFTER DASH REPAIR

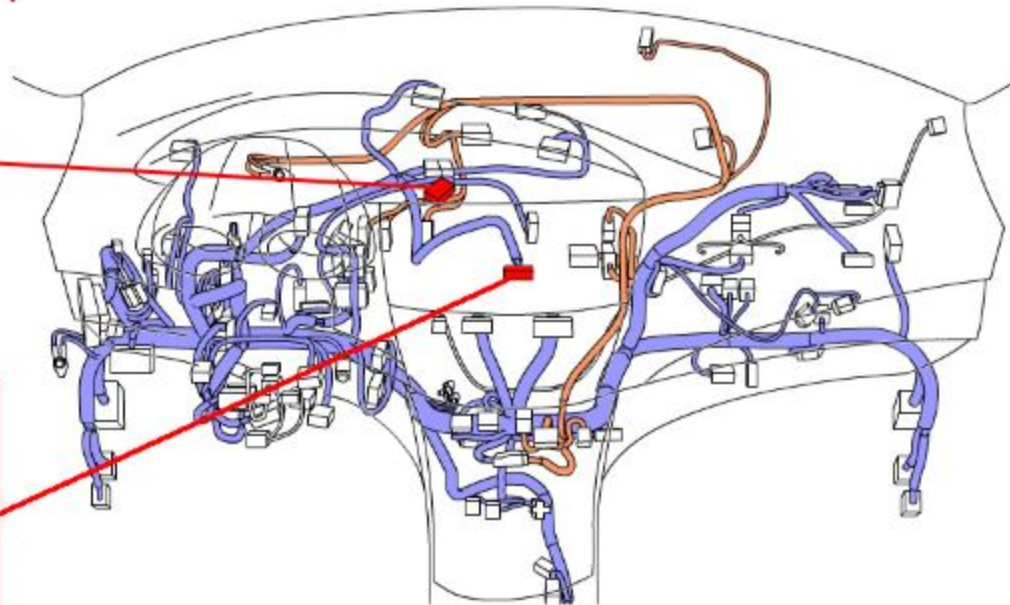
If you encounter the hazard warning lights staying on after a dash repair, you may have crossed the hazard warning switch connector with another connector, such as the Bluetooth microphone connector. The two connectors have the same number of pins.

0920-403
MICROPHONE

0918-501
HAZARD WARNING SWITCH /
HAZARD WARNING SWITCH
ILLUMINATION /
CLOCK SWITCH
