# Technical Service Bulletin

## 90 Oil change service interval not displayed

90 16 65 2043855/1 April 1, 2016.

Model(s)	Year	VIN Range	Vehicle-Specific Equipment
A4	2017	All	Not Applicable

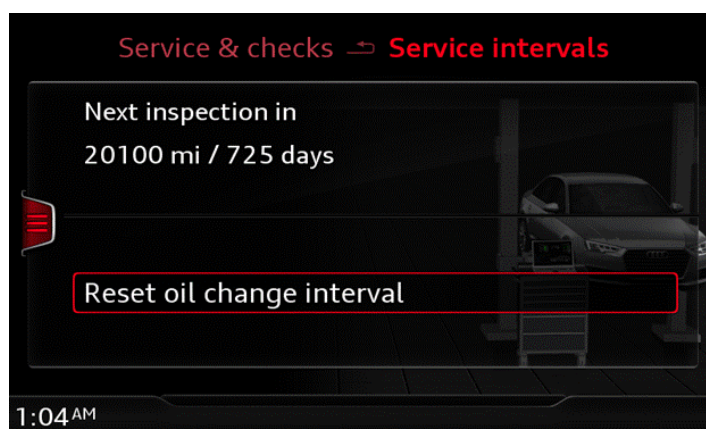
During PDI, the MIB display does not show the initial 10,000 mile service interval counter.

The maintenance interval displayed on the MIB screen (Figure 1) has not fully synced with the instrument cluster at time of PDI.

**Figure 1.** Service intervals menu is not showing the 10,000 mile service counter.

During PDI, If the initial 10,000 mile service interval counter is missing from the Service intervals menu in the MIB, the interval must be reset so that it will be populated in the MIB menu.

This will reset the counter to 10,000 miles, so it should only be done during PDI.

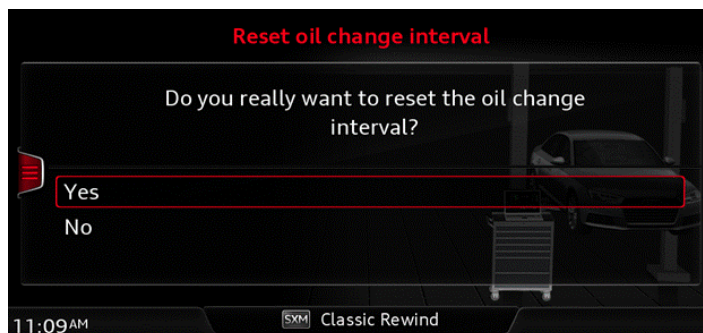
**Figure 2.** Confirm the oil change interval reset.

Select “Reset oil change interval” from the Service intervals menu. Follow the prompts and confirm the reset (Figure 2).

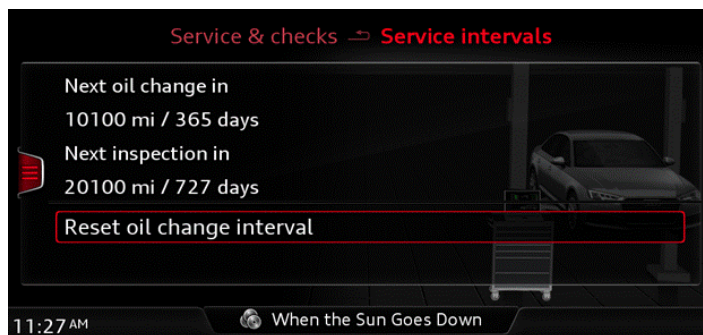
**Figure 3.** 10,000 mile counter and 20,000 mile counter displayed in the Service intervals menu of the MIB.

After the oil change interval has been reset, the 10,000 mile counter and the 20,000 mile counter will be displayed in the Service intervals menu (Figure 3).
