Technical Service Bulletin

90 Oil change service interval not displayed

90 16 66 2043855/2 April 5, 2016. Supersedes Technical Service Bulletin Group 90 number 16-65 dated April 1, 2016 for reasons listed below.

Model(s)	Year	VIN Range	Vehicle-Specific Equipment
2017	A4	All	Not Applicable

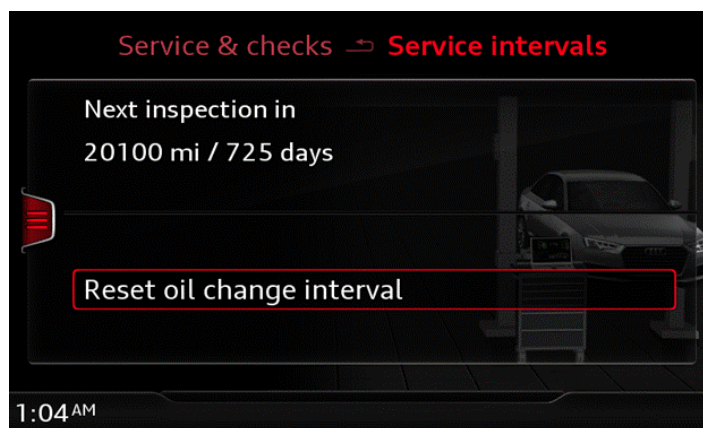
During PDI, the MIB display does not show the initial 10,000 mile service interval counter.

The maintenance interval displayed on the MIB screen (Figure 1) has not fully synced with the instrument cluster at time of PDI.

Figure 1. Service intervals menu is not showing the 10,000 mile service counter.

During PDI, If the initial 10,000 mile service interval counter is missing from the Service intervals menu in the MIB, the interval must be reset so that it will be populated in the MIB menu.

This will reset the counter to 10,000 miles, so it should only be done during PDI.

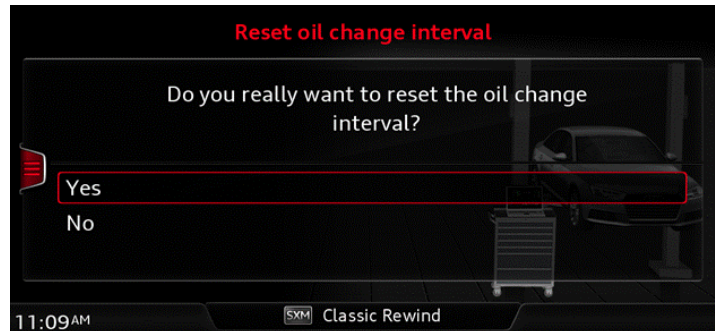
Figure 2. Confirm the oil change interval reset.

Select “Reset oil change interval” from the Service intervals menu. Follow the prompts and confirm the reset (Figure 2).

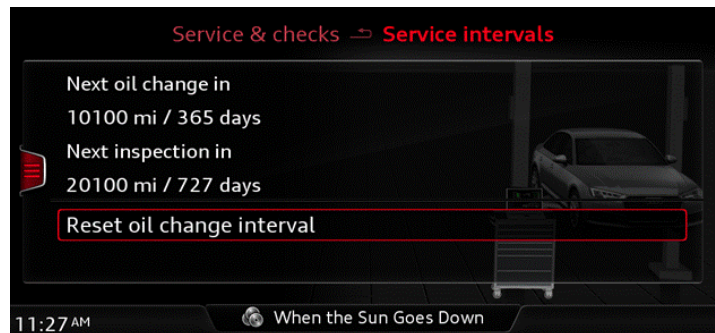
Figure 3. 10,000 mile counter and 20,000 mile counter displayed in the Service intervals menu of the MIB.

After the oil change interval has been reset, the 10,000 mile counter and the 20,000 mile counter will be displayed in the Service intervals menu (Figure 3).
