Reference	SSM72784
Models	F-PACE / X761 (061340 → 045591)
Title	Creak from rear when braking/ accelerating and cornering
Category	Body
Last modified	13-Jul-2016 00:00:00
Symptom	111000 Body Panel(s)/Unibody
Attachments	1Graphic.pdf (1Graphic.pdf)

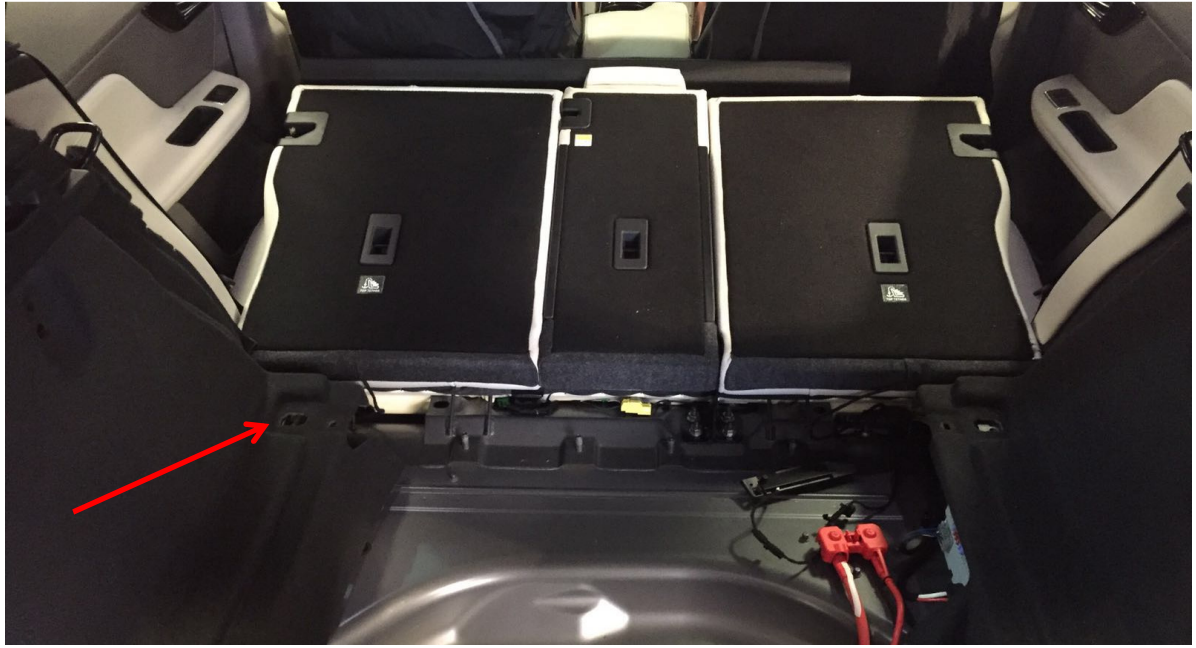
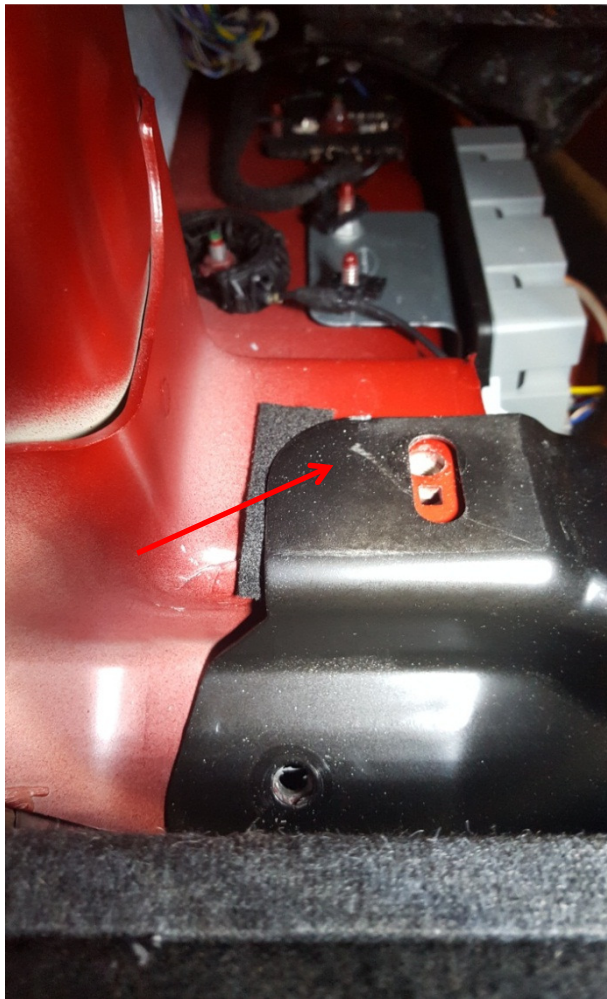
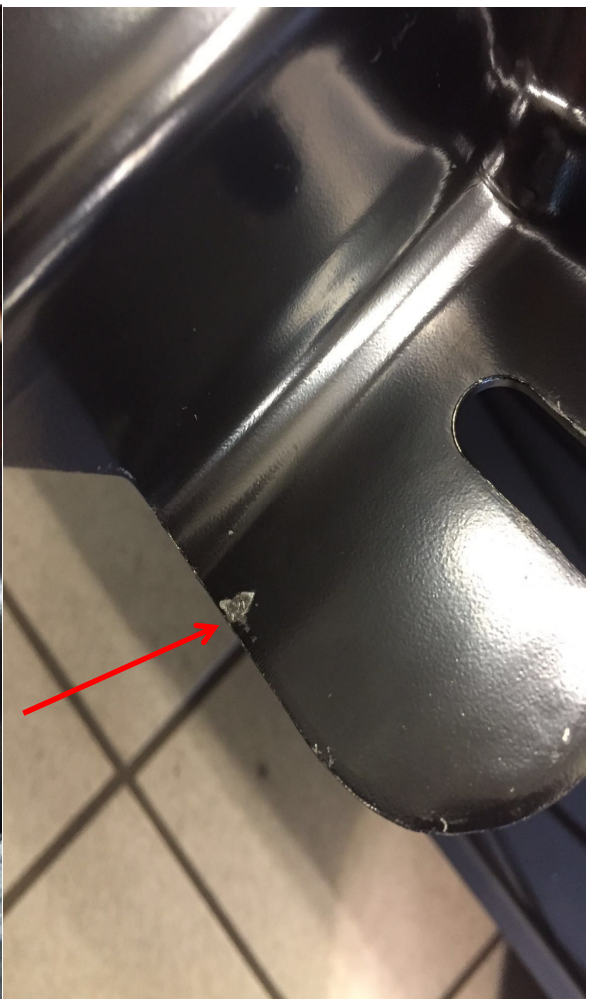
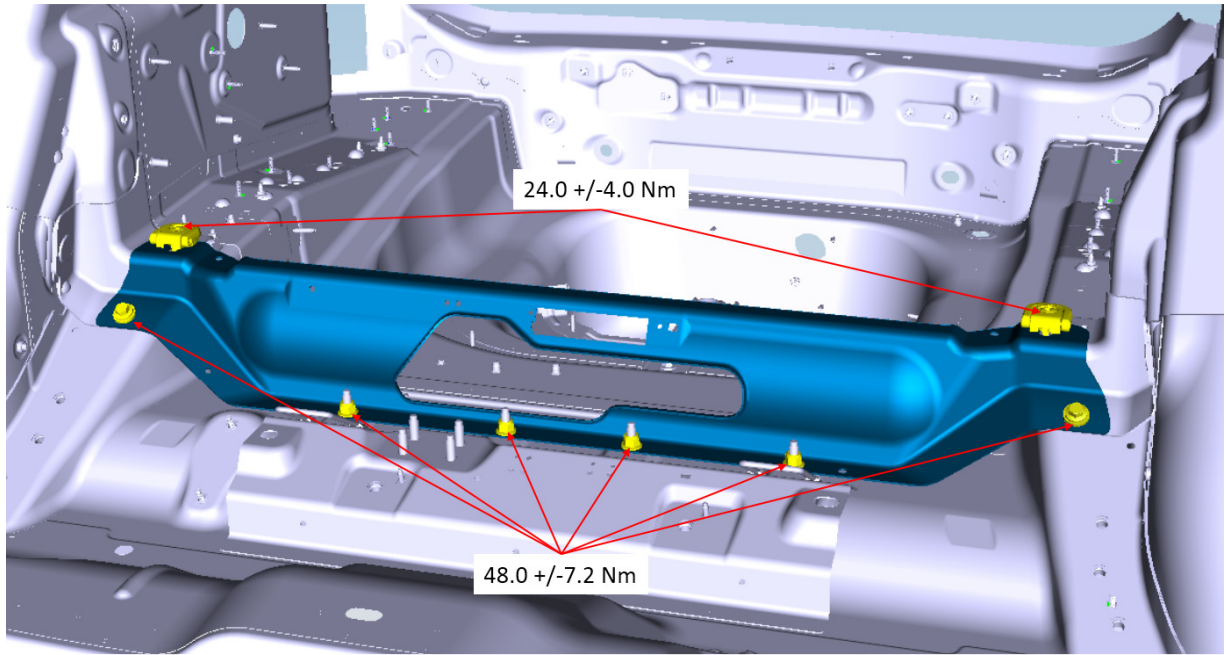
Creak from rear when braking/accelerating and cornering.

Deformation of the body panel.

1. Fold the second row seats forward.
2. Remove LH and RH rear luggage hoops.
3. Remove the painted Cross Car Brace (see attachment).
4. Pull back carpet to reveal any witness mark on upper strut reinforcement panel.
5. Cut a length of 1.6mm thick AV felt tape from squeak and rattle kit, apply to the panel covering the witness mark (see attachment).
6. Repeat step 5 on the corresponding surface of the Cross Car Brace (see attachment)
7. Reassemble referencing the attached document for correct torque values.
