Technical Service Bulletin

94 Headlight switch pressed in

94 16 82 2017566/6 September 16, 2016. Supersedes Technical Service Bulletin Group 94 number 15-66 dated April 17, 2015 for reasons listed below.

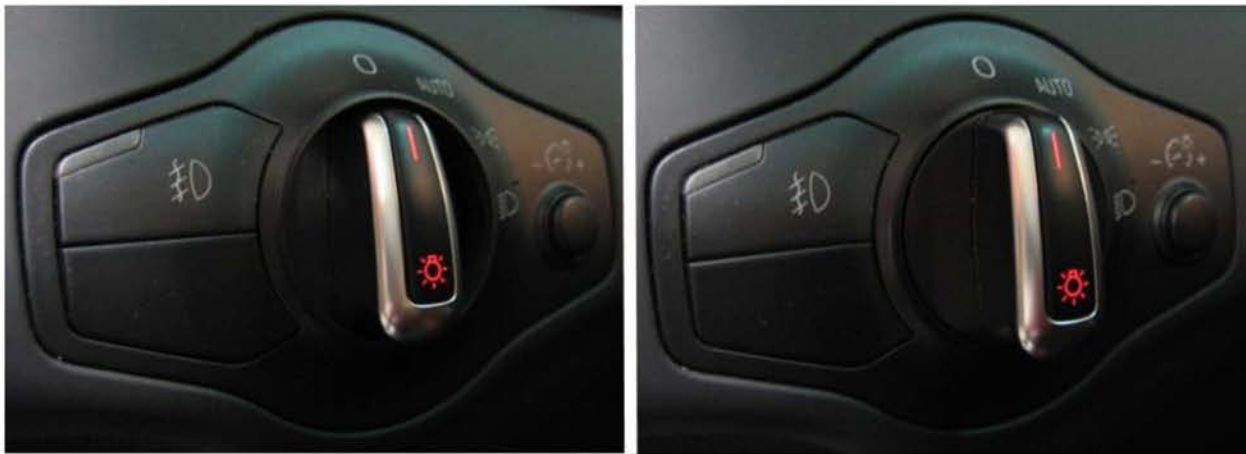
The headlight switch knob was designed with a normal position and a pushed-in position (Figure 1, Figure 2, and Figure 3). This feature was designed to avoid injuries during a collision.

Figure 1. B8 headlight switch knob pushed in (left) and in normal position (right).

1. Pull out the knob and return it to the original position.
2. Explain the *Technical Background* to the customer.

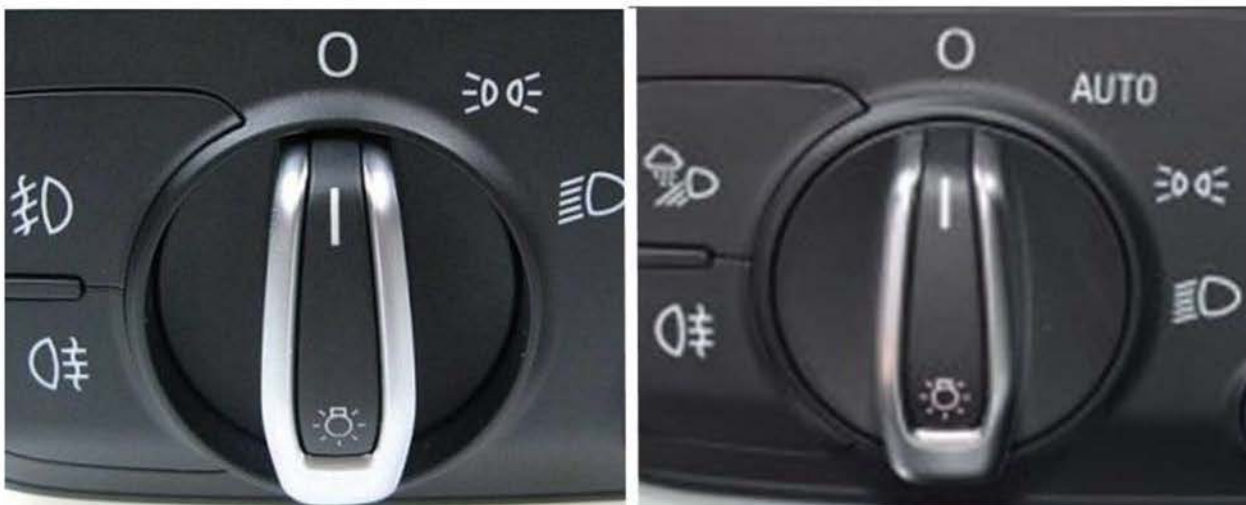
Figure 2. A3 headlight switch knob pushed in (left) and in normal position (right).

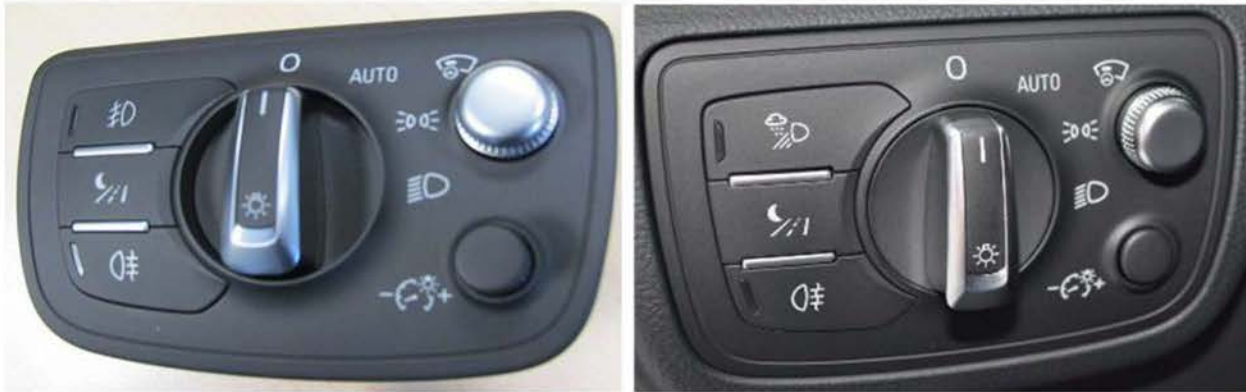
Figure 3. A6 and A7 headlight switch knob pushed in (left) and in normal position (right).
