1.5L GTDI - LOW COOLANT - WHITE EXHAUST SMOKE AND/OR ILLUMINATED MALFUNCTION INDICATOR LAMP (MIL) - MULTIPLE DTCS

TSB 16-0150

2014-2017 Fusion

2017 Escape

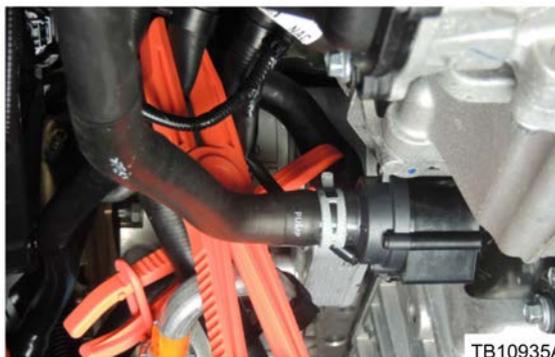
Figure 1 - Article 16-0150

1. Check engine coolant level. Refer to Workshop Manual (WSM), Section 303-03. Does the vehicle have a low coolant level?
 - a. Yes - proceed to Step 3.
 - b. No - proceed to Step 2.
2. Connect the Ford Integrated Diagnostic System (IDS) service tool or equivalent scan tool and check for DTCs. Are DTCs P0217, P0300, P0301, P0302, P0303, P0304, P0316 and/or P1299 stored in the powertrain control module (PCM) memory?
 - a. Yes - proceed to Step 3.
 - b. No - this article does not apply. Refer to WSM, Section 303-00 for normal diagnostics.
3. Pressure test the cooling system. Refer to WSM, Section 303-03. Does the pressure remain constant for 2 minutes?
 - a. Yes - this article does not apply. Refer to WSM, Section 303-00 for normal diagnostics.
 - b. No - proceed to Step 4.
4. Using hose pinch pliers, pinch off CAC coolant inlet and outlet hoses. (Figure 1)

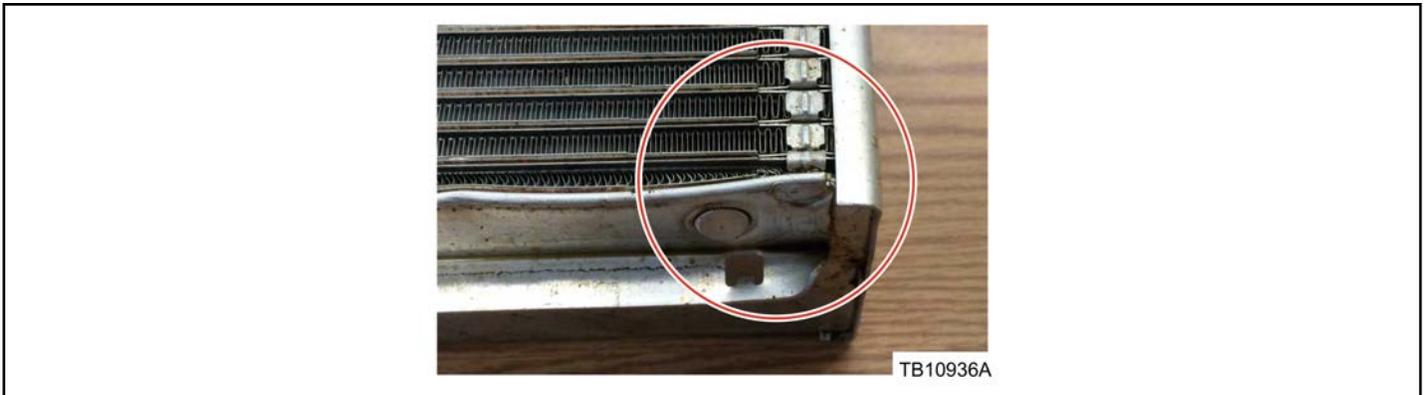
Figure 2 - Article 16-0150

Some 2014-2017 Fusion and 2017 Escape vehicles equipped with a 1.5L Gasoline Turbocharged Direct Injection (GTDI) engine may exhibit low coolant, white exhaust smoke and an illuminated MIL if diagnostic trouble codes (DTCs) P0217, P300, P0301, P0302, P0303, P0304, P0316 and/or P1299 are present. This condition may be due to an intake manifold bolt backing out causing damage to the charge air cooler (CAC).

5. Pressure test the cooling system. Does the pressure remain constant for 2 minutes?
 - a. Yes - proceed to Step 6.
 - b. No - this article does not apply. Refer to WSM, Section 303-00 for normal diagnostics.
6. Remove the CAC. Refer to WSM, Section 303-12.
7. Does the CAC show damage from bolt contact? (Figure 2)

- a. Yes - proceed to Step 8.
 - b. No - replace the CAC. Refer to WSM, Section 303-12.
8. Replace the intake manifold and CAC. Refer to WSM, Section 303-01.
