## EPA Emission Control Decal Replacement 9700 (B13R)

### MODEL YEAR(S) AND VEHICLE SERIAL NUMBERS (VIN) INVOLVED

### DESCRIPTION

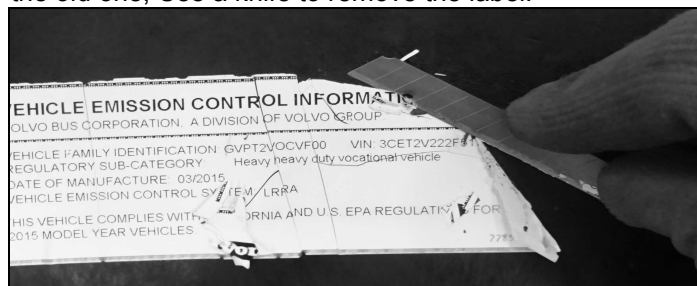
FIG.3 REMOVAL

2. Remove the vehicle EPA decal located in the engine compartment (see Fig.3 & 4). Do not install the new decal over the old one; Use a knife to remove the label.

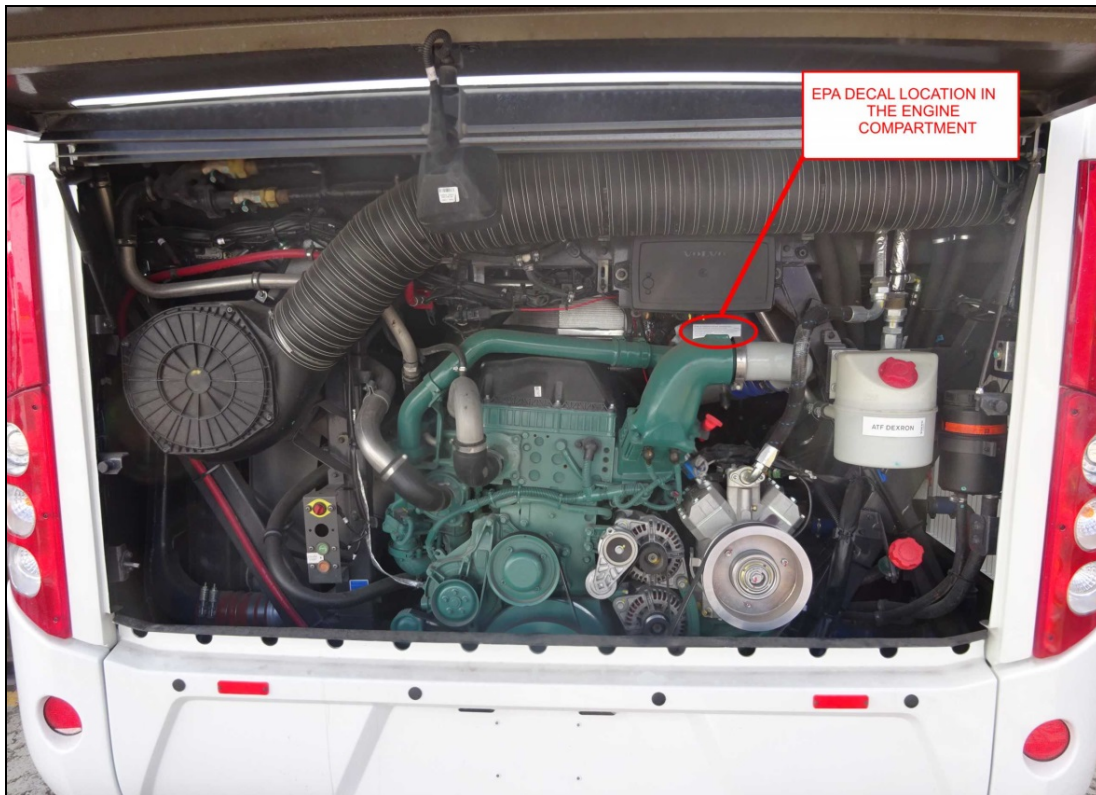
FIG.4 EPA DECAL LOCATION IN THE VEHICLE ENGINE COMPARTMENT

On the vehicles affected by this bulletin the EPA (US Environment Protection Agency) decal located in the engine compartment displays incorrect information related to the vehicle emission control.

Specifically, the first character, indicating the model year in the vehicle family identification number is incorrect and the California state EPA compliance notice is missing.

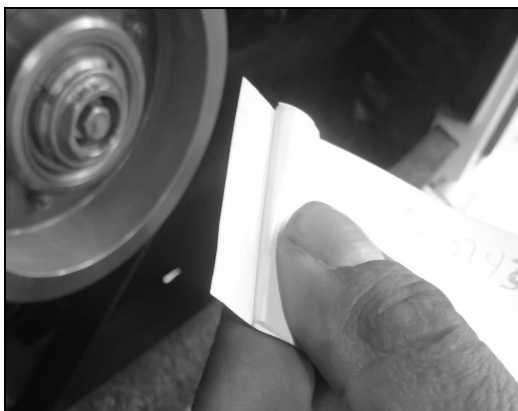
FIG.5 INSTALLATION OF THE LABEL

3. Carefully clean the decal area from all traces of dirt, road grime and old adhesive.
4. Once the area is dry, reinstall the new decal at the same location on the vehicle; make sure of proper adhesion (see Fig 5).

Note: The label is very sensitive and can break easily, **make sure to handle with care!**
