TECHNICAL BULLETIN

LTB00861NAS2
10 OCT 2016

Roof Moulding Loose / Adrift

Situation: The roof moulding(s) may be loose / adrift.

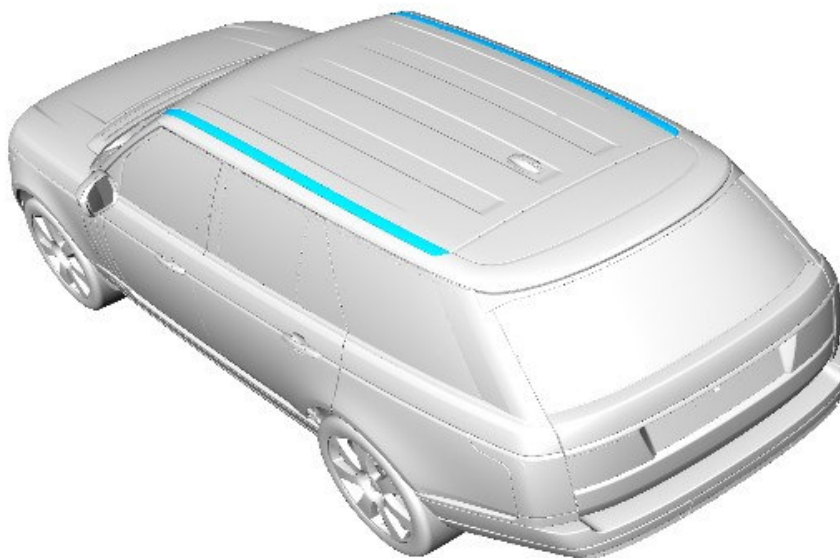
E183616

**NOTE:**
Range
Rover
(L405)
non-
panoramic
roof
shown; all
others
similar.

Location of
components.

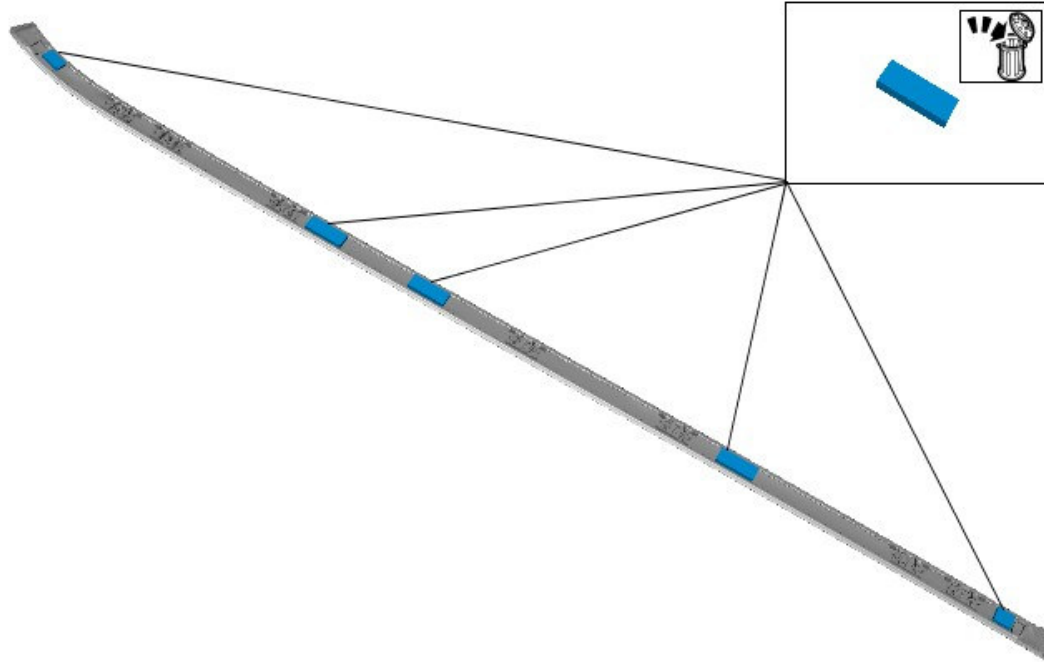
E183735

Remove and
discard the
foam pads.

**NOTE:**
Use a
suitable
degreaser
to clean
any
residue
from the
foam pads.

**NOTE:**
Inspect the
roof
moulding
for
damage.

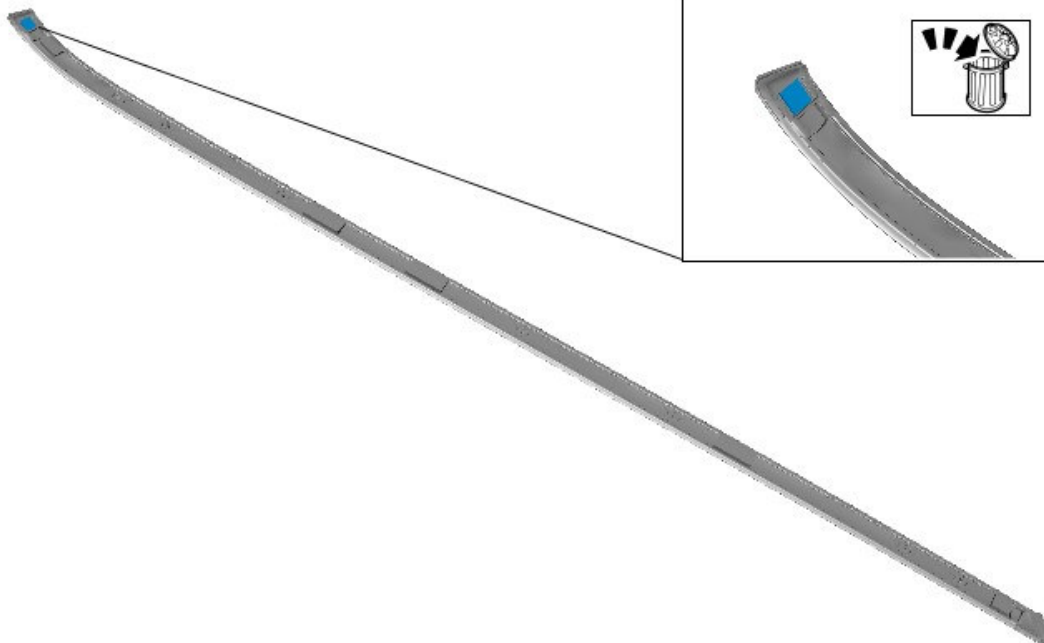
E183737

Remove the
roof
moulding
adhesive
pad.

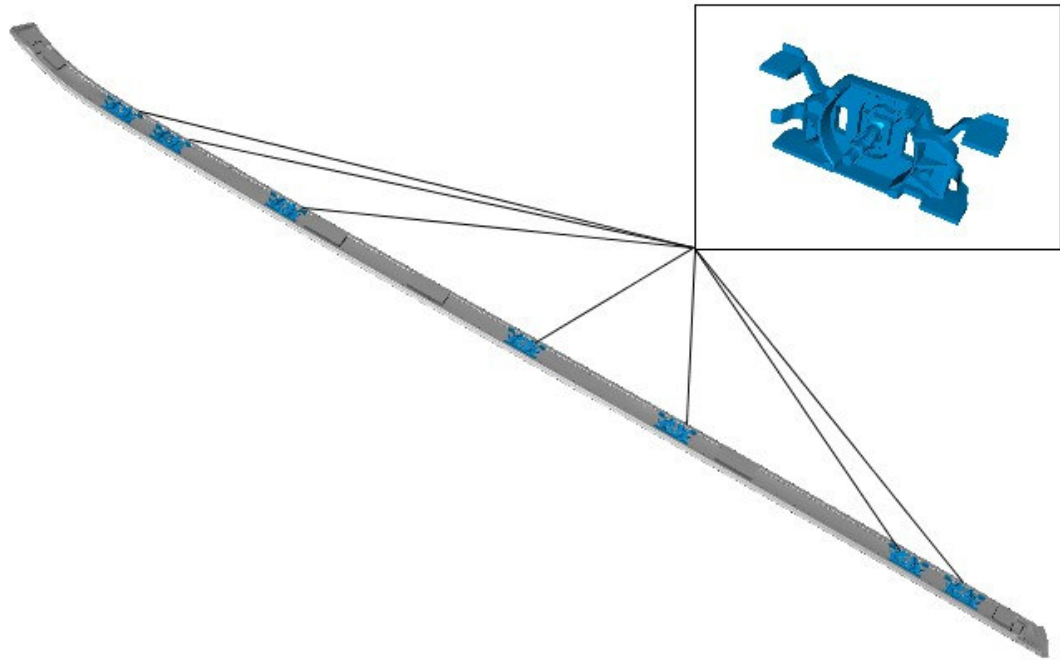
E183736

Remove the roof moulding clips.

5.   **CAUTION:**
The roof
moulding
clips are a
one time
installation
only.

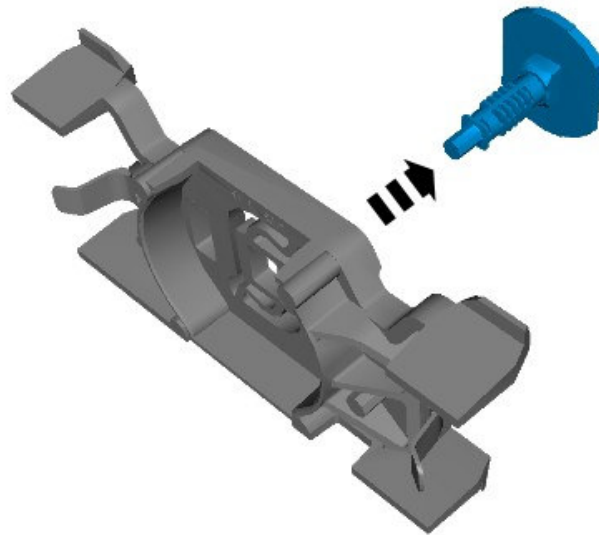
E183739

Remove and discard the original clips from the plastic retaining clips.

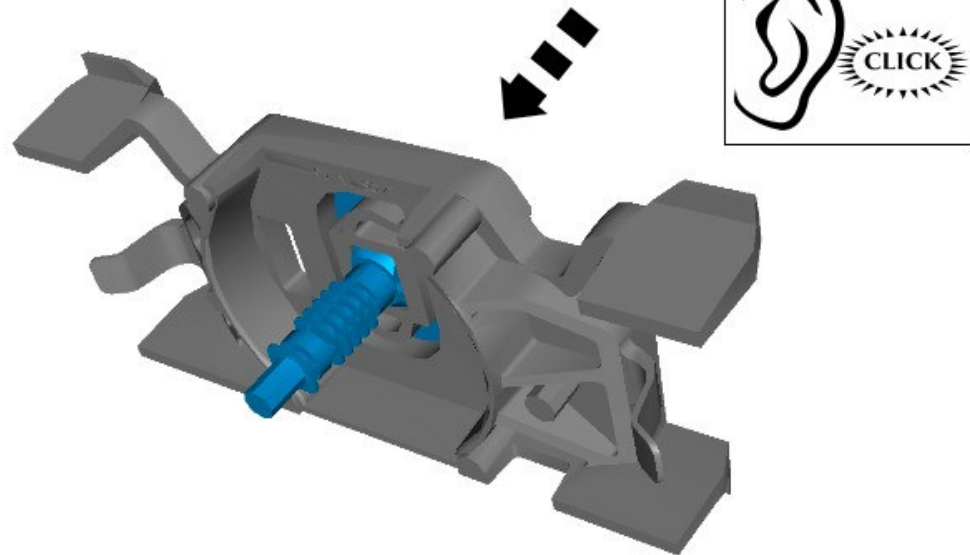
E183740

Install the
new clips
into the
plastic
retaining
clips.

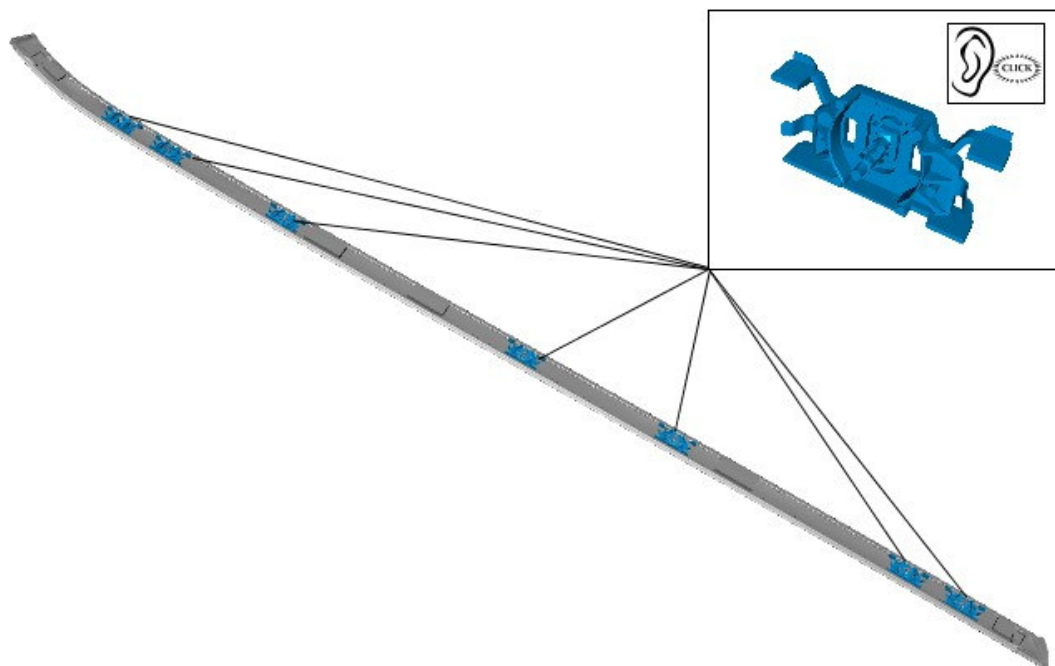
E183738

Install the
roof
moulding
clips into the
roof
moulding.

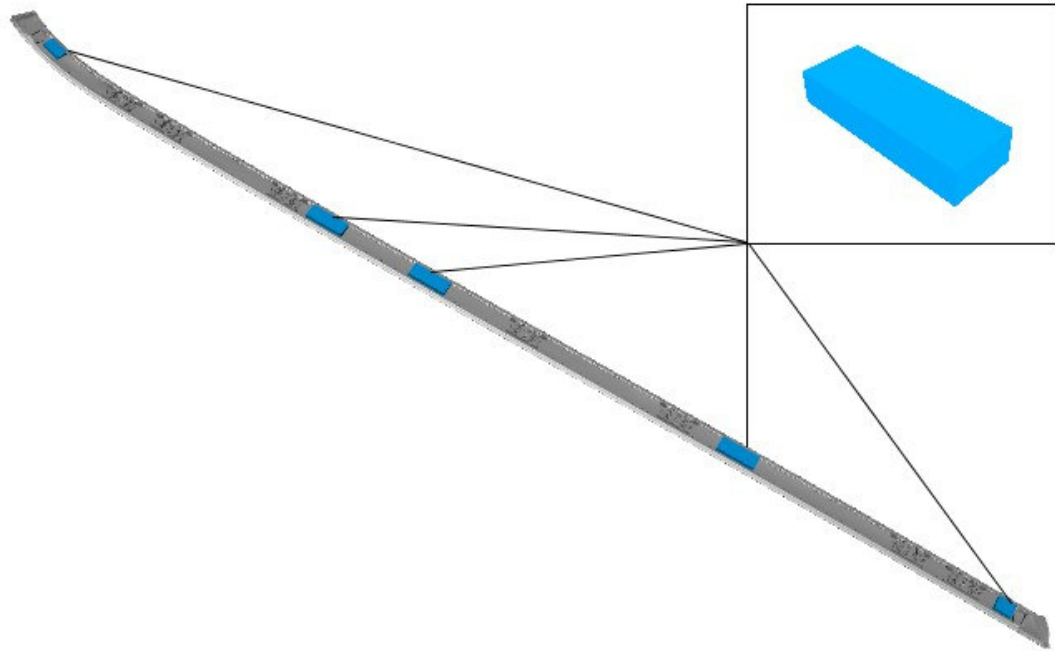
E185099

Install the
new roof
moulding

foam pads in the same location they were removed from.

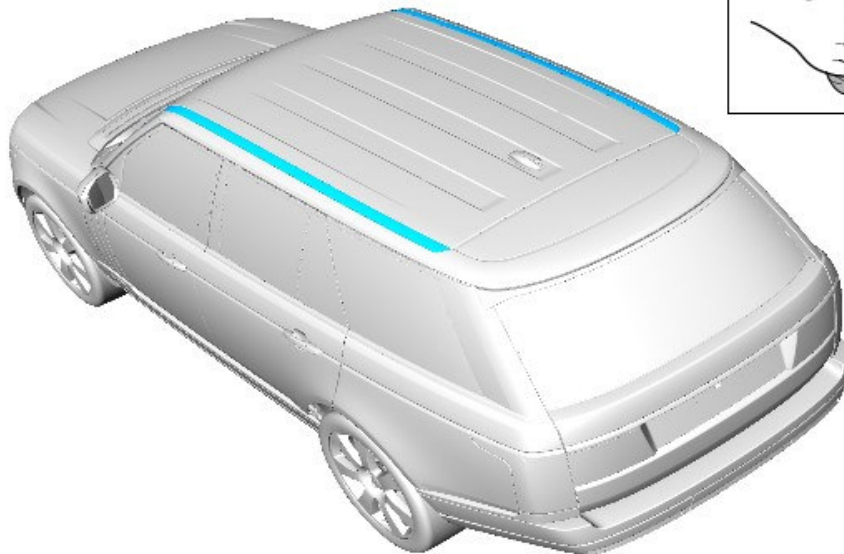
E183621

Clean the vehicle with a suitable cleaner in the area shown.

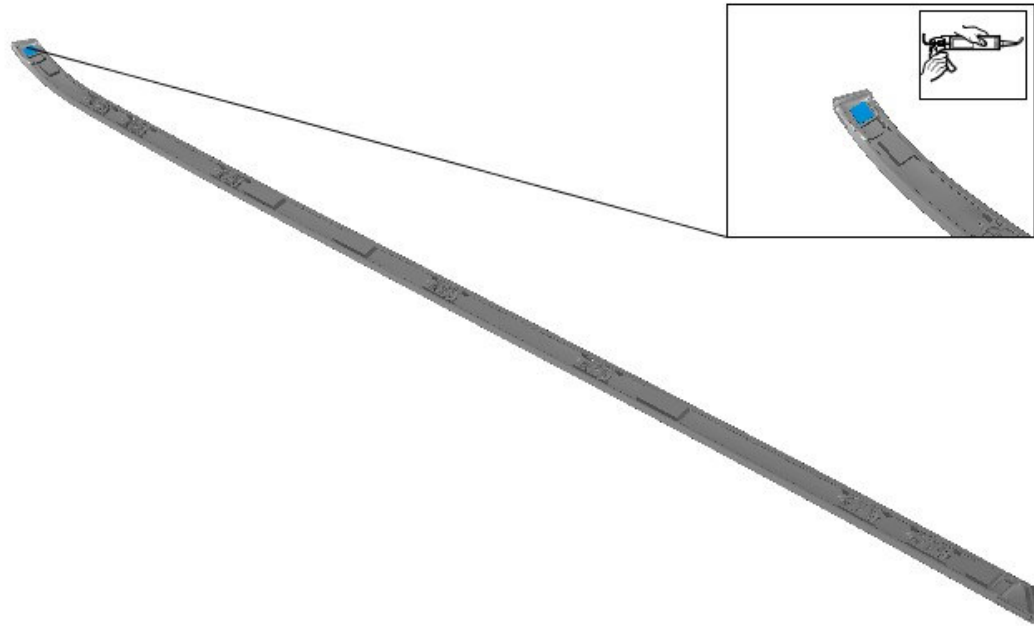
E185128

Apply the sealer in the area shown.

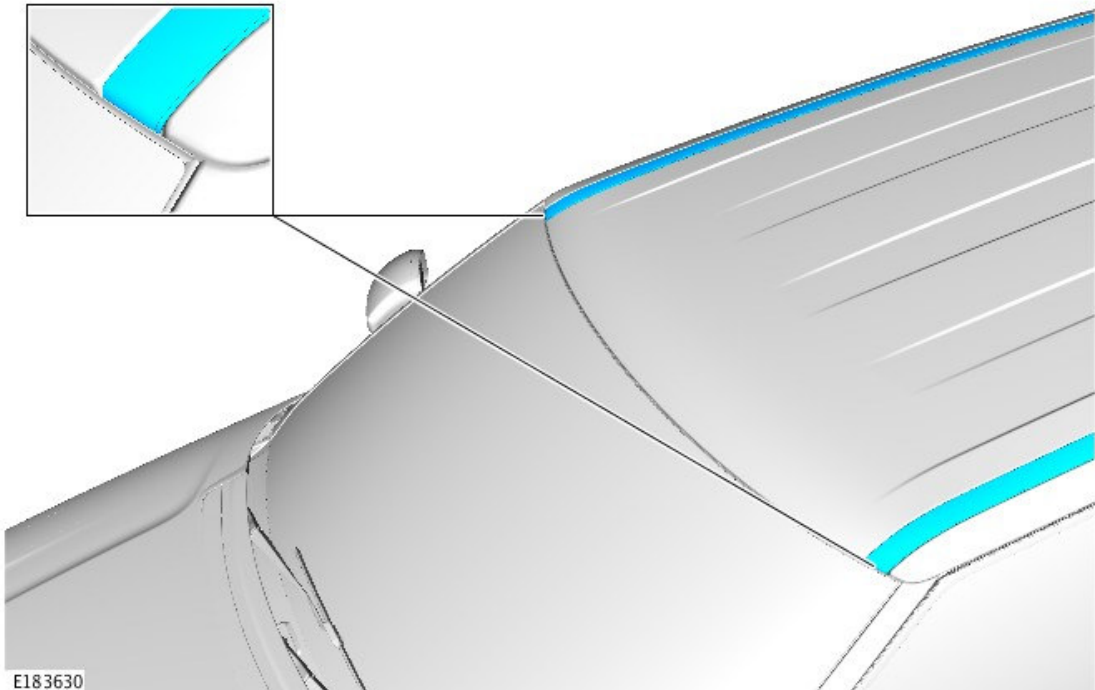
E183630

Make sure the roof moulding is correctly installed.

- Use a suitable tape to

hold
down the
roof
moulding
in the
area
shown.

- NOTE:**
The roof moulding must fit under the windshield aperture seal.

- NOTE:**
Remove the securing tape and any residue from the tape with a suitable cleaner when the sealer has fully cured.
