Reference	SSM72939
Models	Discovery Sport / L550
Title	L550 - 2nd Row Seat Back Damaged by Seatbelt Buckle
Category	Body
Last modified	19-Aug-2016 00:00:00
Symptom	101000 Seating
Attachments	13.pdf (13.pdf) 2.pdf (2.pdf)

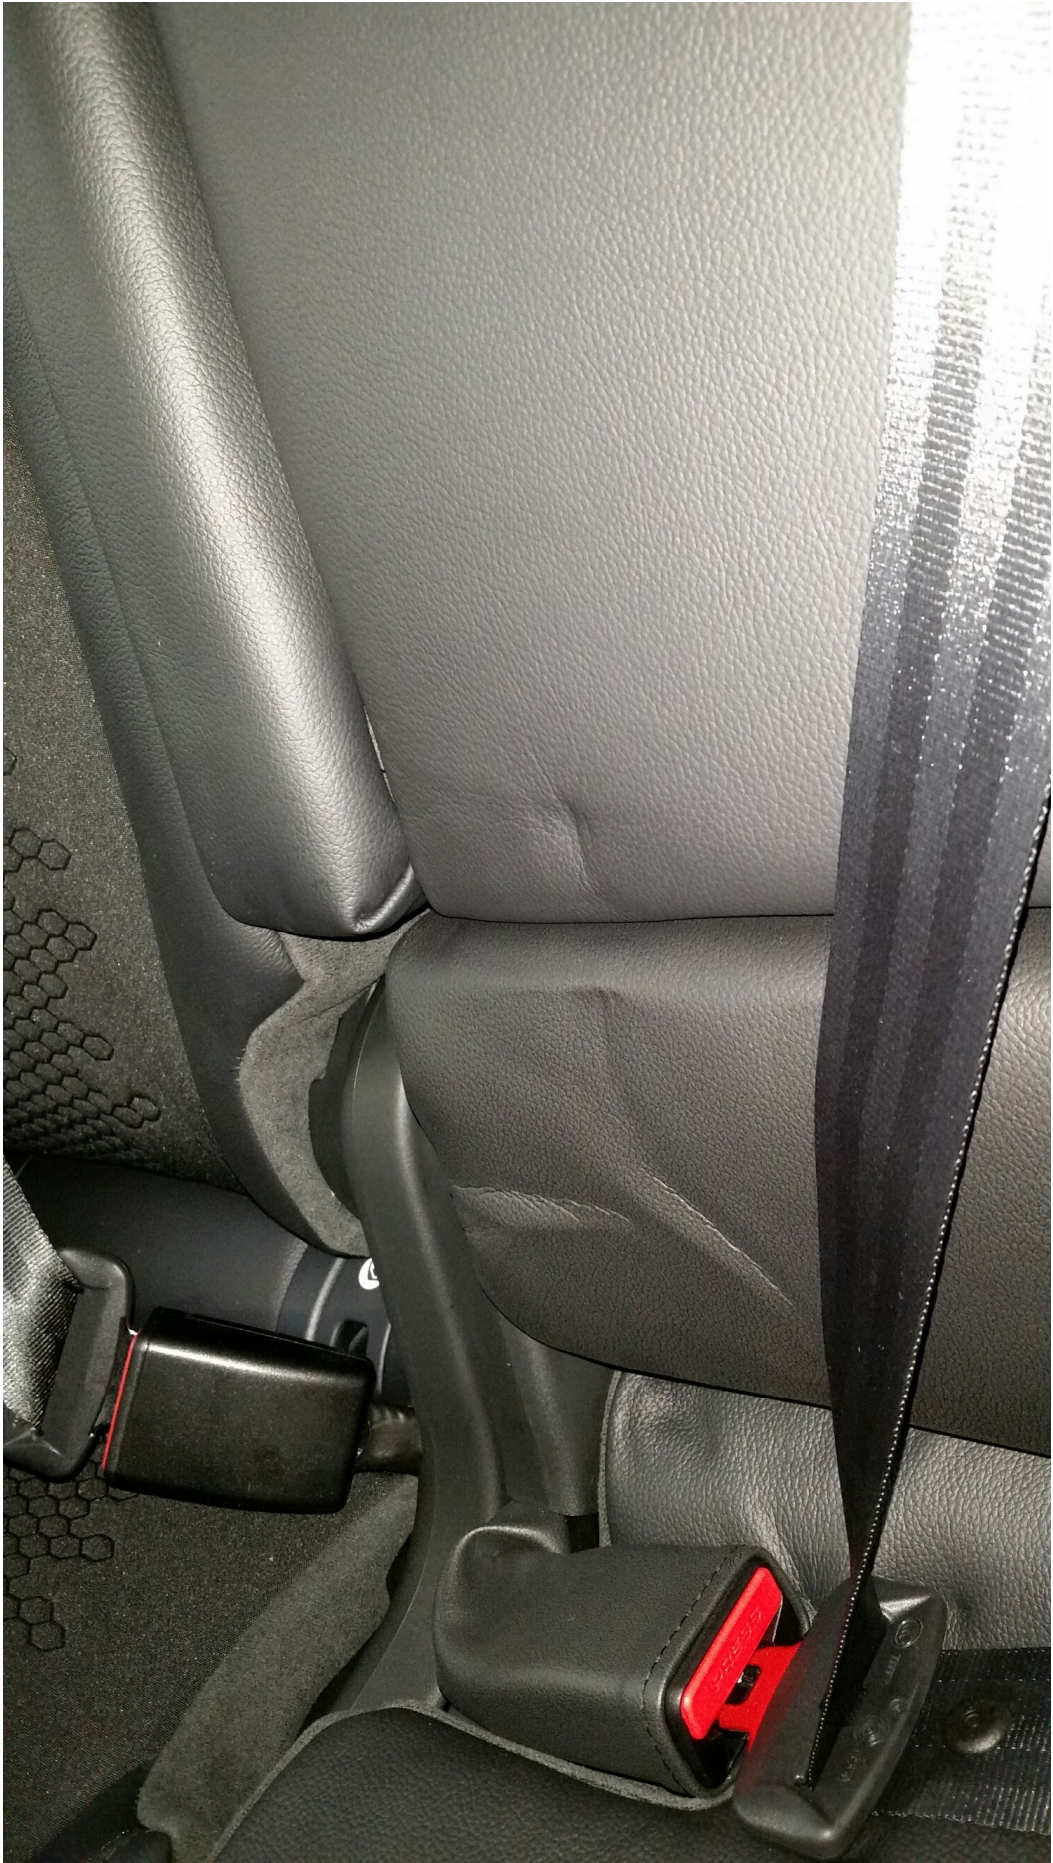
A customer may express a concern that the 2nd Row Seat backrest has been damaged when the seats have been lowered in order to extend the luggage space

This can occur on both the fixed and sliding 2nd Row Seat variations – see attached image 1.

The central seatbelt buckles of the 2nd Row Seats could damage the seat back if the correct procedure for the lowering of the seat back is not followed by the customer.

Please refer to Topix Section 501-10, Seat Smoothing in order to rectify the damage to the seat back.

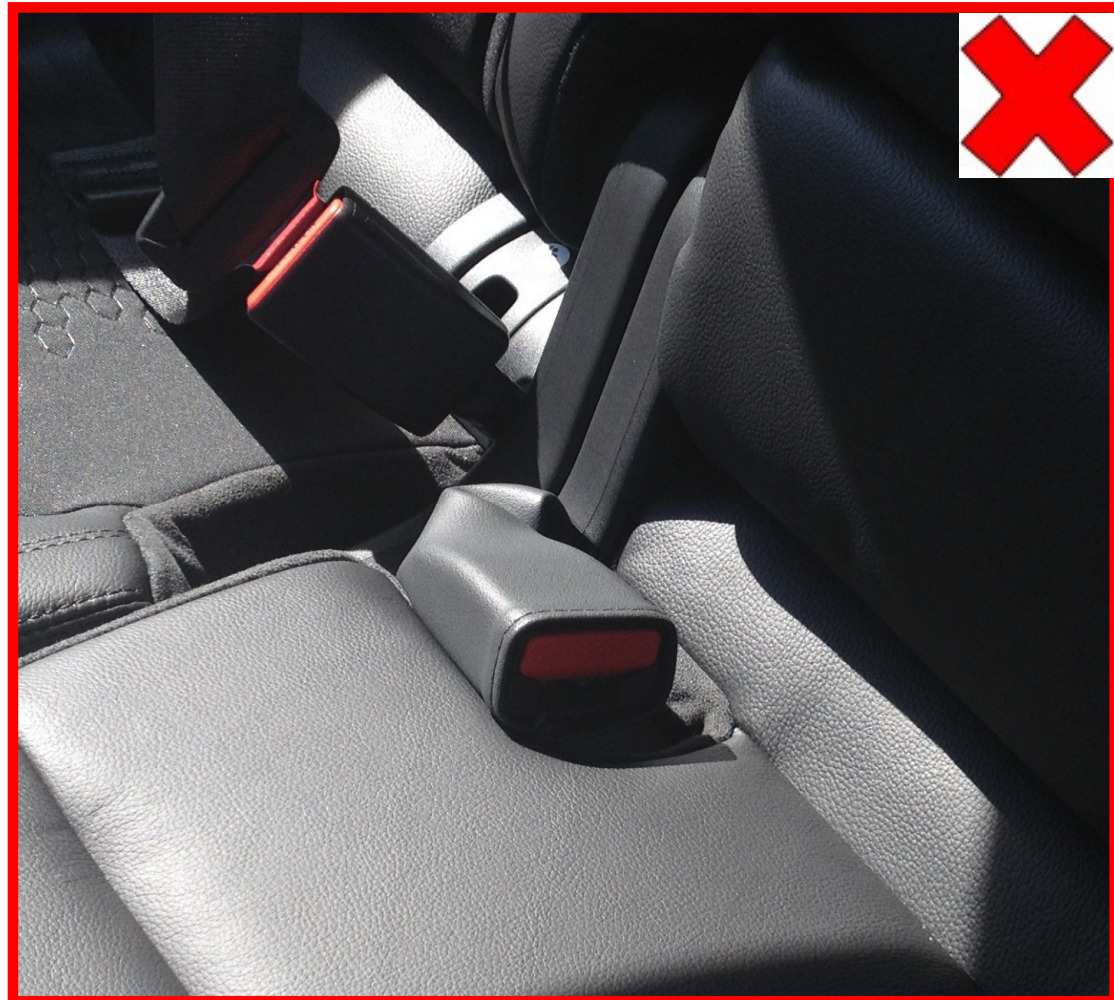
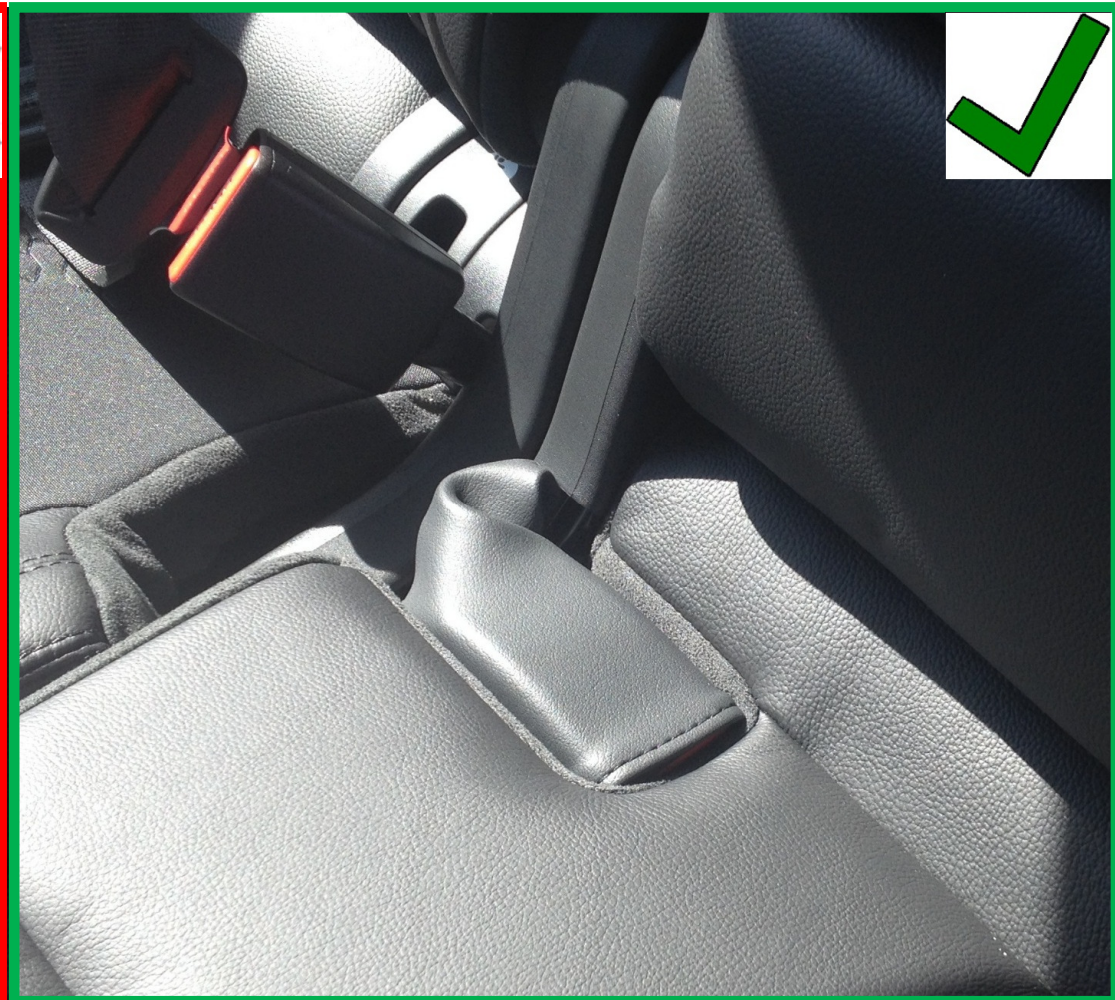
1. Reference the Rear Seats section of the owner's manual, Folding and Raising the Sliding Seats.
2. Please remind the customer of the correct procedure for the folding of the seat back rest when more luggage space is required.
3. Highlight the need to ensure that the seatbelt buckles are pushed securely into the recesses of the seat base prior to the seat backs being folded – see attached image 2 for guidance.
4. Demonstrate the folding of the seat if required.

If the car is fitted with a sliding 2nd Row Seat:
