Service Bulletin

05820 Version 3

Noncompliance Recall: HR-V Emission Label

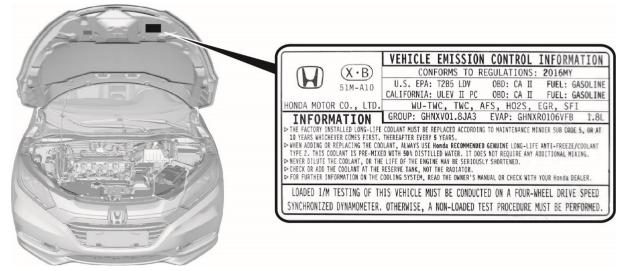
- 1. Open the hood and make sure the emission label is present at the location shown.
 - If the label is present, go to step 2.
 - If the label is missing, apply a new one:
 - NOTE: There are 2 emission labels available. Make sure you order the correct one for the vehicle.
 - Using alcohol and a clean shop towel, clean the hood area where the emission label is placed. Allow the area to dry.
 - Peel off the backing from the emission label, and apply it to the hood. Press the label firmly to make sure it sticks. The vehicle is OK. Return the vehicle to the customer.

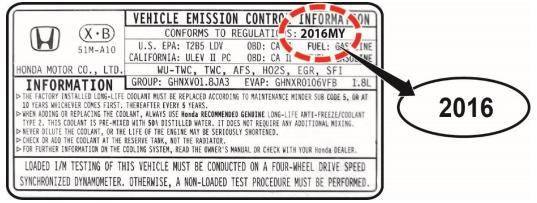
2. Inspect the emission label to make sure **2016** is the model year listed as shown.

- If the correct model year is listed, the vehicle is OK. Return the vehicle to the customer.
- If the wrong model year is listed, replace it with the correct one.
 - Remove the original label and use 3M adhesive remover to clean any remaining adhesive residue.
 - Using alcohol and a clean shop towel, clean the hood area where the emission label is placed. Allow the area to dry.
 - Peel off the backing from the emission label, and apply it to the hood. Press the label firmly to make sure it sticks. The vehicle is OK. Return the vehicle to the customer.
