## SERVICE POLICY LETTER

| Reference number: | SPL-03-0594 | Issued: 3 February 2017 |
| Subject: | Engine Oil Leaks for Vehicles still in Manufacturer's Warranty | |

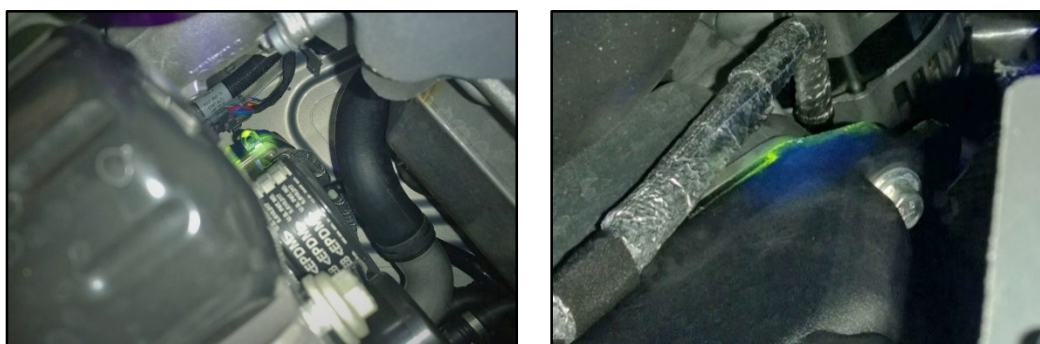
Figure 1 - Examples of dye in engine oil

When you use the correct lamp, the dye in the oil of new AML engines will glow bright green (refer to Figure 1).

To do a check if there is dye in the engine oil, remove the oil filler cap and point the UV lamp into the oil filler opening. You should see the dye glow green.

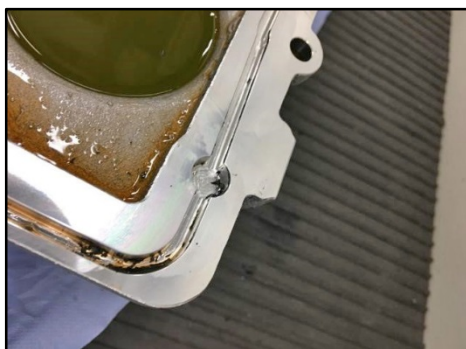
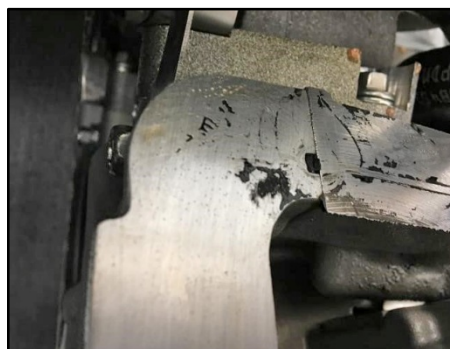
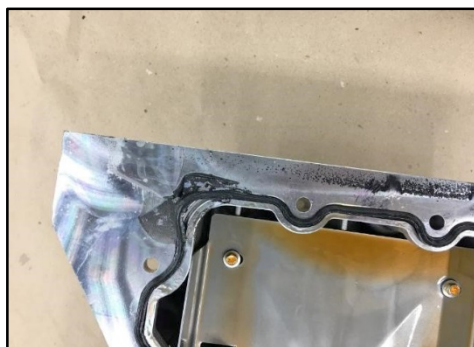
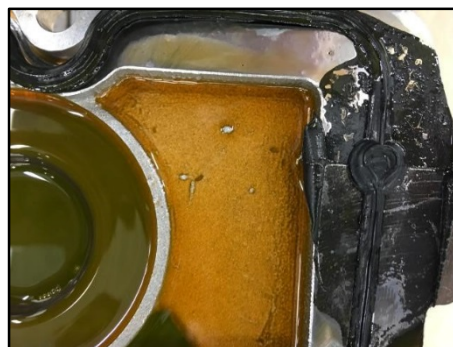
After we have given the approval to do the repair, during the repair process, please take more photographs. We ask you to do this to give us more information about why the leak occurred. This will help us to increase reliability and quality in the future. For examples, refer to Figure 2 thru Figure 5. The photographs must show data about the cause of the leak.
