QUARANTINE NOTICE

Reference number:	QN-01-0056	Issued: 24 March, 2017
Subject:	Possible missing fuel line heat deflector	
Model(s):	V12 Vantage S and Vanquish	
VIN Range:	Refer to the list of applicable VIN published separately.	
Applicable to:	All Dealers	
Distribute to:	After Sales Manager Executive Manager Service Manager Sales Manager	Warranty Staff Technician(s) Parts Staff

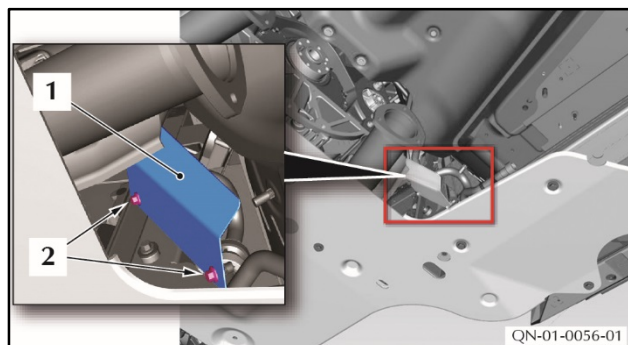
Because of an error during manufacture, it is possible that some of the vehicles in the affected VIN list do not have the heat deflector installed for the fuel line.

1. Lift the vehicle and make it safe.
2. Refer to Figure 1 and examine the area at the corner of the floor pan where the fuel pipe goes into the engine bay.
3. If the heat deflector (1) is installed, you do not need to do more work. If the heat deflector (1) is not installed, do the steps that follow.

4. Put the heat deflector (1) in position.
5. Install and torque the two M6 attachment screws (2) to 9 Nm.
