SERVICE BULLETIN

RS16-016

2014 – 2016 ROGUE OCCUPANT CLASSIFICATION SYSTEM RETROFIT

APPLIED VEHICLES: 2014 – 2016 Rogue (T32)

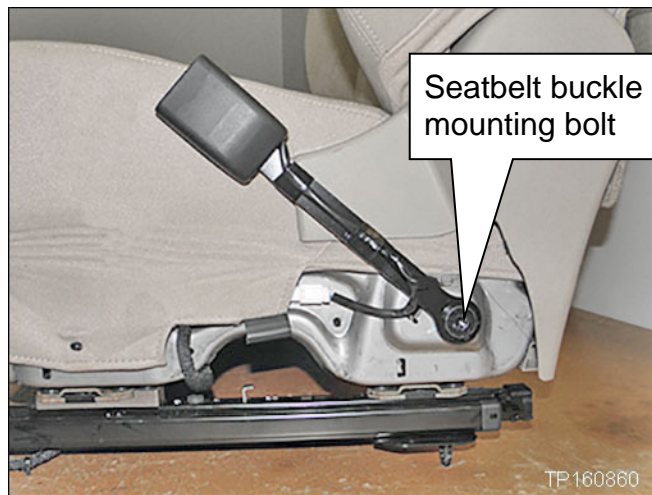
Figure 1

7. Remove the seatbelt buckle.

- Buckle is held on with one bolt.
