SERVICE BULLETIN

Classification: BT17-003	Reference: NTB17-023	Date: February 27, 2017
-----------------------------	-------------------------	----------------------------

2017 ARMADA; OUTSIDE MIRROR(S) LOOSE AT BASE

APPLIED VEHICLE: 2017 Armada (Y62)

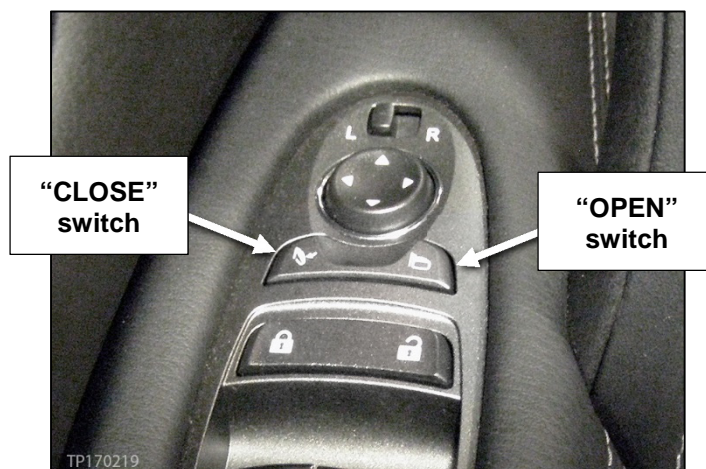
Figure 1

If the power foldable outside mirrors are manually folded/unfolded or bumped, the mirror body can become loose at the pivot point.

If this occurs, the mirrors should be adjusted again electrically before driving.

To readjust the mirrors, press the “CLOSE” switch (see Figure 1) until the mirrors are fully folded in, then press the “OPEN” switch until the mirrors are fully open.
