BT17-010

## 2009-2015 G37/Q60 CONVERTIBLE; CENTER ROOF WEATHER STRIP REPAIR

**APPLIED VEHICLE:** 2014-2015 Q60 Convertible (V36)  
2009-2013 G37 Convertible (V36)

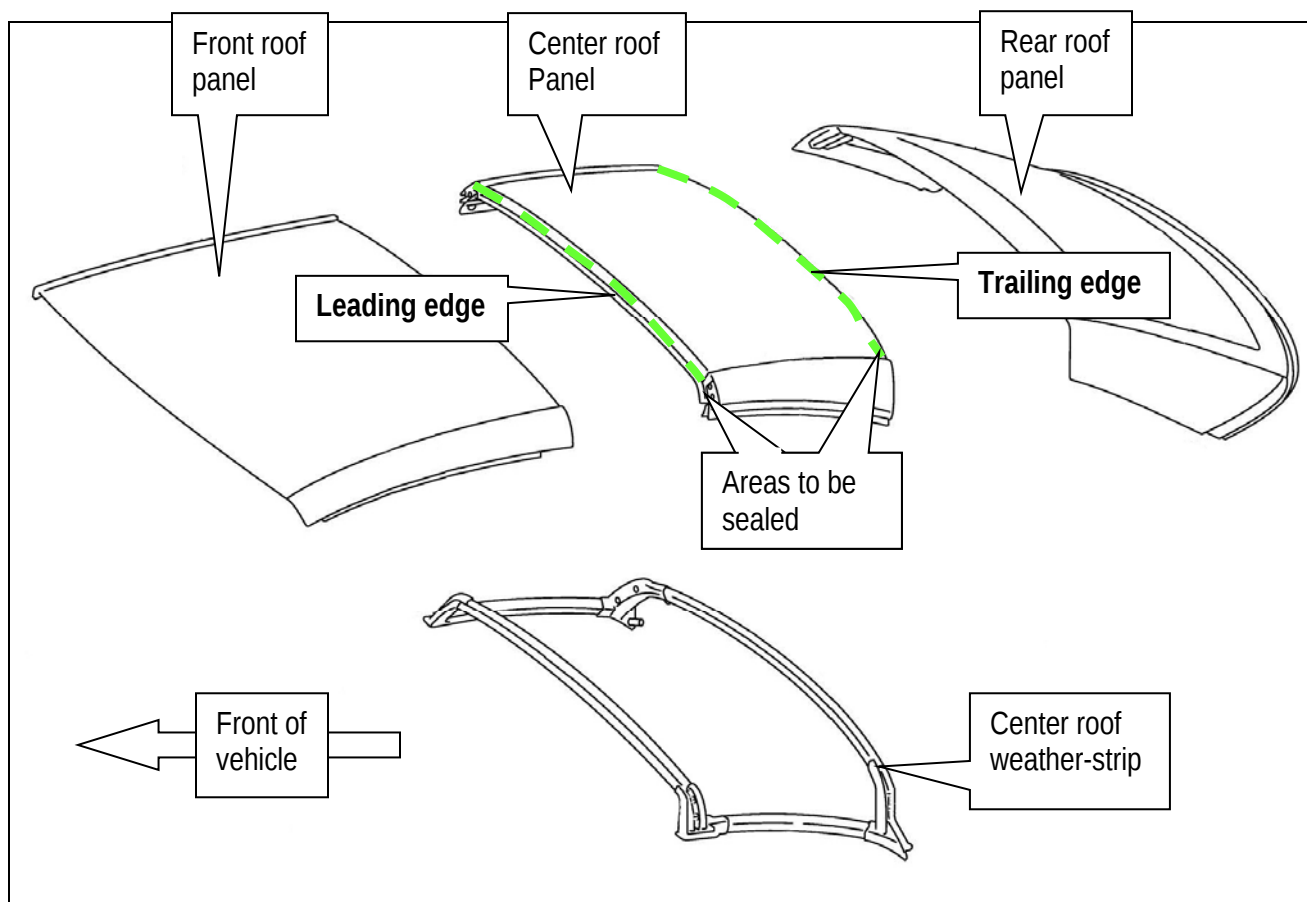
Figure A below is reference for the following service procedure.

- See Figure A on page 2 for leading edge location.
- Gently pull the center roof weather-strip away from center roof panel just enough to apply a 1/8 inch bead of silicone into gap.
  - Apply silicone sealant where shown in Figures 4 and 5 by green dash line.
  - Apply sealant as shown in Figure 3.

- See Figure A on page 2 for trailing edge location.
- Gently pull the center roof weather-strip away from center roof panel just enough to apply a 1/8 inch bead of silicone into gap.
  - Apply silicone sealant where shown in Figures 9 and 10 by green dash line.
  - Apply sealant as shown in Figure 8.

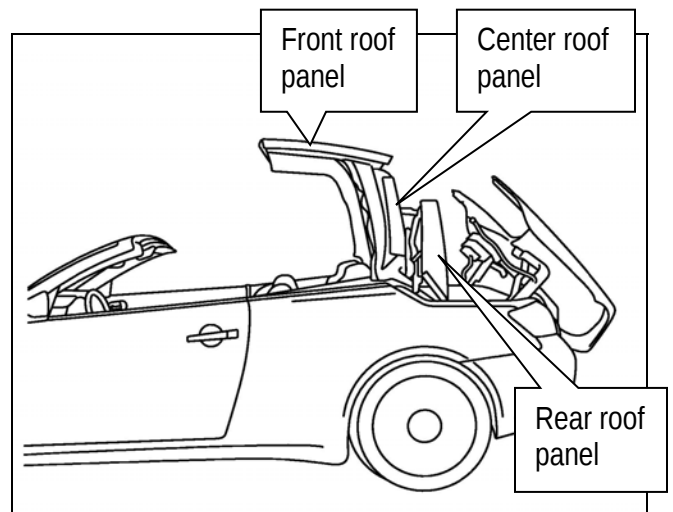
Figure 1

1. Open the convertible top half way, to allow access to the center roof weather-strip as shown in Figures 1 and 2.
  - The center roof panel will be vertical.
  - The front roof panel will be close to horizontal.

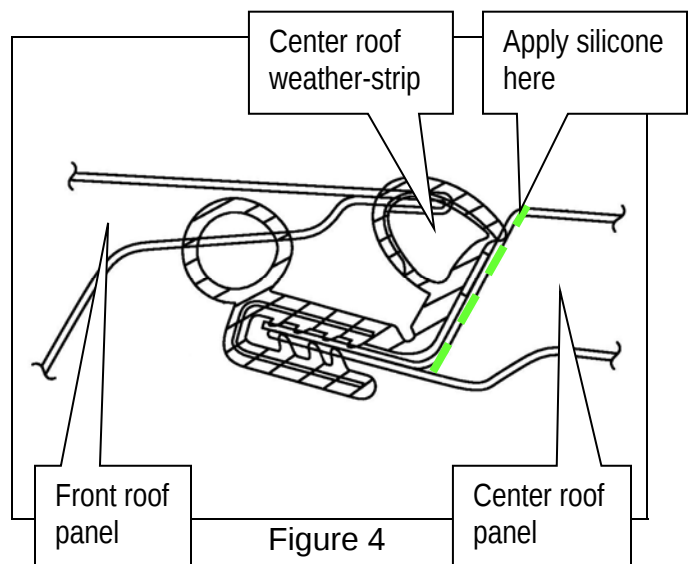
- Figure 4 is a cross section of front roof panel, center roof weather-strip and center roof panel.

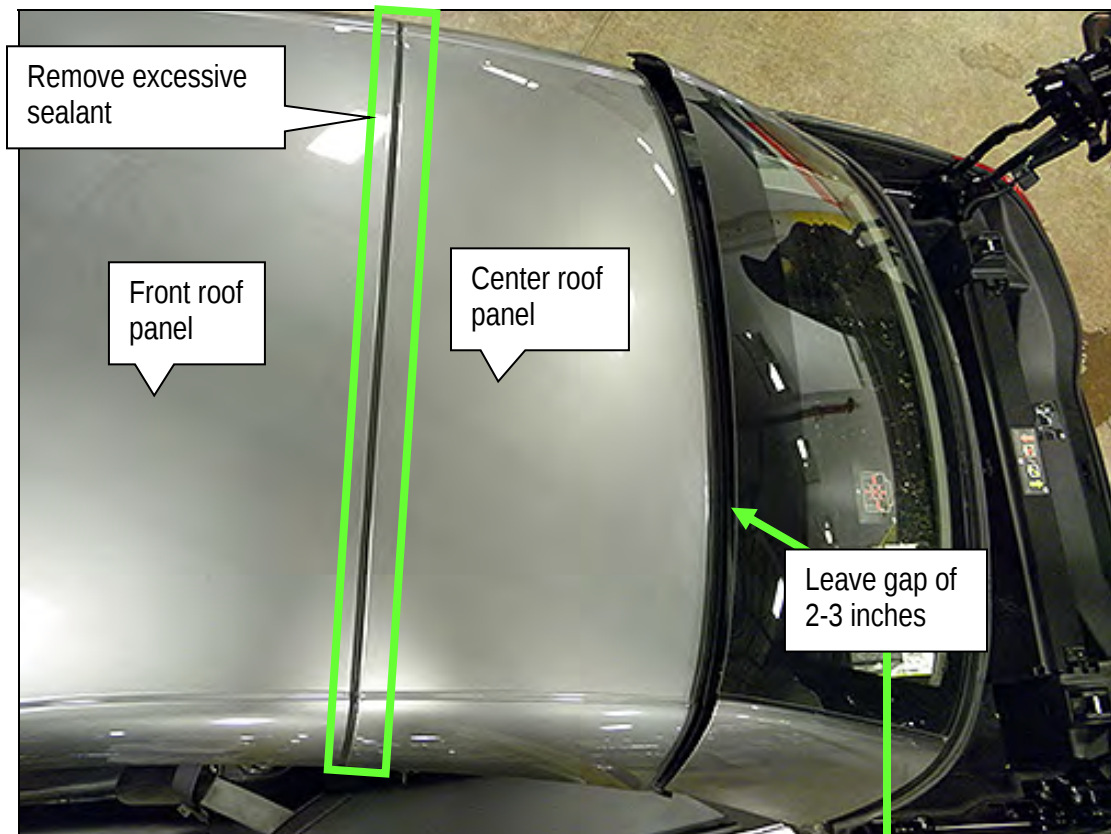
Figure 6

4. Partially close the roof as shown in Figure 6.
5. Remove excess silicone sealant from the front and center roof panels (see Figure 6).
  - Silicone sealant can be removed with Isopropyl alcohol.
  - Leave the roof partially open and proceed to step 7 on the next page.

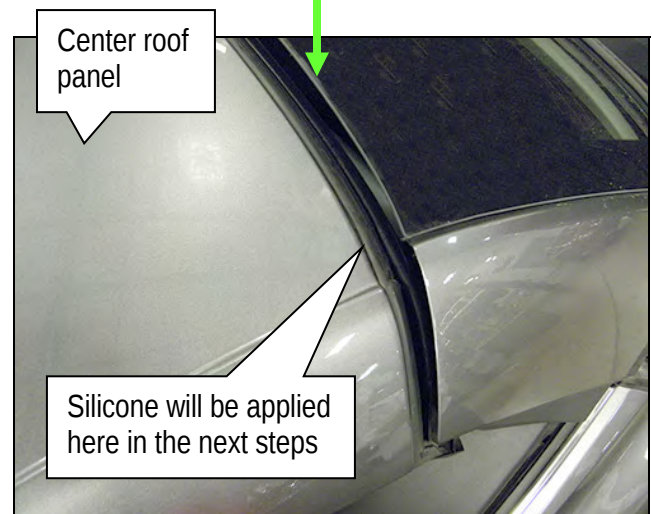
- Figure 7 shows necessary gap.

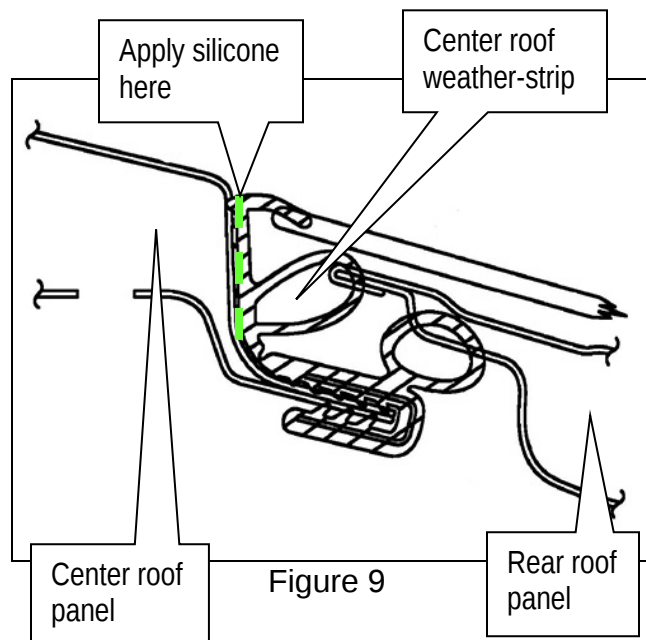
- Figure 9 is a cross section of center roof panel, center roof weather-strip and center rear panel.

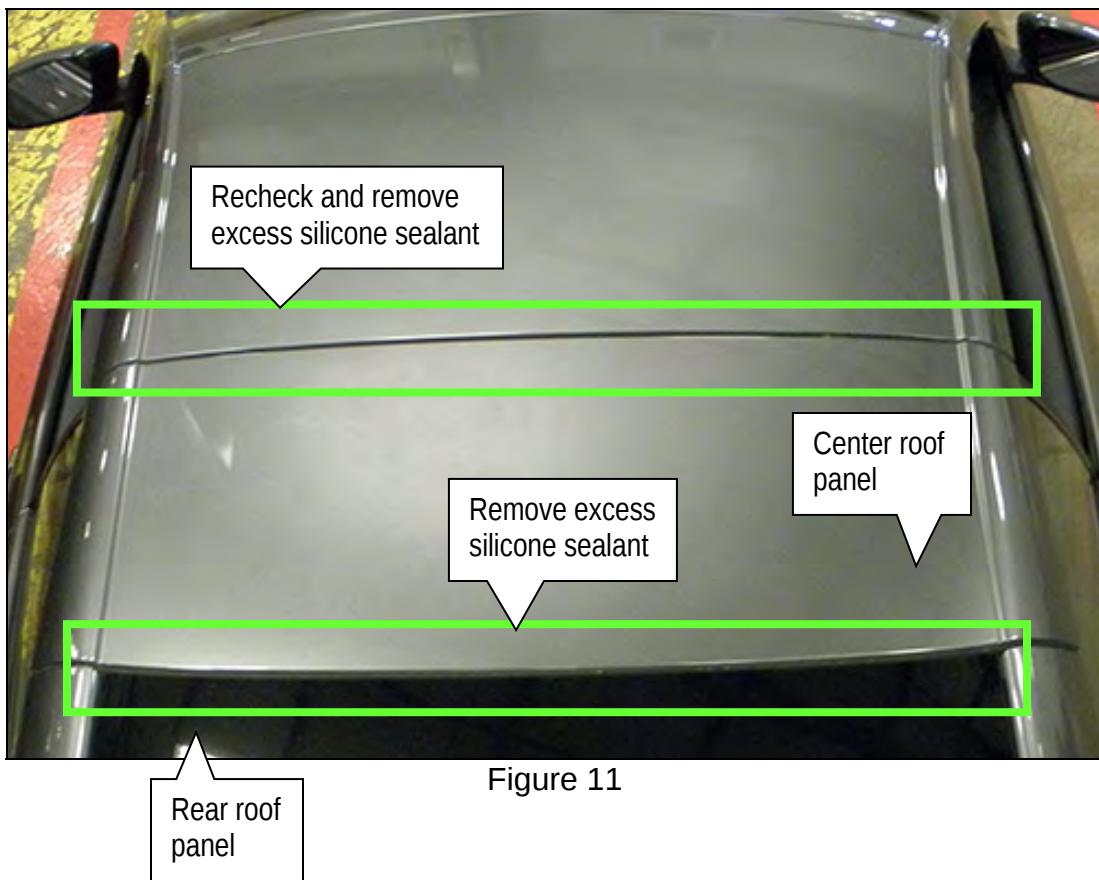
Figure 11

7. Close the roof completely.
8. Remove excess silicone sealant from the center and rear roof panels (see Figure 11).
  - Silicone sealant can be removed with Isopropyl alcohol.
  - If any additional silicone sealant has been forced out from between the front and center roof panels, remove the excess.
