**Subject:** Shit Toe peg

**Specific components: heel and toe shift toe pegs (cosmetic issue only).**

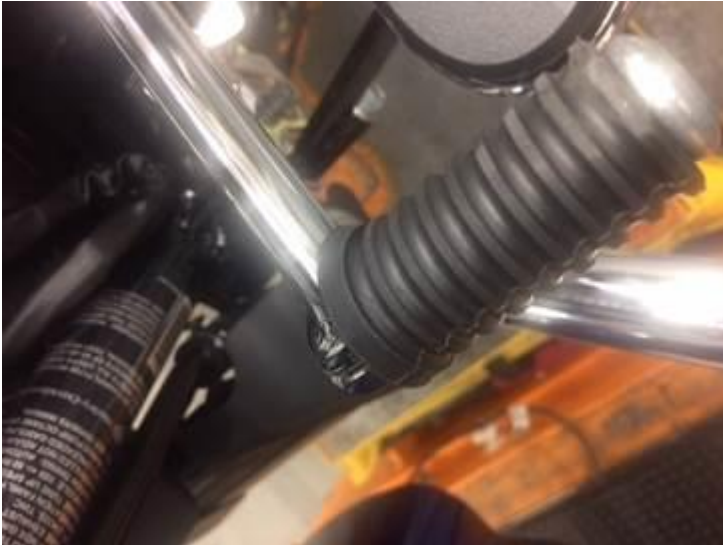
**Incorrect** installation shown below, rubber is distorted against shift lever arm, entire head of screw peg is exposed.

- Visual inspection – If incorrect remove and install new "Toe Shifter Peg Kit" part number 34611-65A.
- The torque spec is 96-144 in/lbs.
- If there are questions, follow the procedure in the Service Manual.

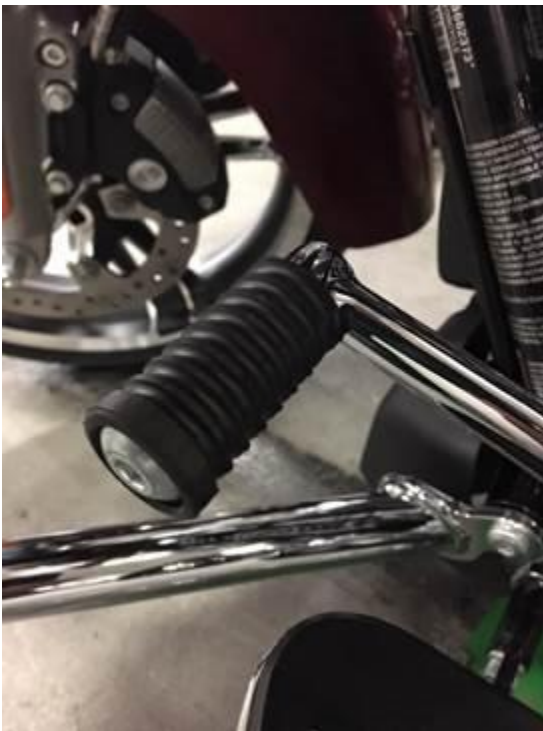
**Correct** installation shown below, head of screw peg is countersunk within (toe) rubber.
