PREVOST

WARRANTY BULLETIN

WB16-02E

DATE :	MAY 2016	SECTION :	06 - Electrical
EXPIRATION:	MAY 2018		
SUBJECT :	CHARGING SYSTEM IMPROVEMENT

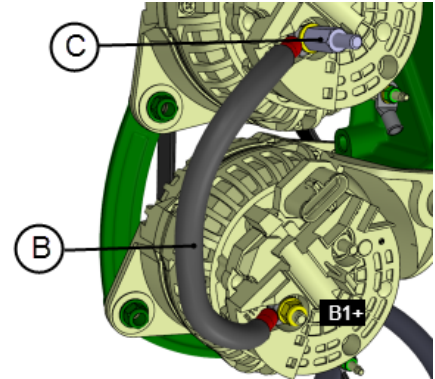
FIGURE 2

B : (+) JUMPER CABLE

C : (+) STUD ADAPTER

2. Disconnect jumper cable **B** from the upper alternator **B1+** stud terminal. To do so, unscrew and remove stud adapter **C** and flat washer.
3. Disconnect jumper cable **B** from the lower alternator **B1+** stud terminal. To do so, remove hex nut and washer.

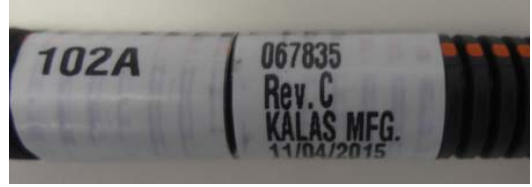
FIGURE 6

Rev.C lug terminal through hole dia.= 5/16" **CORRECT**

Rev.B lug terminal through hole dia.= 13/32" **INCORRECT**

6. Reinstall the jumper cable **#067835 revision C** included in kit #7770176 (FIGURE 6, FIGURE 7).

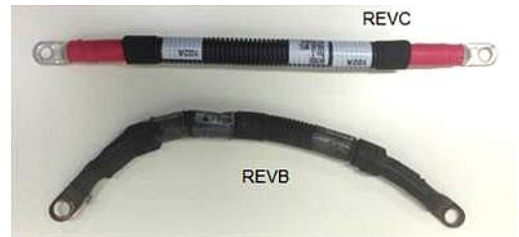
FIGURE 8

Rev.B diameter of the through hole is too large, reducing contact surface with the stud and the nut thus reducing electrical conductivity between the lug and the alternator stud (FIGURE 8).

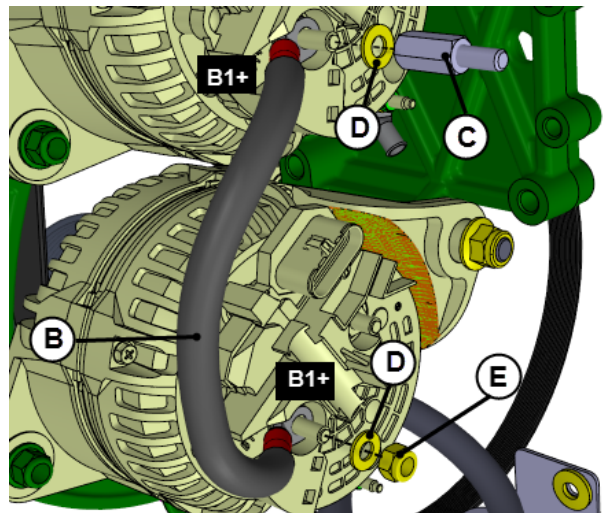
FIGURE 9

B : JUMPER CABLE #067835 revision C

C : STUD ADAPTER #060297 torque: 10 lbf-ft

D: FLAT WASHER #5001341

E: NUT M8 #5001787 torque: 10 lbf-ft

7. Reinstall appropriate jumper cable **B** (i.e. rev.C) with appropriate stud adapter. Refer to FIGURE 9.

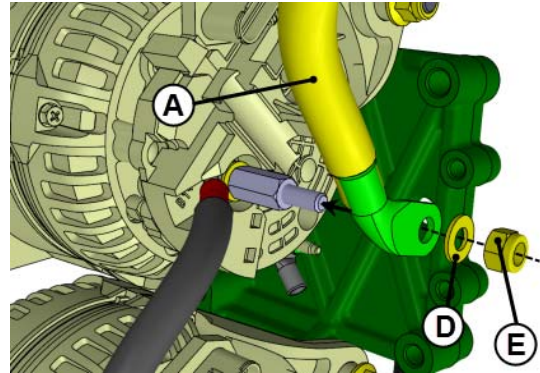
FIGURE 10

A : POWER CABLE

D: FLAT WASHER #5001341

E: NUT M8 #5001787 *torque: 10 lbf-ft*

-
8. Reinstall power cable **A**. To do so, connect power cable **A** to the upper alternator **B1+** stud terminal. Refer to **FIGURE 10**.

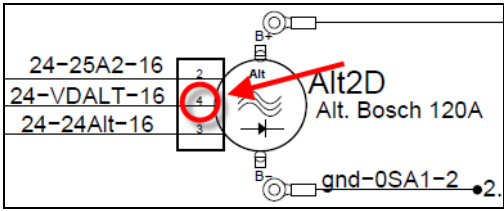
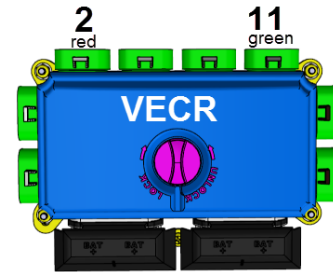
FIGURE 11 : VECR

1. Inside rear electrical compartment (rear junction box), locate VECR module (FIGURE 11).

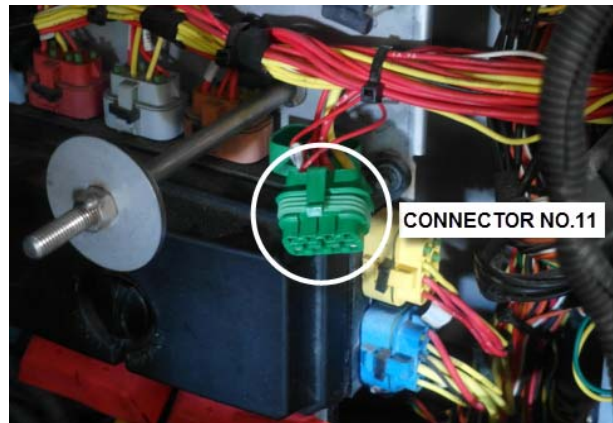
FIGURE 12

3. Using an extractor tool or a small flat blade screwdriver, remove wire 24VDALT from cavity H of connector no.11 (FIGURE 12 to FIGURE 15).

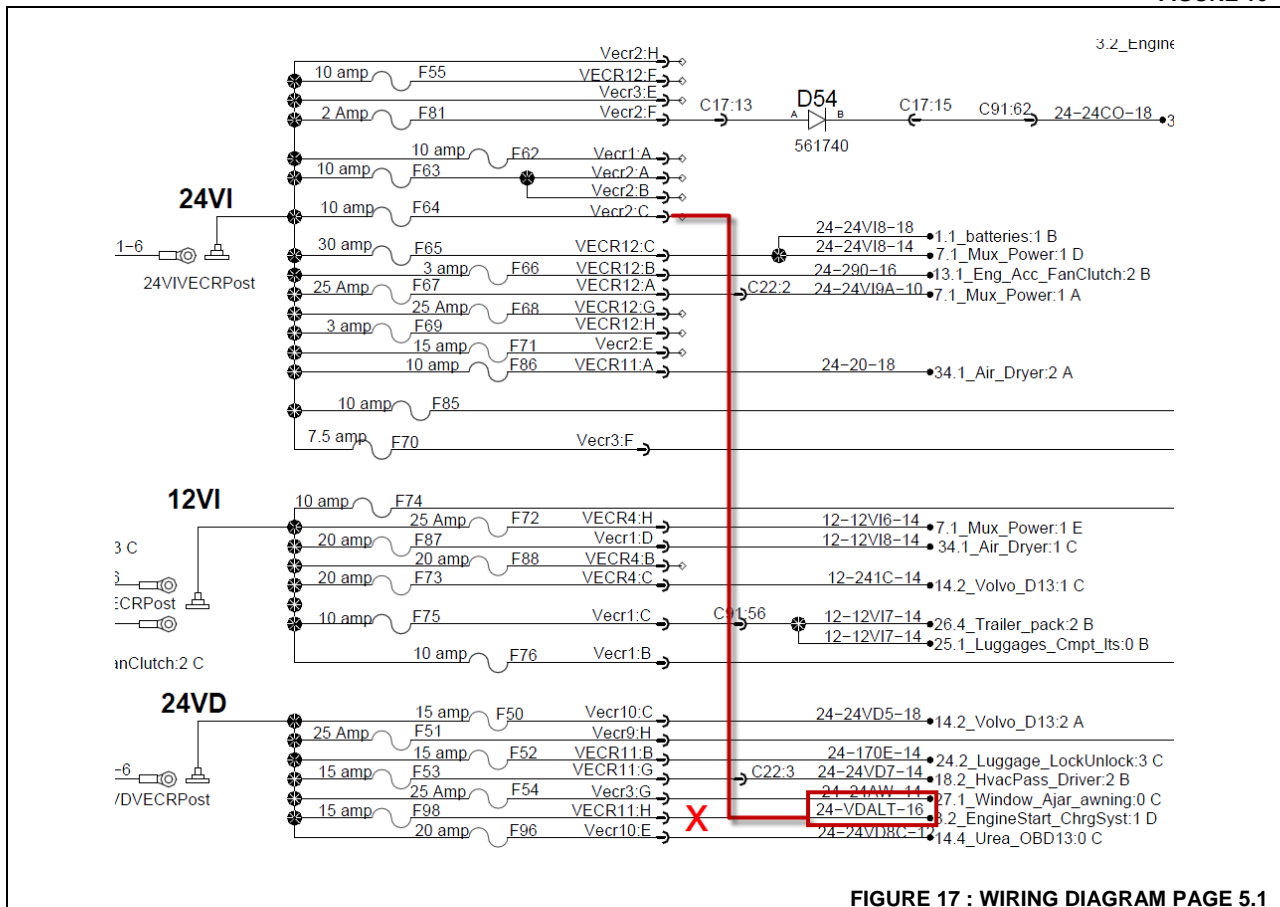
FIGURE 17 : WIRING DIAGRAM PAGE 5.1

Cavity **C** of connector no.2 should be available. This branch of the circuit will be protected by 10A fuse F64 (see FIGURE 17 below).

Should cavity C not be available, refer to your vehicle wiring diagram page 5.1 to select another free cavity protected by a 10A or 15A fuse (see FIGURE 17 for reference).

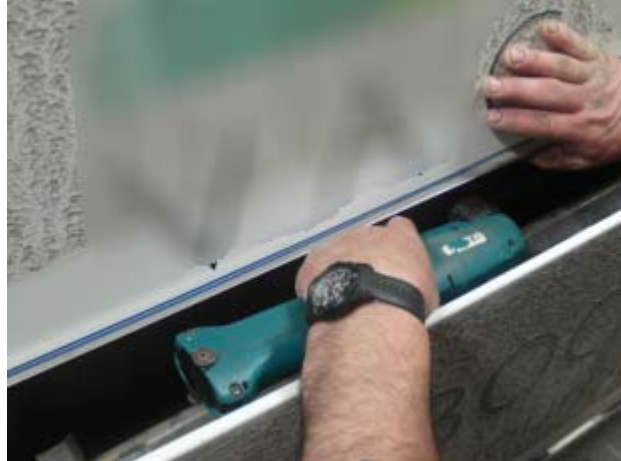
Drill using a 9/64 bit. FIGURE 35 shows how to drill holes with the access hatch in place using a right angle drill.

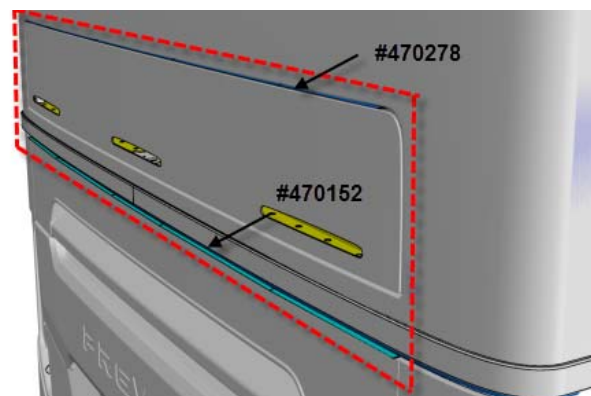
2. See on FIGURE 41 where each drip edge will be positioned. The drip edges will be fastened on the vehicle body, **not on** the ATS access hatch.

5. Clean dirt on the area located right above the ATS access hatch and the area where the lower drip edge will be installed (FIGURE 41). It is very important to install the drip edges on a clean surface to ensure water tightness.

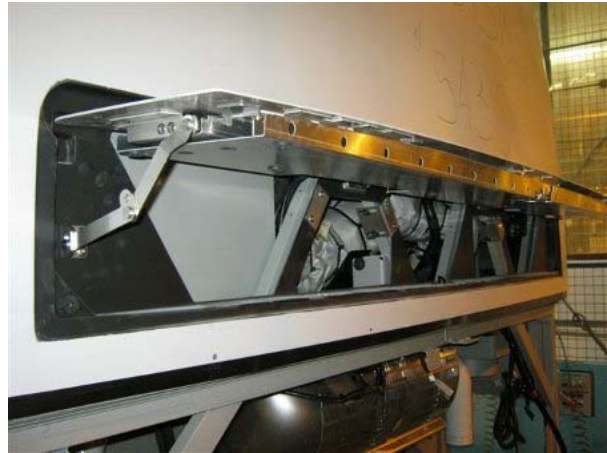
FIGURE 43

4. Remove the **exhaust aftertreatment system (ATS) access hatch**.

Prior to removing the access hatch, protect the surrounding surfaces using wide paper masking tape.

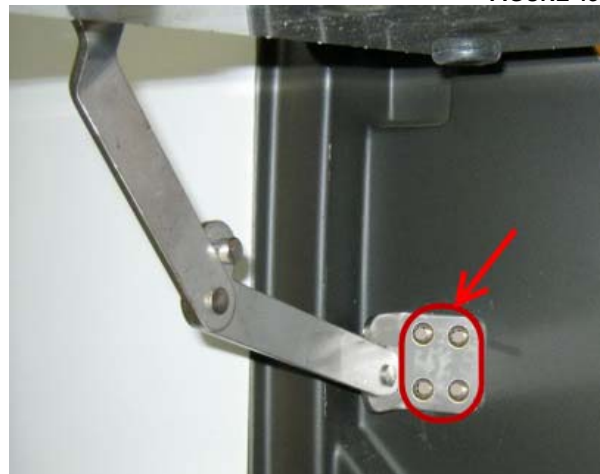
- a) To do so, drill through the folding arm rivets (4 rivets) shown on FIGURE 44
- b) Disconnect the “high mounted stop lights” cable harness.
- c) Unscrew the hinges mounting bolts (2 bolts per hinge). Spacers may be found behind the hinges. Make sure you identify the spacers in order to reinstall the access hatch using the proper spacer at the correct location (FIGURE 45).

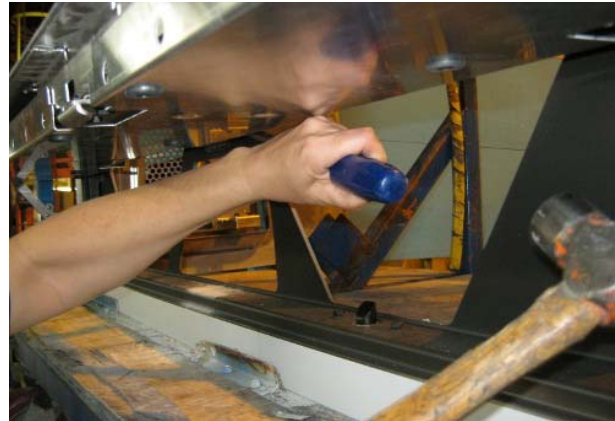
FIGURE 57

-
19. Check the upper part of the access hatch for rubbings against the rivets when opening and closing the hatch. If this is the case, the hatch has to be moved downward.
 20. Loosen the hinge mounting bolts (4 bolts) slightly.
 21. Use a screwdriver and hammer, tap slightly on the hinges to move the door for proper fit (FIGURE 57).
