## Service Bulletin No. 449

| MODEL<br><b>J4500</b> | TYPE<br><b>Field Change Program</b> | SECTION/GROUP<br><b>3-Body</b> | DATE<br><b>April 13, 2017</b> |
| SUBJECT<br><b>RH DASH ASSEMBLY DEFROSTER VENTS</b> | | | |

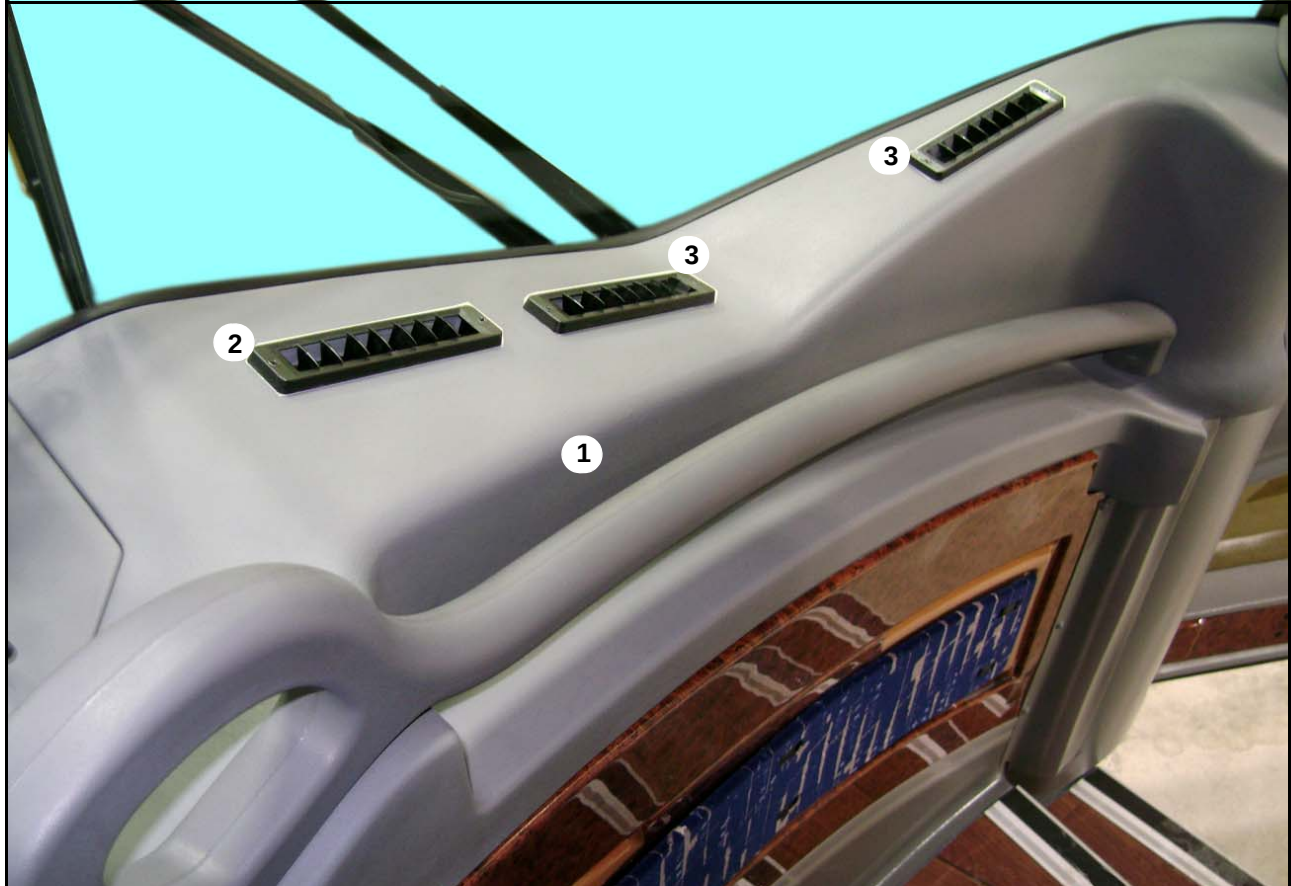
1. Turn the main battery disconnect to the OFF position.
2. Chock both sides of the tires.
3. Enter the coach cabin.
4. Locate the three ( 3 ) defroster vents on the RH dash assembly shown in Figure 1.

**Figure 1. Defroster vents located on upper face of the RH dash assembly.**

| Item | Figure 1 Description |
| 1 | RH dash assembly |
| 2 | Defroster vent, p/n 16-14-1678. Larger profile opening. |
| 3 | Defroster vent, p/n 16-14-1679. Smaller profile opening. |

5. Carefully remove and discard the defroster vent mounting screws. Carefully lift upwards to remove the defroster vent from the RH dash assembly. Discard the defroster vent.
6. Orient the new defroster vent, p/n 16-14-1678, in the larger open cavity shown as Item 2 in Figure 1. Using new screws, p/n 19-01-1895, secure the defroster vent to the RH dash assembly. Tighten screws to secure.
7. Repeat Steps 5 and 6 to the new defroster vents, p/n 16-14-1679, in the smaller open cavity shown as Item 3 in Figure 1.
