GROUP	NUMBER	
	CAMPAIGN	17-01-014	
	DATE	MODEL(S)	
Technical Service Bulletin	FEBRUARY 2017	Sonata Hybrid (YF HEV)	
SONATA HYBRID (YF HEV) UNDERBOD	Y CORROSION PREVE	NTATIVE SERVICE

SUBJECT: (SERVICE CAMPAIGN 943) This bulletin supersedes TSB 15-01-047 to specify cavity wax application directions a

YF HEV UNDERBODY CORROSION PREVENTATIVE (SERVICE CAMPAIGN 943)

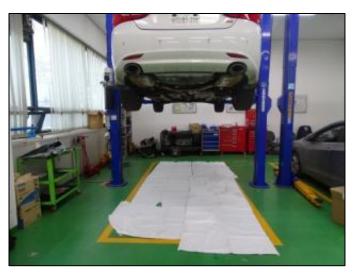
1. When applying the cavity wax, the floor might be contaminated due to the cavity wax. It is recommended to put a plastic vinyl sheet on the floor before applying wax.

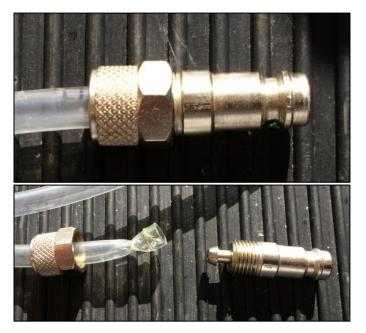
2a. Remove the compression fitting from the nozzle assembly that originally comes with the wax gun by unscrewing the nut, then removing the fitting from the tube.

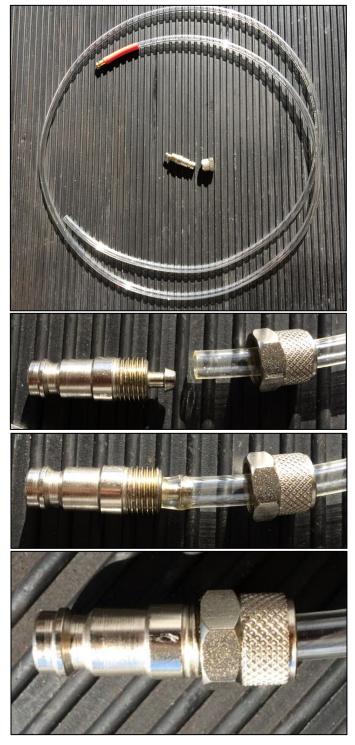
2b. Attach the compression fitting to the tubing on the new nozzle assembly.

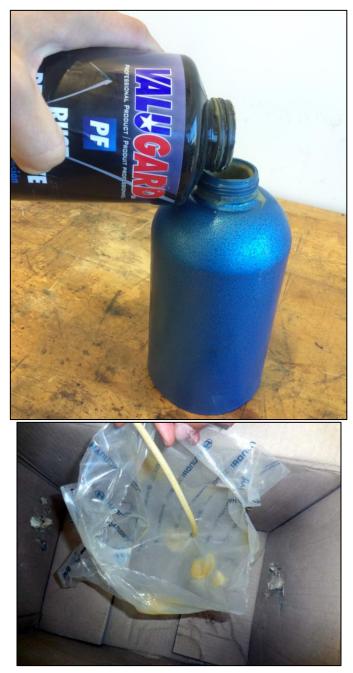
If volume of wax coming out of the nozzle slows significantly (so that a light mist is no longer visible), prime the gun again.

It may speed the priming process to block the nozzle with a rag while spraying the gun until the flow of wax increases.

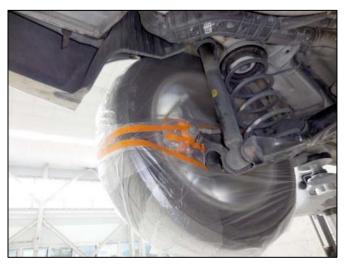
3. Wrap large plastic bags around the wheel/tire/brake assemblies to protect them from overspray. Use tape to secure the plastic in place.

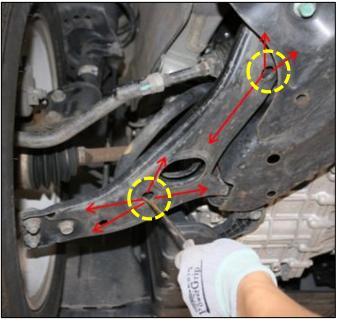
- Front cross member (B-type) Interior 3a. surfaces (<u>using "inside" nozzle</u>) - Four (4) locations

- 10 seconds each

- 3b. Front lower control arms (B-type) - Interior surfaces (using "inside" nozzle)
 - Two (2) locations each arm -
 - 7 seconds each _

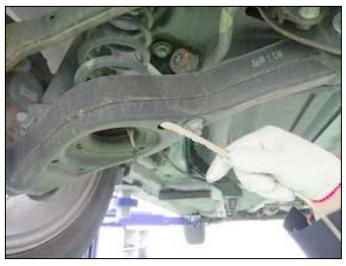
Rear upper control arms – Interior surfaces but <u>using the "outside" nozzle</u> because the opening is too small for the "inside" nozzle.

- Four (4) locations each arm
- 7 seconds each
