Service Bulletin

Subject: Check engine light- P0446- Check EVAP canister for restriction

Brand:	Model:	Model Year:		VIN:		Engine:	Transmission:
		from	to	from	to		
Buick	Encore	2013	2017	SOP	END	ALL	ALL
Chevrolet	Sonic	2012	2017	SOP	END	ALL	ALL
Chevrolet	Trax	2013	2017	SOP	END	ALL	All

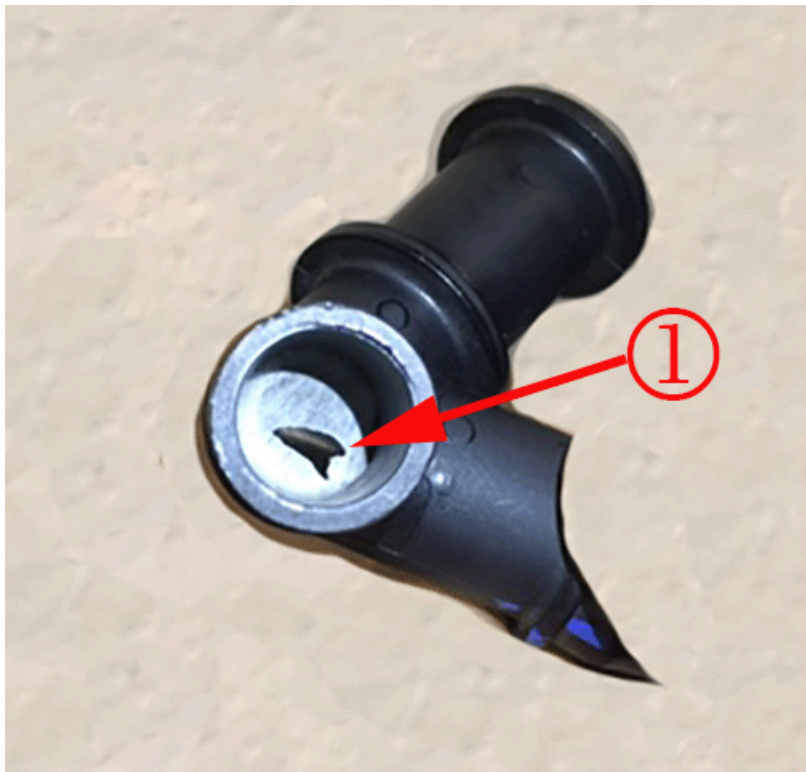
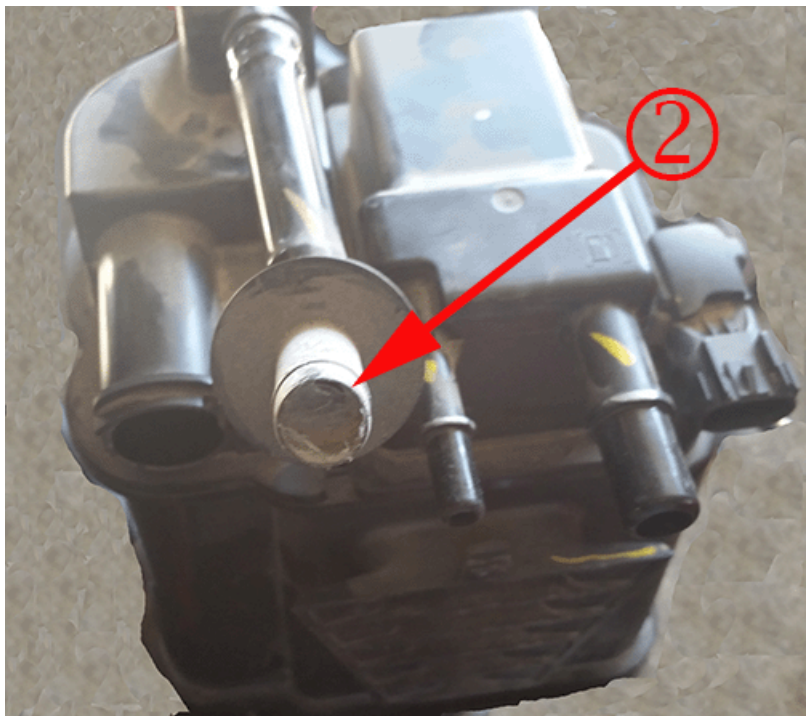
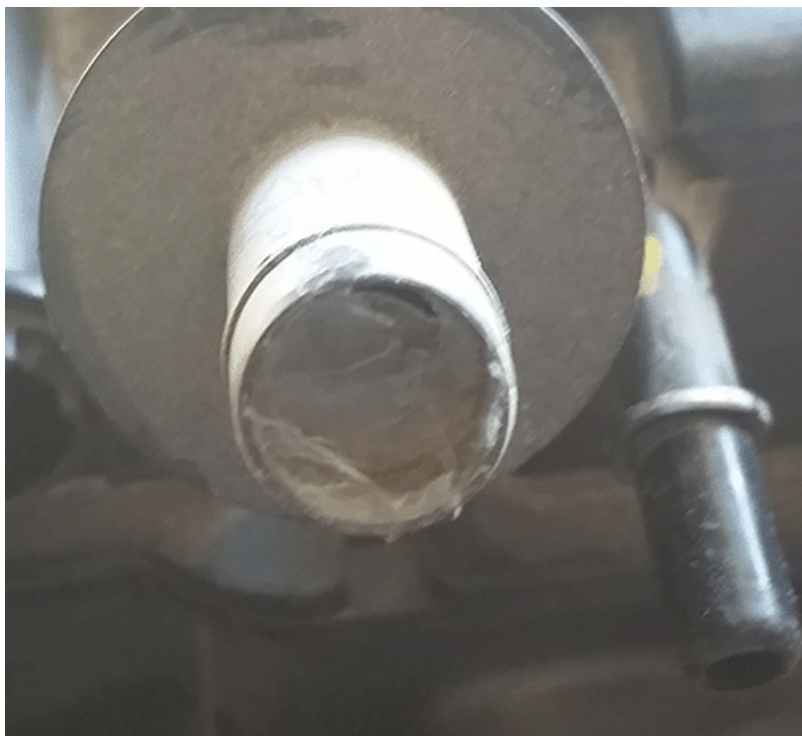
Involved Region or Country	North America
Additional RPO/s:	N/A
Condition	Check Engine Light; P0446
Cause	Restriction in fresh air inlet port caused by spiders

Remove the evap canister vent cap and Inspect evap canister for spider nesting in the fresh air inlet port (see picts). Replace evap canister.
