Service Bulletin

Subject: Diagnostic Tip - MIL On With DTC P0442 Stored Current Or History

Brand:	Model:	Model Year:		VIN:		Engine:	Transmission:
		from	to	from	to		
Chevrolet	VOLT	2016	2017	All		1.5L (RPO L3A)	N/A

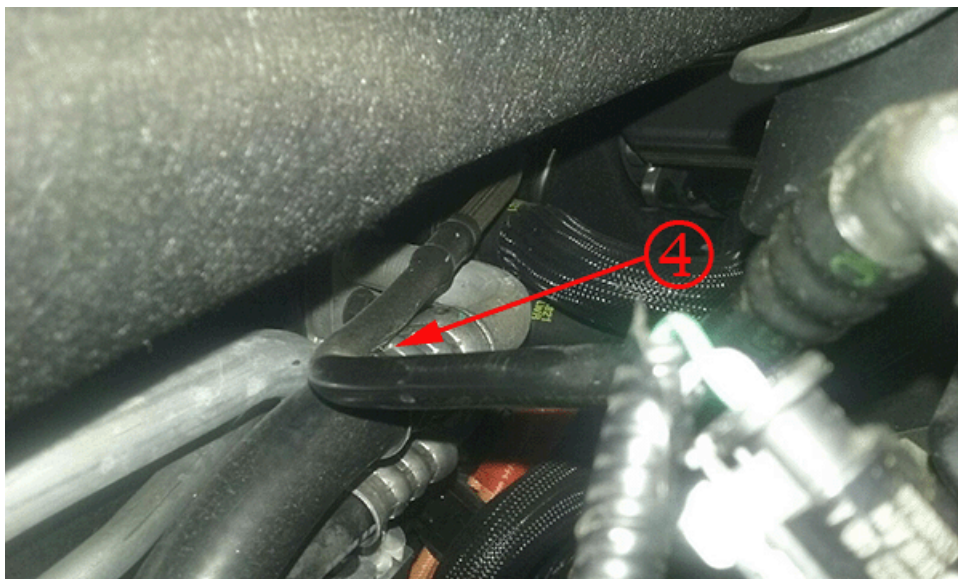
If this concern is experienced, advise the technician to inspect the evaporative emissions purge solenoid pipe for contact damage at the AC evaporator core hose as shown below.

Numbers 1-4 below, show the area of contact. Number 5 shows the damage caused by the contact.

If the damage shown below is found, replace the evaporative emissions purge pipe.
