Bulletin No.: PIT5511A

Service Bulletin

Subject: Cluster DIC Display Dims Or Fades With High Temperature (Normal Operation)

Models: 2014 Chevrolet Silverado 1500

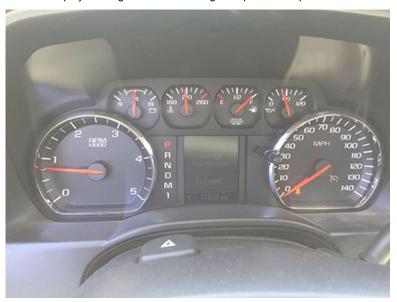
Some owner's may comment that the DIC display in the cluster will dim or fade, as shown below. It may be noticed this concern occurs when the interior is very warm/hot from the sun load or from extended heater operation. It can also occur after extended vehicle use.

The DIC display is designed to dim with high temperature exposure. This is done to protect the DIC display from damage.

None. If the DIC display is dimming due to high temperature exposure, it is performing as designed.
