Preliminary Information

PIP5491 Intermittent service 4wd messages displayed in the DIC

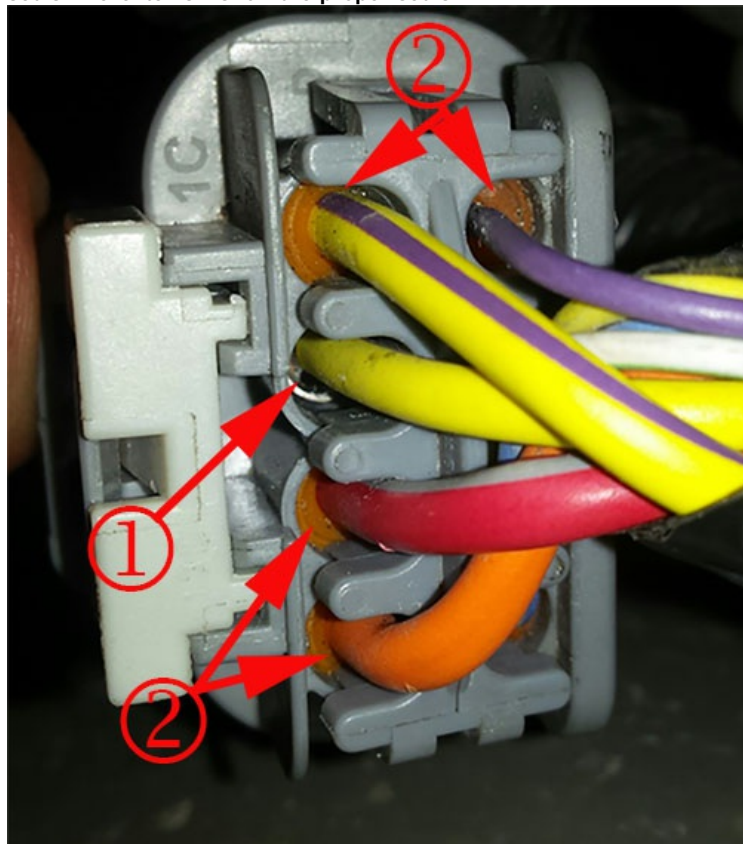
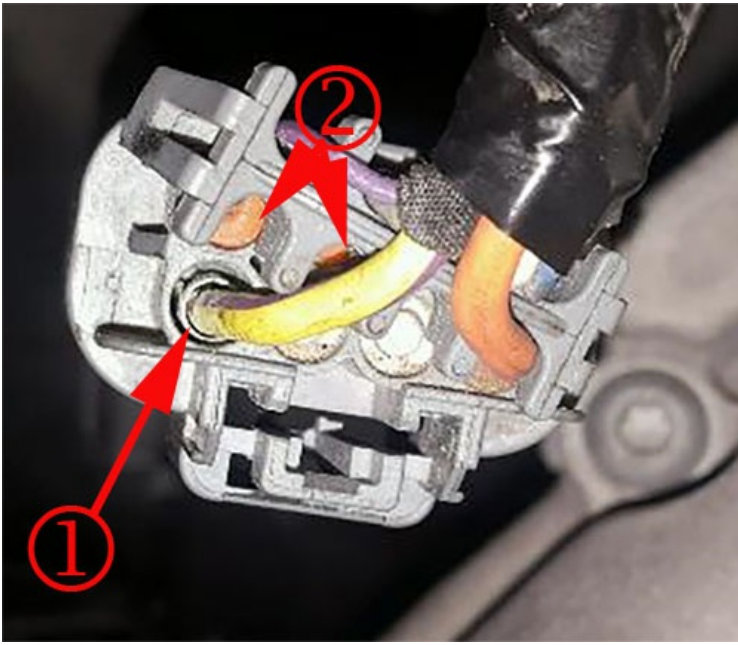
When diagnosing intermittent transfer case control module DTCs related to signal or circuit integrity including C0321, C0392, C0396, C0398, C0306, C039E, C038D inspect the related connectors and ensure that the seals are properly installed in the connectors. Missing seals allow moisture inside the connector and will cause repeat conditions and or different intermittent conditions. Items number 1 below show missing seals where items 2 show the proper seals.

Some connectors are serviced as a connector, some have terminated leads and some are available as harness only. If there is corrosion in the connector and has to be replaced, the mating side of the connector should also be replaced whether it is another connector or electrical component. Example if the connector at the transfer case actuator is replaced due to a missing seal and corrosion is present the transfer case actuator should also be replaced. In this instance use the appropriate labor operation for the wiring repair performed and if component replacement is required submit that as net amount.
