Preliminary Information

PIT5447B Buzz / Rattle Noise From Dash Or Front Of Vehicle

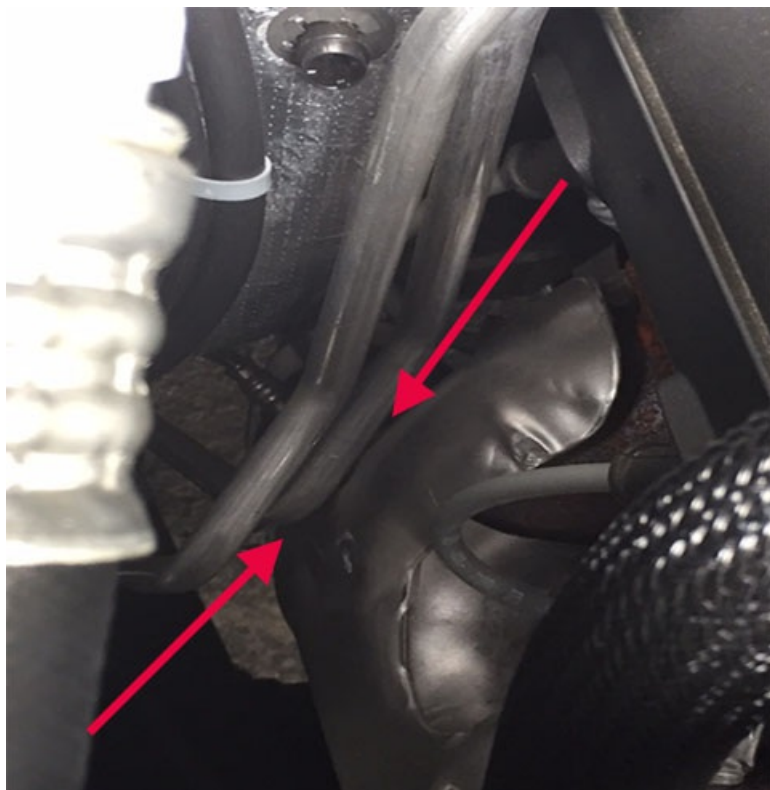
Some customers may comment that they hear a rattle or buzz noise from the dash or front of the vehicle. It may be most noticeable with engine RPM or when turning left or right.

Inspect for the rear heater pipes contacting the passenger side exhaust manifold. If the rear heater pipe is found to be contacting the exhaust manifold (as shown below), reposition the heater pipe so it no longer makes contact.
