# Preliminary Information

PIT5577 SIR MIL On, Service AWD or Service Keyless Start Message or Fuse Open In Rear BEC.

Models

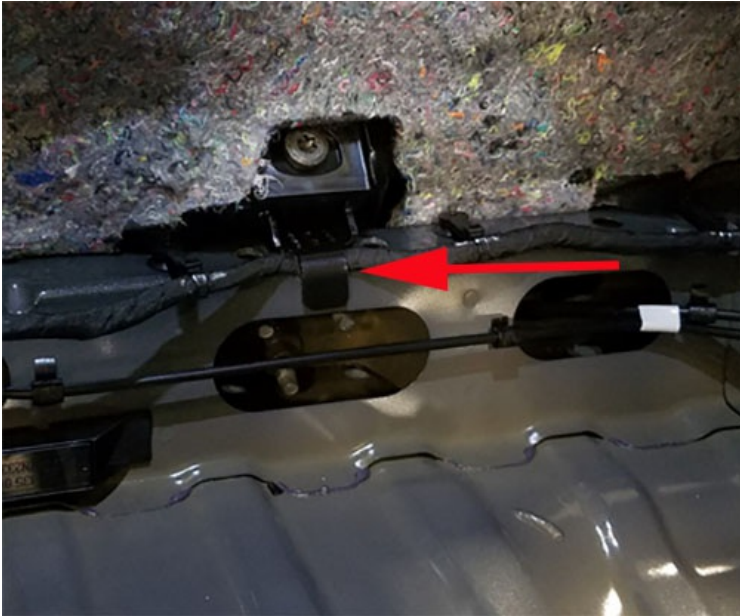
Brand:	Model:	Model Years:	VIN:		Engine:	Transmissions:
			from	to		
Chevrolet	Equinox	2018	All	All	All	All
Involved Region or Country:		North America				
Additional RPO/s:		None				
Condition:		SIR MIL on, Service AWD or Keyless Start message , fuse open in the Rear BEC.				
Cause:		Wiring harness pinched between body and seat bracket behind the rear seat.

Fold rear seatbacks down. Remove the rear cargo area trim to access harness. Inspect for damage and repair as necessary.

Follow instructions for the wiring repairs in eSI.
