Wrinkles in Front Seat Upholstery

Classification	Repair Bulletin	Section/Group	13 - Seats	Country/Region	All
Year	2016-2017	Model	Model S, Model X	Version	Premium Seats

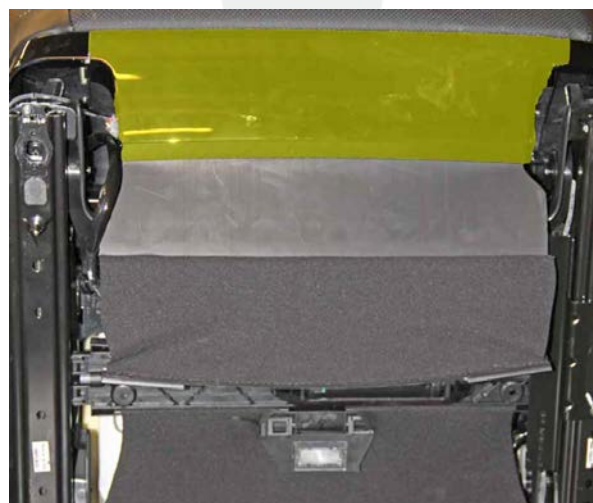
1. Prepare a padded area to place the seat on when it is removed from the vehicle.
2. Remove the affected seat from the vehicle (refer to Service Manual procedure 13040101). Place the seat upright on the padded surface.
3. Remove the front trim cover from the base of the seat (Figure 1).

Figure 1 (Front trim cover highlighted)

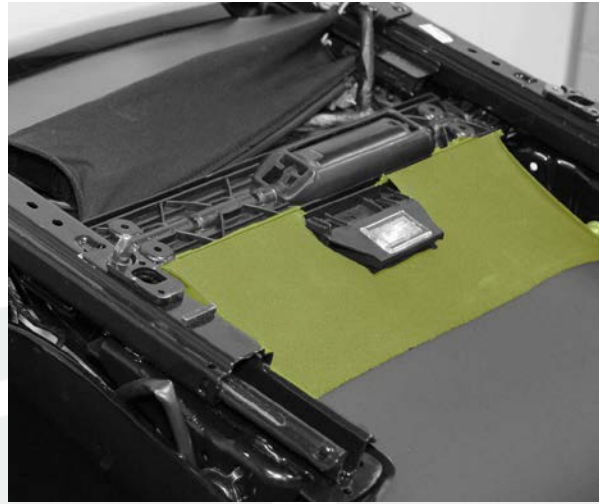
6. Use a pick or similar tool to release the rear lower cover from the underside of the seat (Figure 2).

Figure 2 (Rear lower cover highlighted)

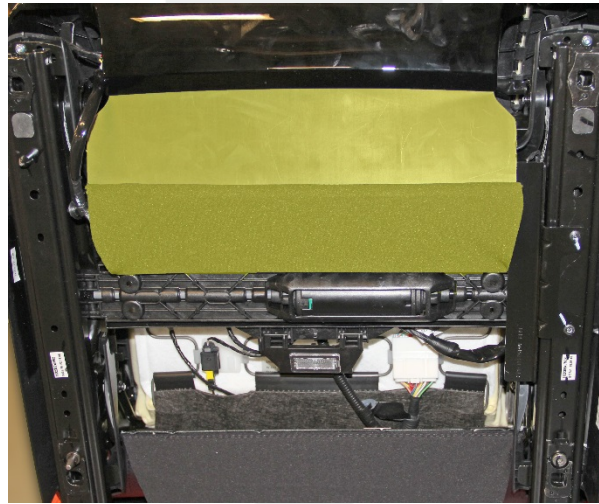
7. Use a pick or similar tool to release the front lower cover from the underside of the seat (Figure 3).

Figure 3 (Front lower cover highlighted)

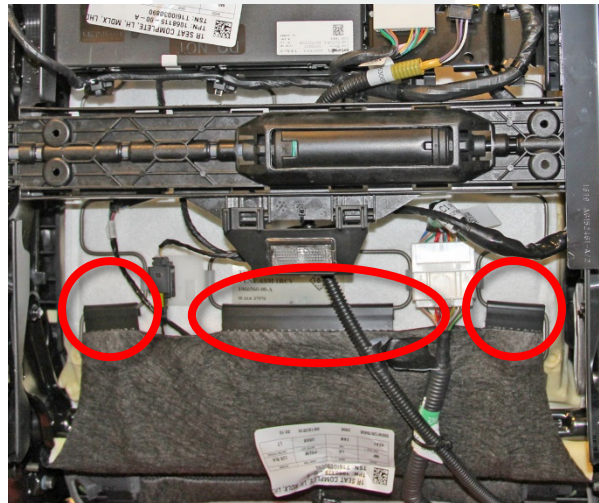
Figure 5

9. Release the J-clips that secure the seat upholstery to the cross wires on the flex mat (Figure 5).

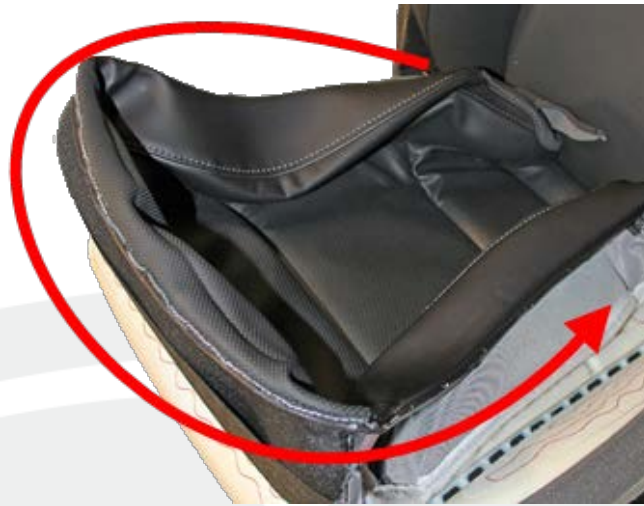
Figure 6

10. Starting from the inboard side of the seat and working around the seat edge, release the upholstery from the seat base (Figure 6).

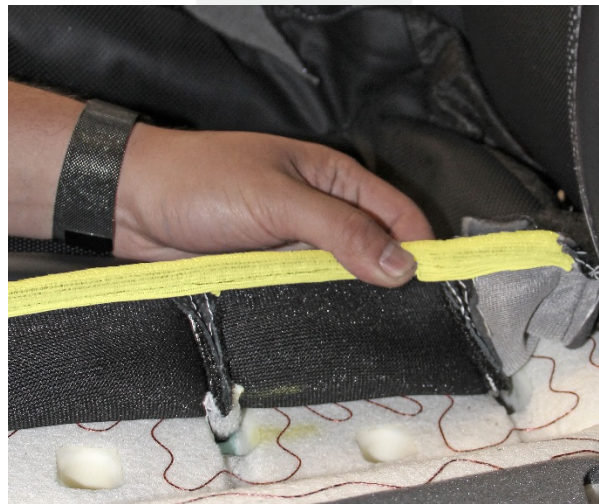
1. Fold the LH edge of the seat base upholstery inboard to expose the strip of hook-and-loop material that secures the seat base upholstery to the foam cushion (Figure 7).

Figure 7 (Hook-and-loop material highlighted in yellow)

NOTE: The strip of hook-and-loop material is folded into a cylindrical channel. The following steps explain how to insert a retention rod inside the channel of hook-and-loop material.

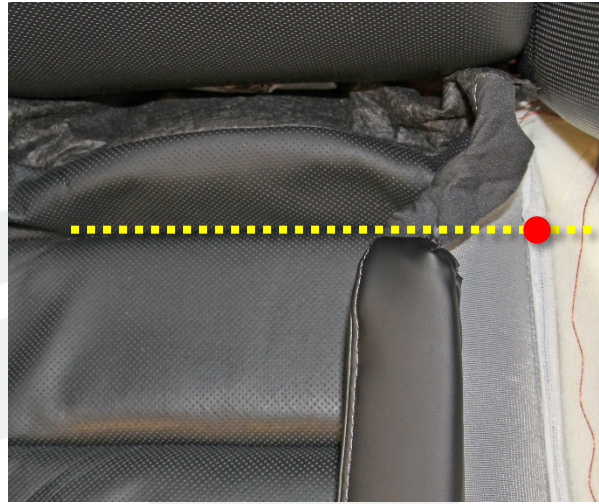
Figure 8

2. Mark a location on the strip of hook-and-loop material in-line with the rearmost seam on the seat base upholstery (Figure 8).

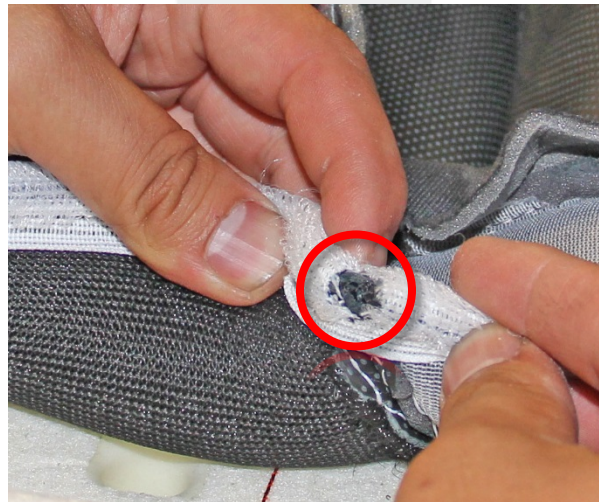
Figure 9

3. Cut an 8 mm slit in the strip of hook-and-loop material at the location that was marked in the previous step (Figure 9).

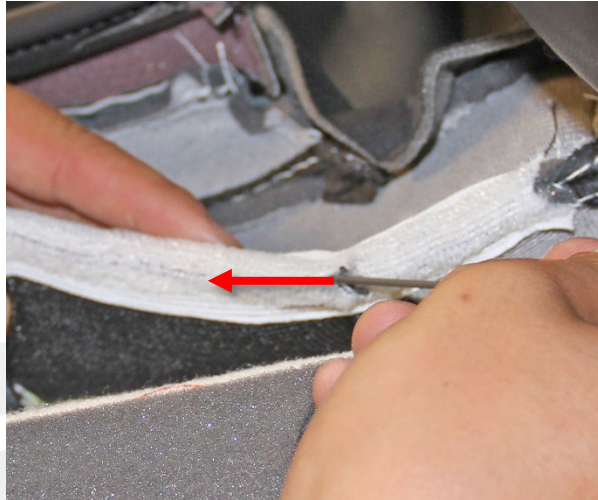
Figure 10

4. Feed the rod through the hole in the hook-and-loop material towards the front of the seat (Figure 10).

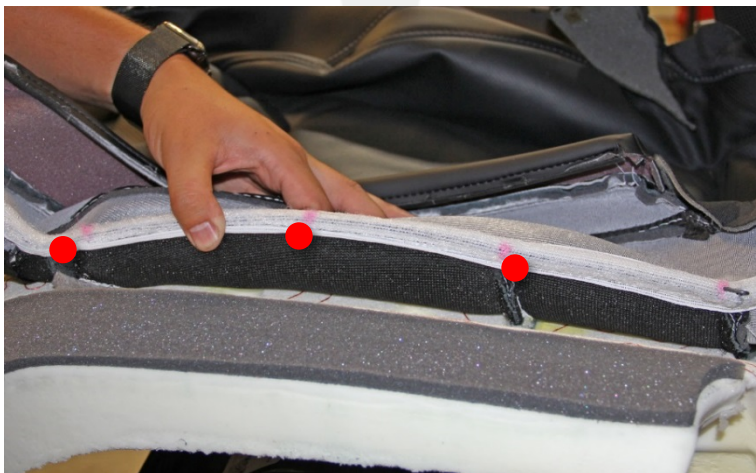
Figure 12

6. Mark 3 additional locations on the strip of hook-and-loop material (Figure 12):
 - In line with the forward-most seam on the seat base upholstery.
 - In line with the middle seam on the seat base upholstery.
 - Halfway between the forward-most and middle seams on the seat base upholstery.

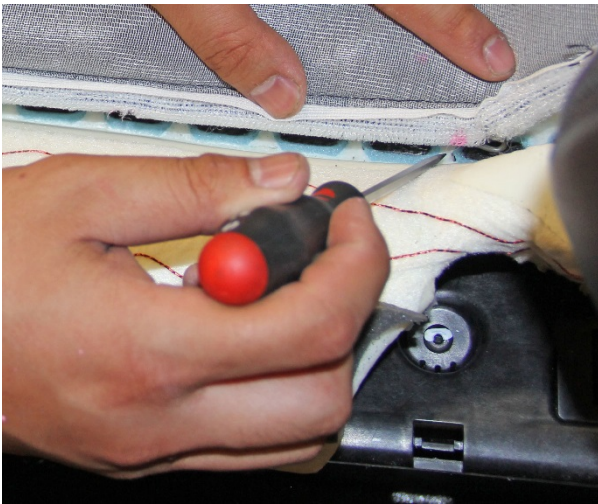
Figure 13

- Cut 8 mm slits in the strip of hook-and-loop material at the locations that were marked in the previous step.
- Align the seat base upholstery with the foam cushion. Note the location where the first hole into which the retention rod was inserted contacts the foam (Figure 13). Use a small flathead screwdriver or similar tool to make a hole through the foam (Figure 14). A cable tie will be inserted through this hole in a later step.

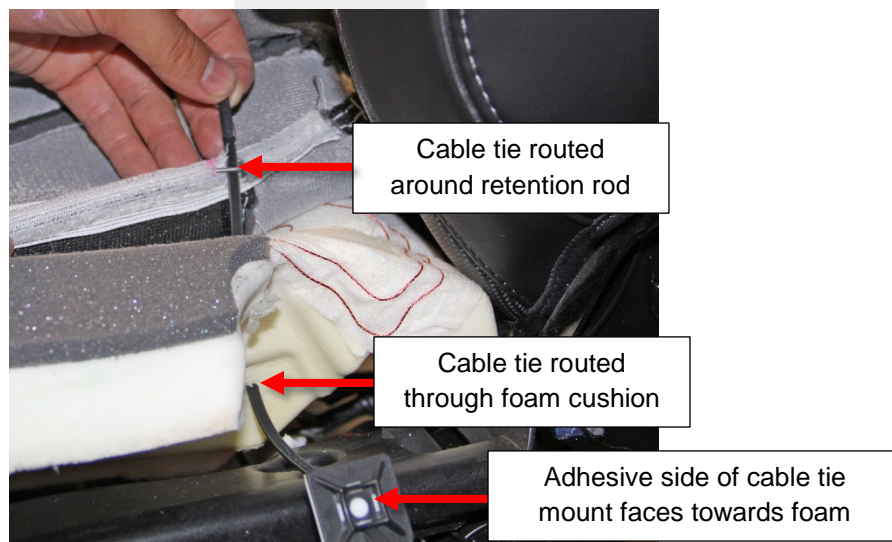
Figure 15

- Repeat the previous step for the 3 other locations that were marked on the strip of hook-and-loop material.
- Starting with the adhesive side of the cable tie mount facing the seat cushion foam, route a cable tie up through the rearmost hole in the foam and around the retention rod (Figure 15), then route it back through the hole in the foam. Loosely secure the cable tie, but do not fully tighten it.

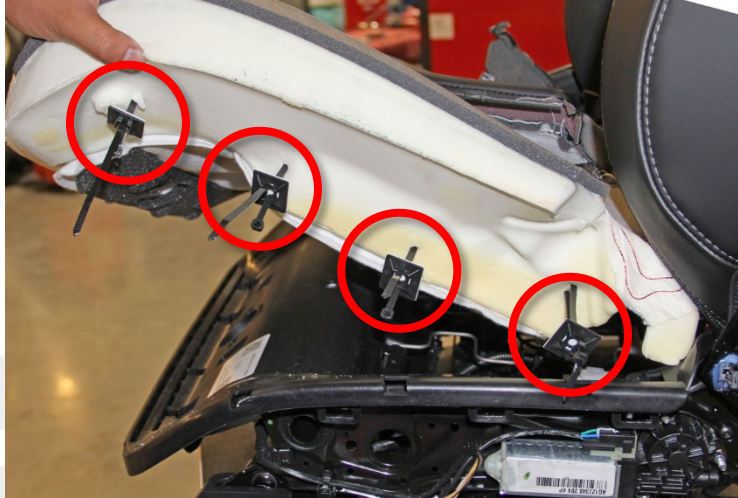
Figure 16

11. Repeat the previous step to install 3 additional cable ties and mounts (Figure 16).

12. Fully tighten all cable ties. Remove and discard any excess tie.
