**July 12, 2017**

07016 Version 2

**Product Update: MDX Accessory Temporary Spare Tire Kit**

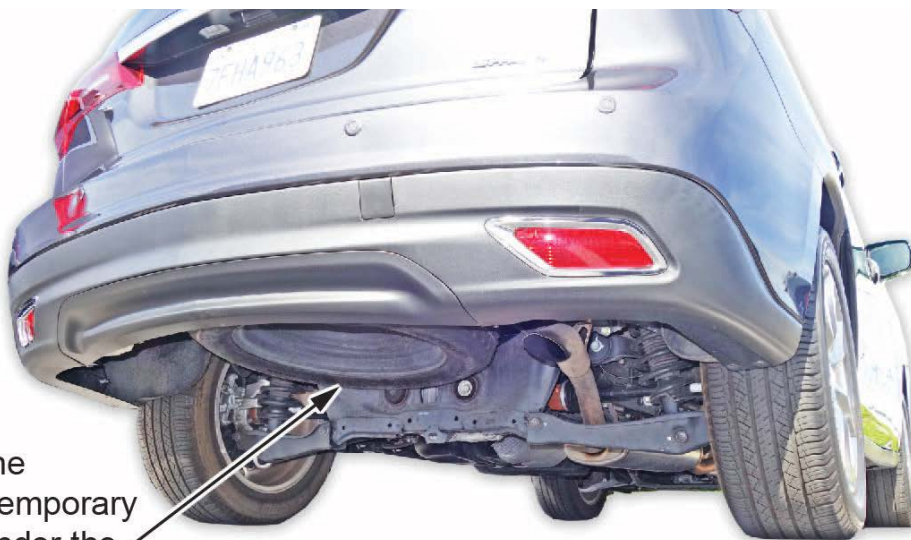
Check for the accessory temporary spare tire under the rear bumper.

1. Look beneath the rear cargo area to see if there is an accessory temporary spare tire kit installed on the vehicle.

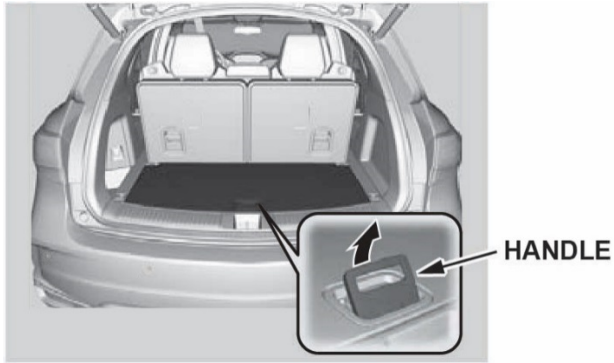
1. Open the rear tailgate.
2. Push the rear edge of the handle on the floor lid and open the lid.

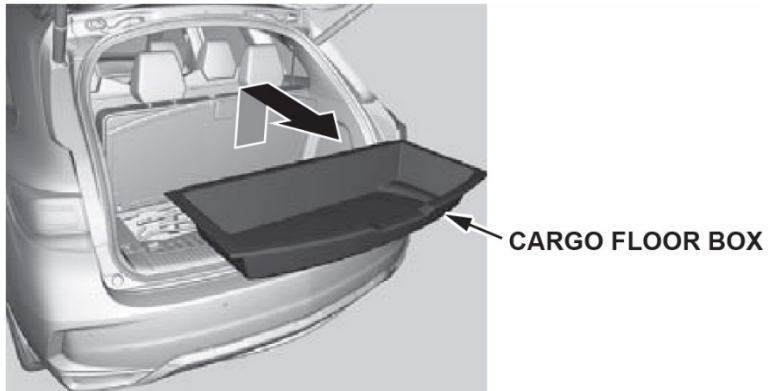
3. Take out the cargo floor box.

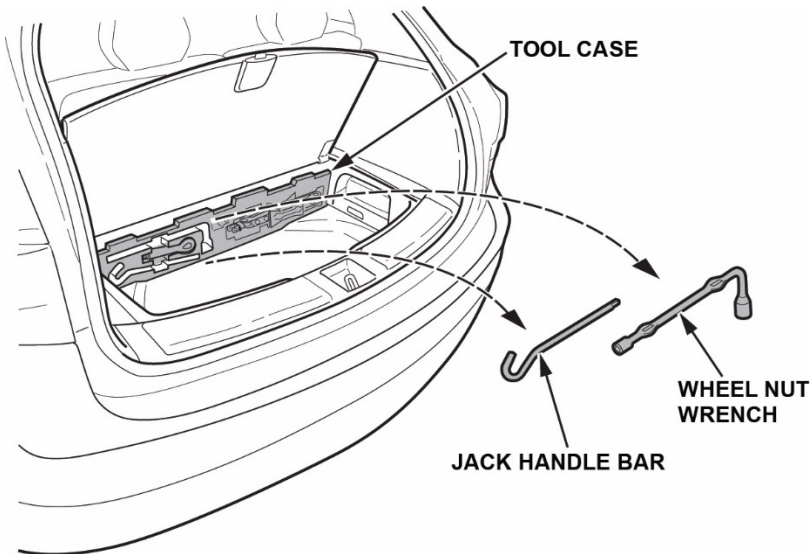
4. Take the wheel nut wrench and jack handle bar out of the tool case.

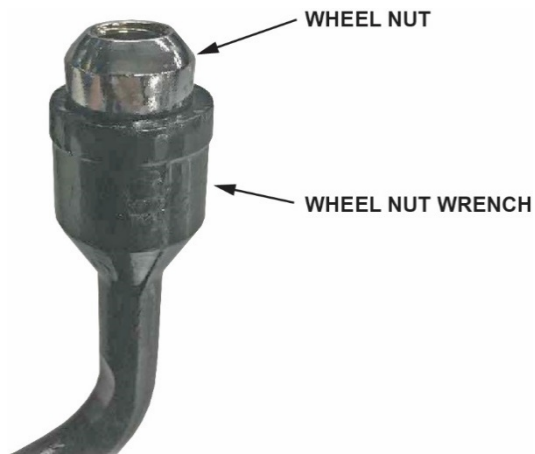
5. Check the wheel nut wrench properly fits the wheel nut on the vehicle.

No – Replace the wheel nut wrench with the correct one and go to step 6.

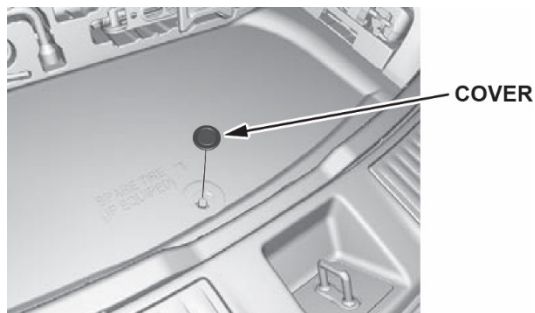
6. Remove the cover on the cargo area lining to access the shaft for the spare tire hoist.

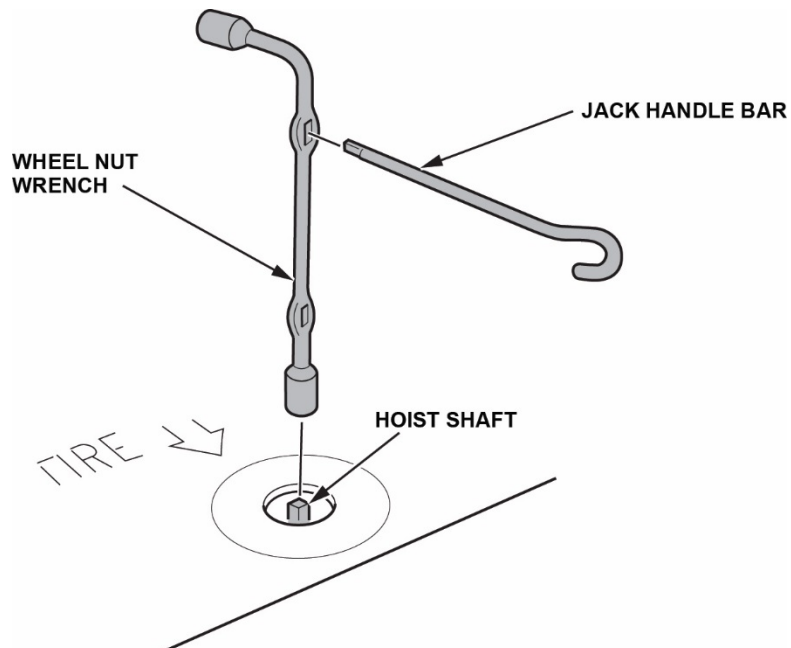
7. Put the wheel nut wrench with the jack handle bar on the hoist shaft, and turn the hoist shaft counter clockwise to lower the spare tire to the ground.

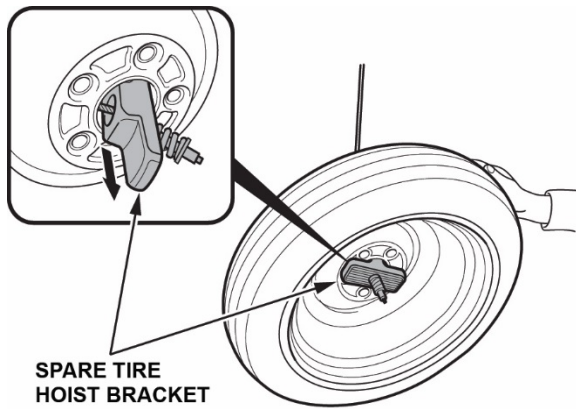
8. Keep turning the wheel nut wrench to create slack in the cable. Then, remove the bracket from the spare tire.

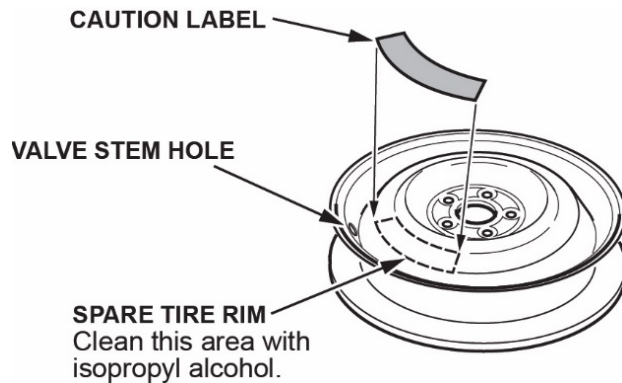
9. Using an AHM approved tire-changing machine, dismount the tire from the spare wheel you just removed from the vehicle.
10. Using isopropyl alcohol on a shop towel, clean the new spare wheel in the area shown.

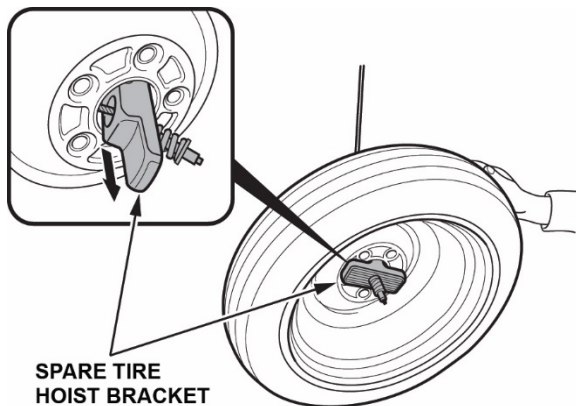
11. Remove the adhesive backing from the caution label, and attach the caution label to the new spare wheel in the area shown.
12. Install a new valve stem into the new spare wheel.
13. Using an AHM approved tire-changing machine, install the spare tire (that you had previously removed) onto the new spare wheel. Inflate the spare tire to 60 psi (420 kPa, 4.2 kgf/cm<sup>2</sup>).
14. Insert the hoist bracket into the center hole of the spare tire as shown.

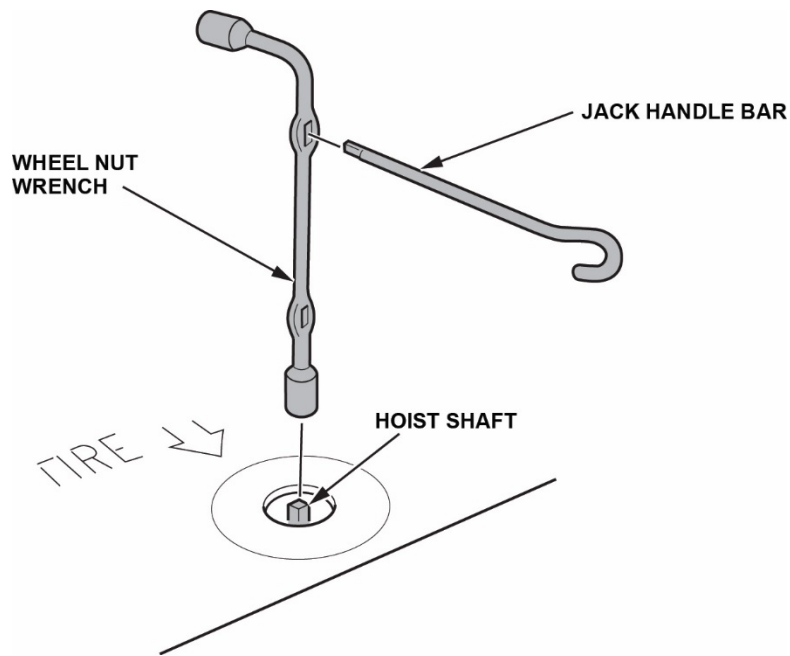
15. Use the wheel nut wrench with the jack handle bar to turn the hoist shaft clockwise until the spare tire rests snugly against the underbody of the vehicle.

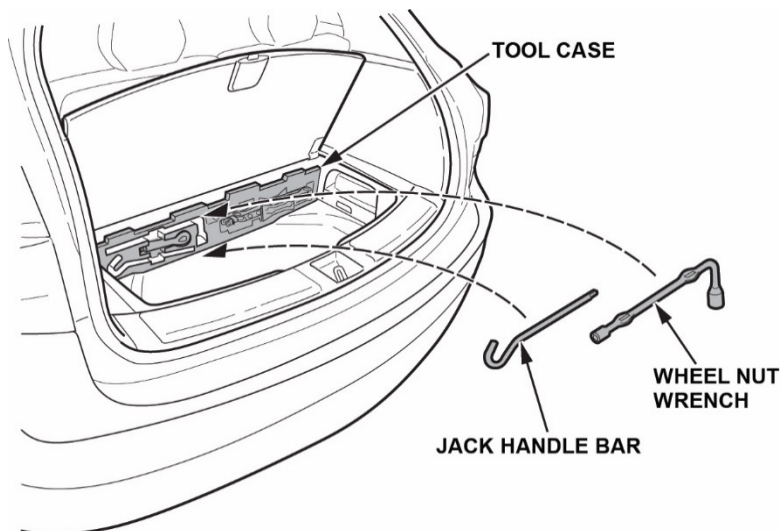
16. Install the correct wheel wrench in the tool case.
